Elaborazione differenziale integrale dal basso

Riferimento 000:30/10/2017

Sito: PMA-FS Tubo: SSI-SP02

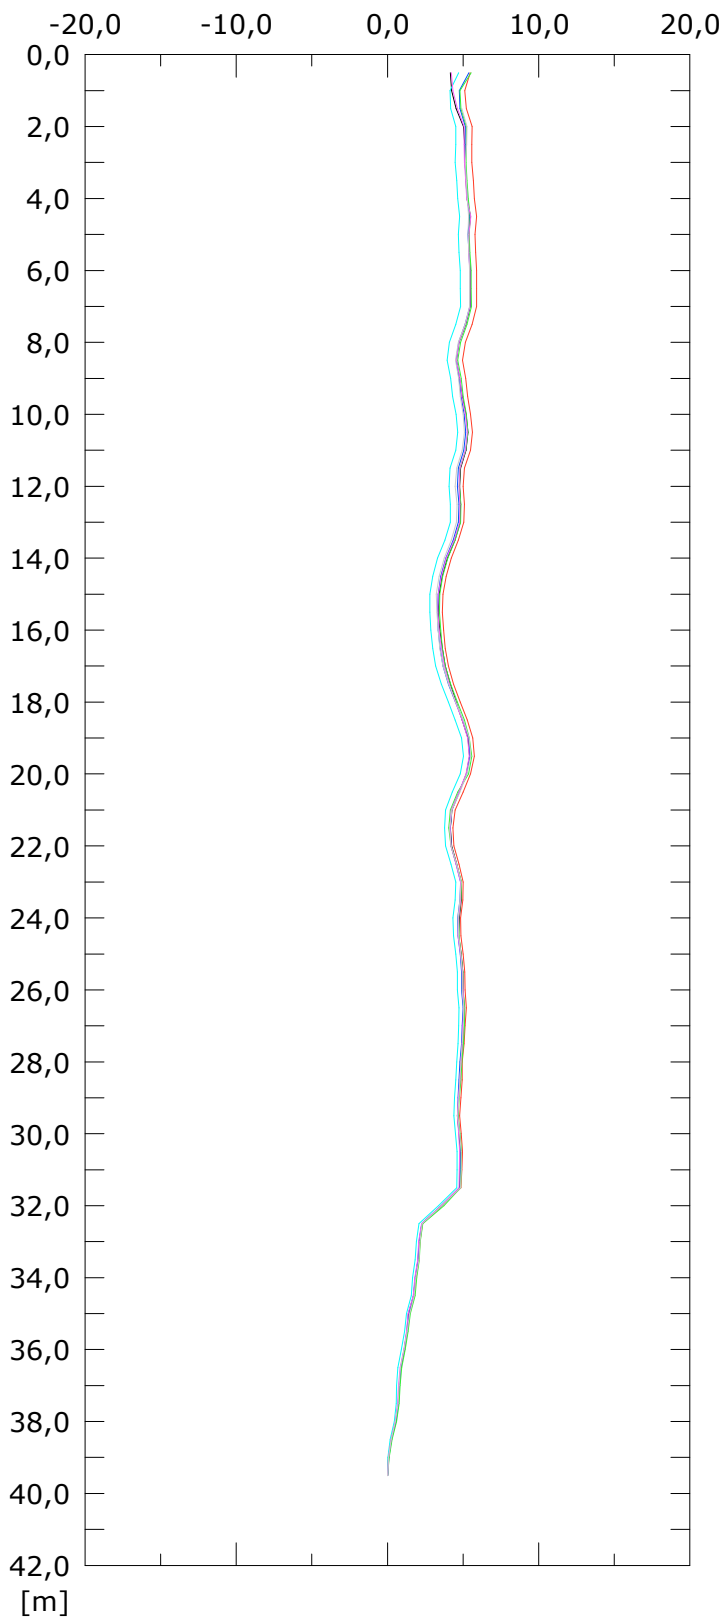
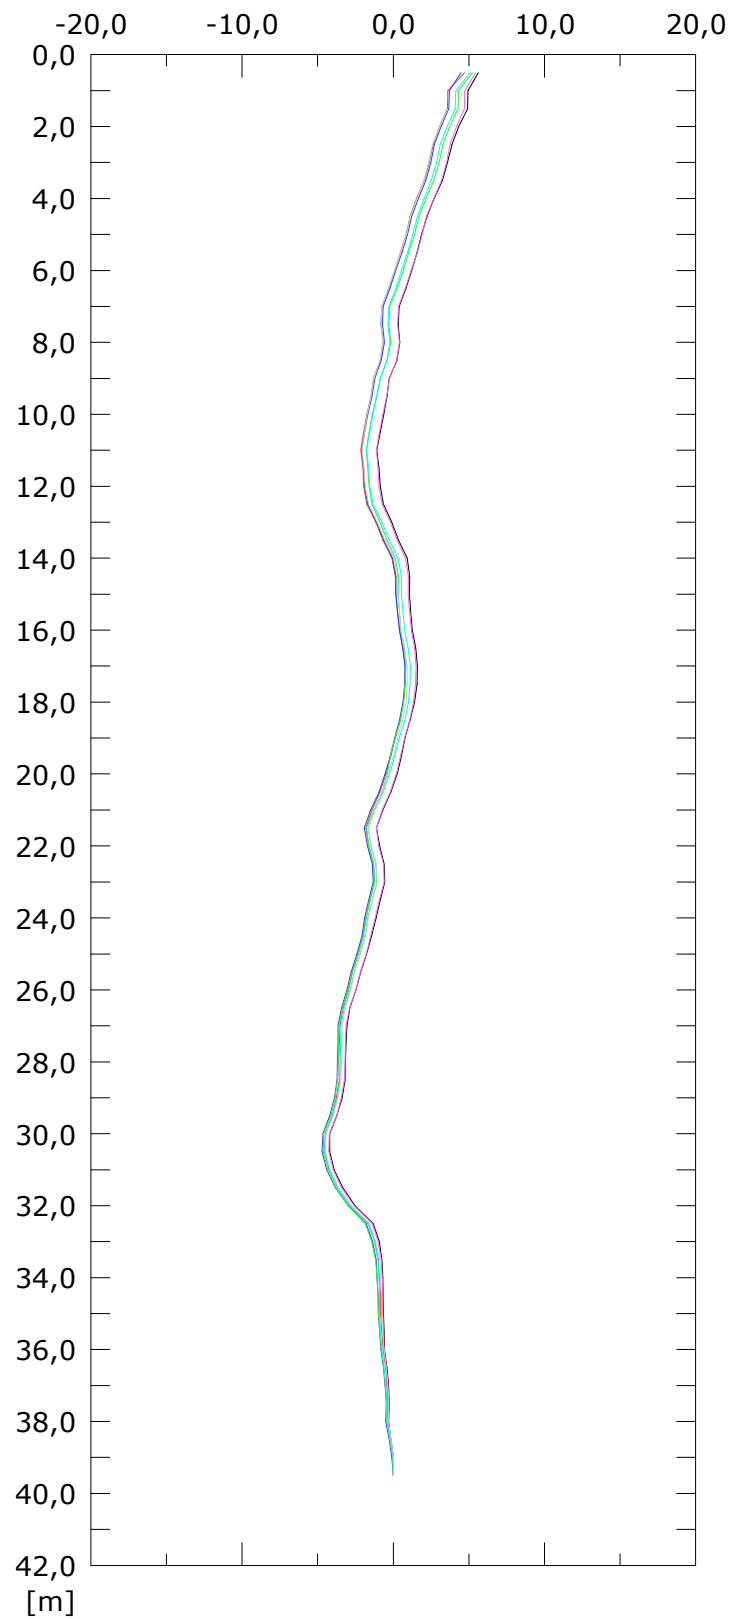
Spost. EST [mm]

Spost. NORD [mm]

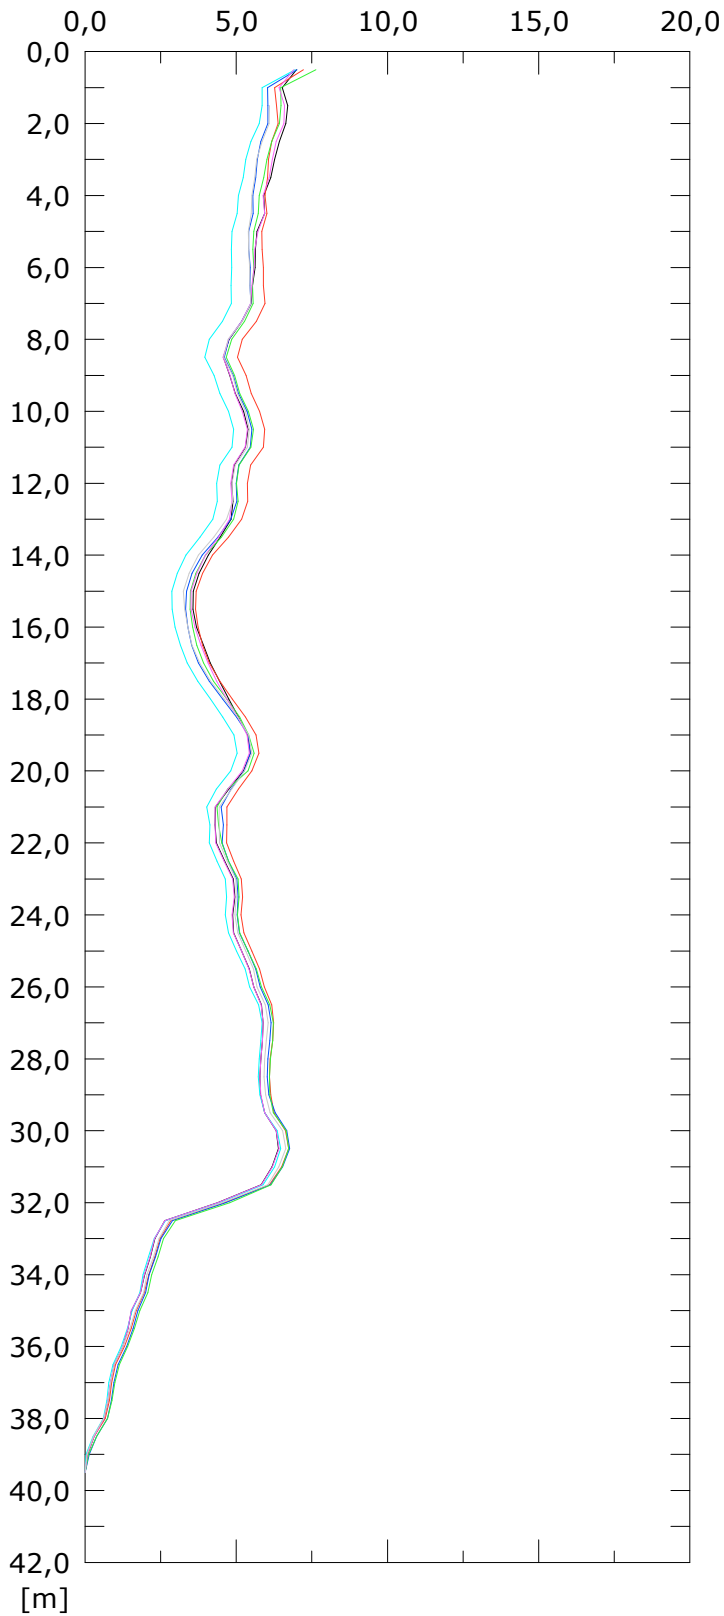
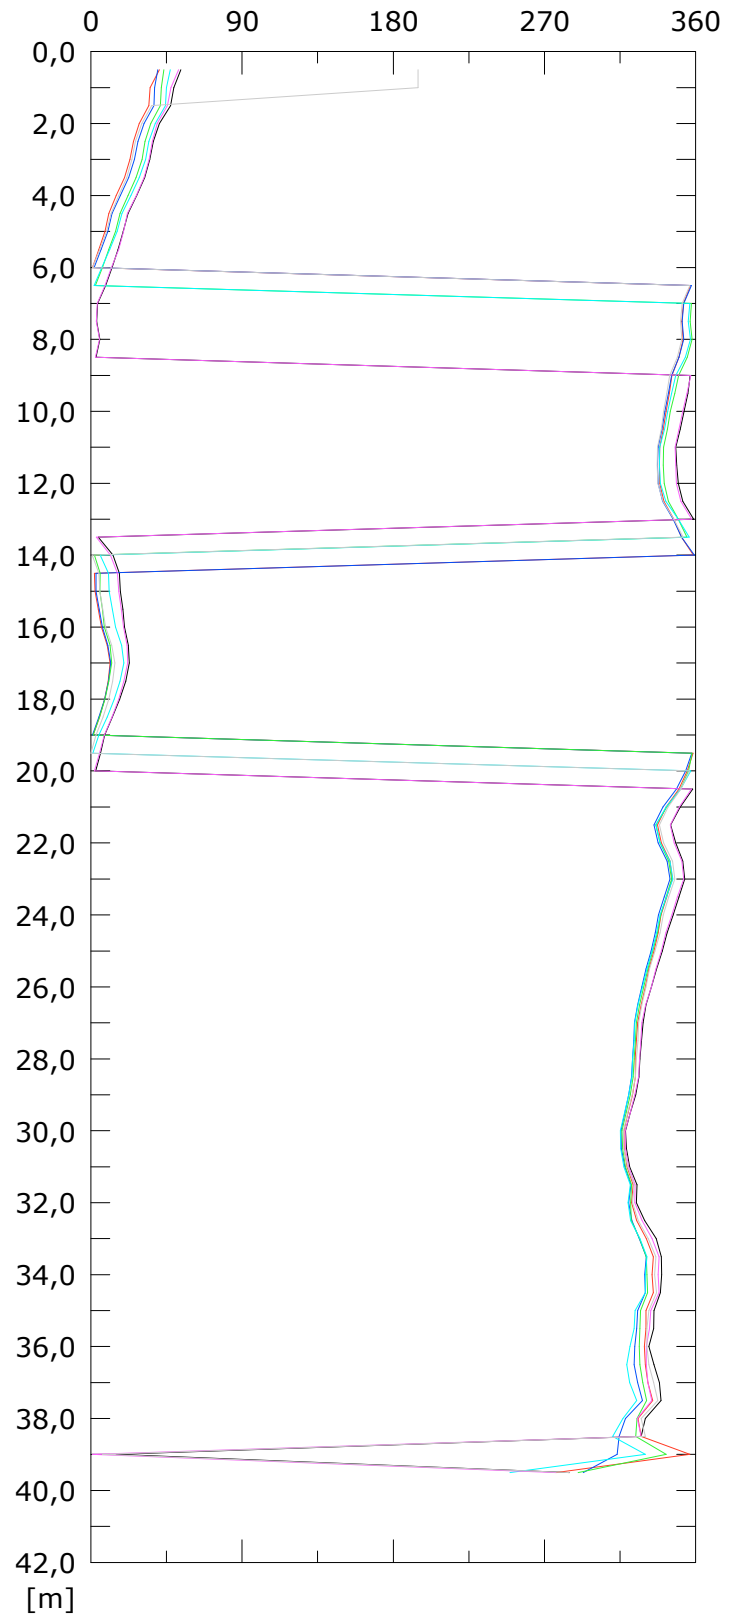
Elaborazione differenziale integrale dal basso

Risultante spost. [mm]

Angolo [gradi]

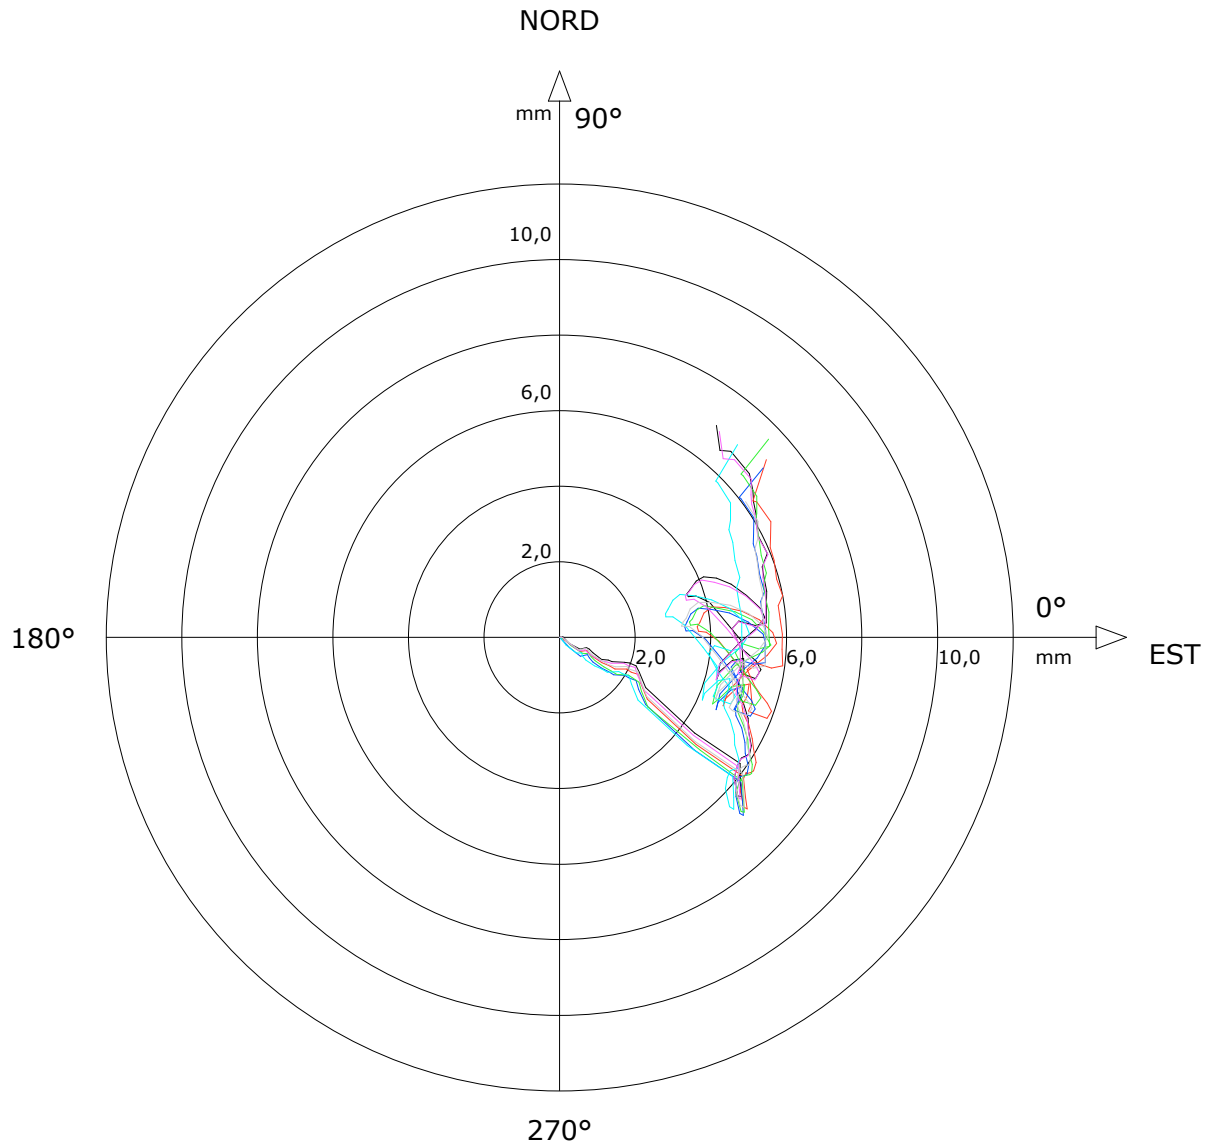
Elaborazione differenziale integrale dal basso

Diagramma polare della deviazione

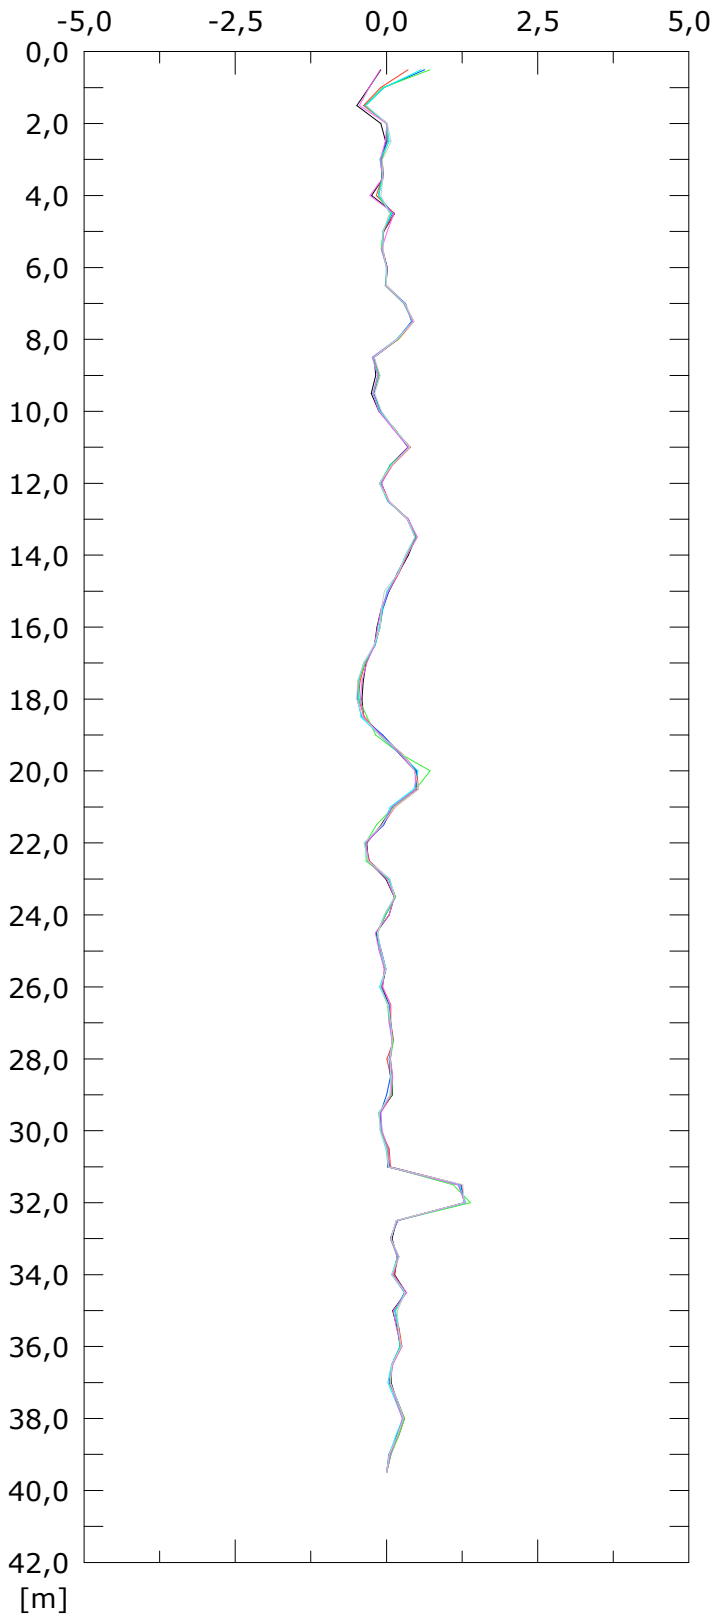
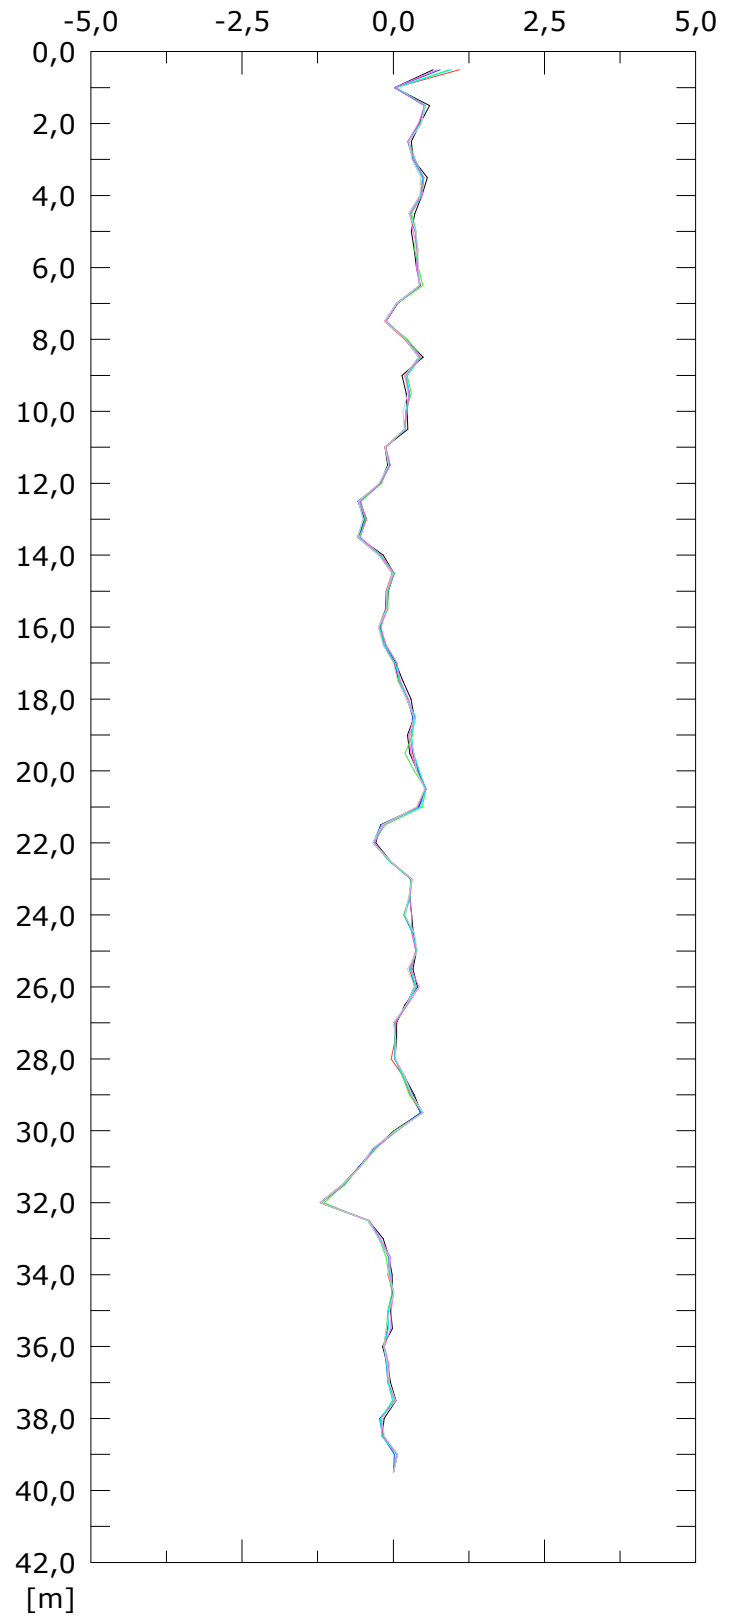
Elaborazione differenziale locale dal basso

Spost. EST [mm]

Spost. NORD [mm]

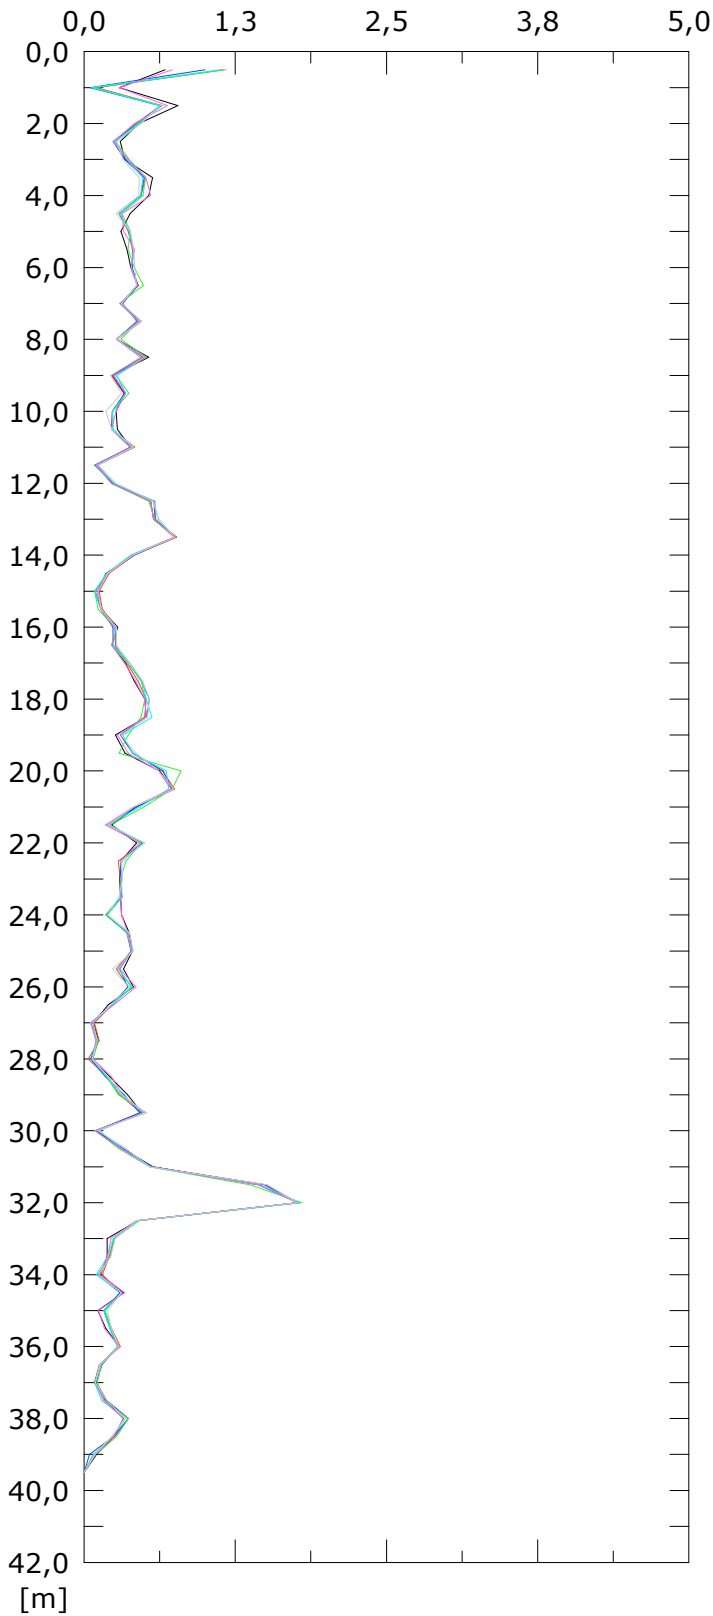
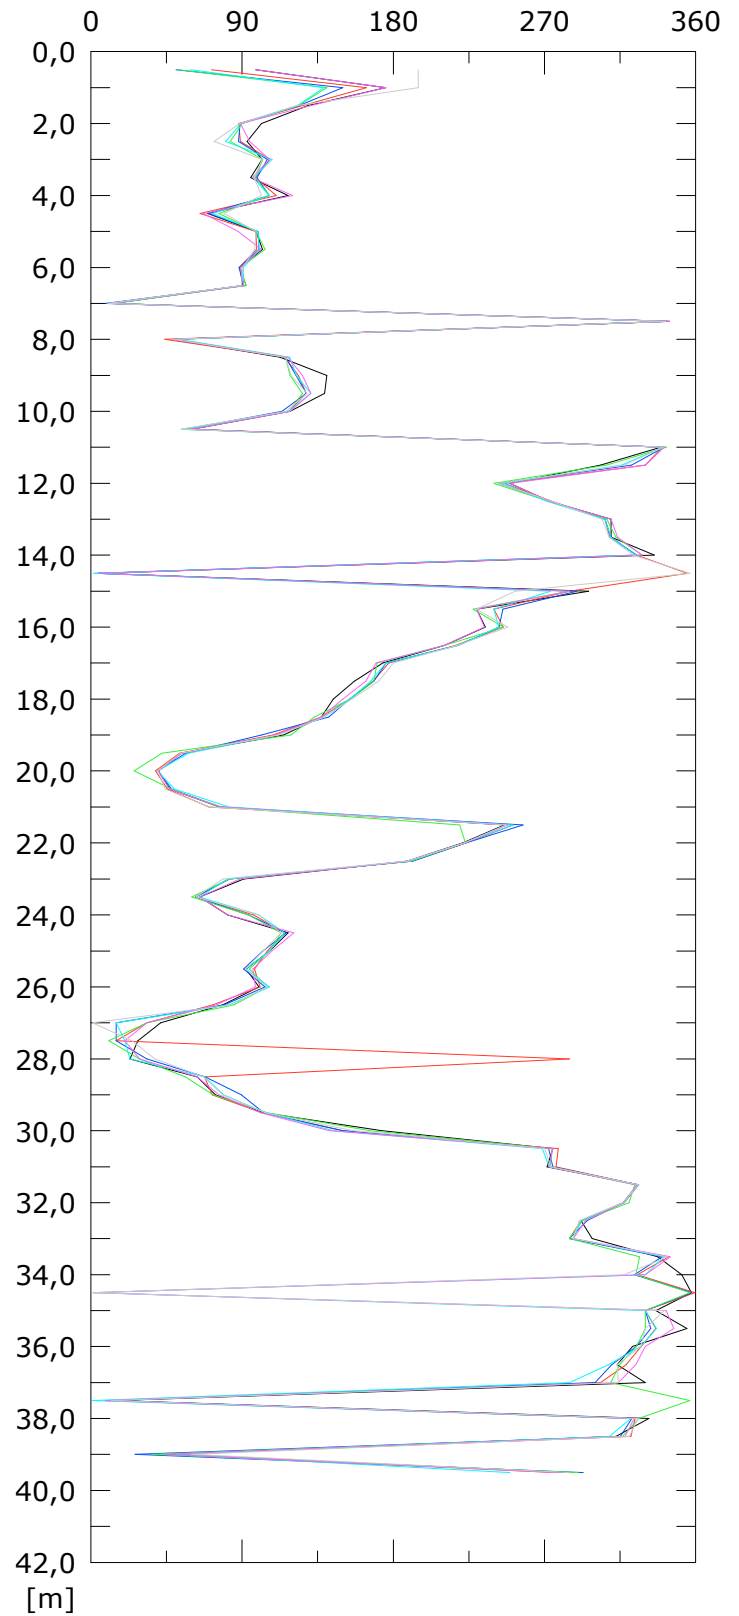
Elaborazione differenziale locale dal basso

Risultante spost. [mm]

Angolo [gradi]

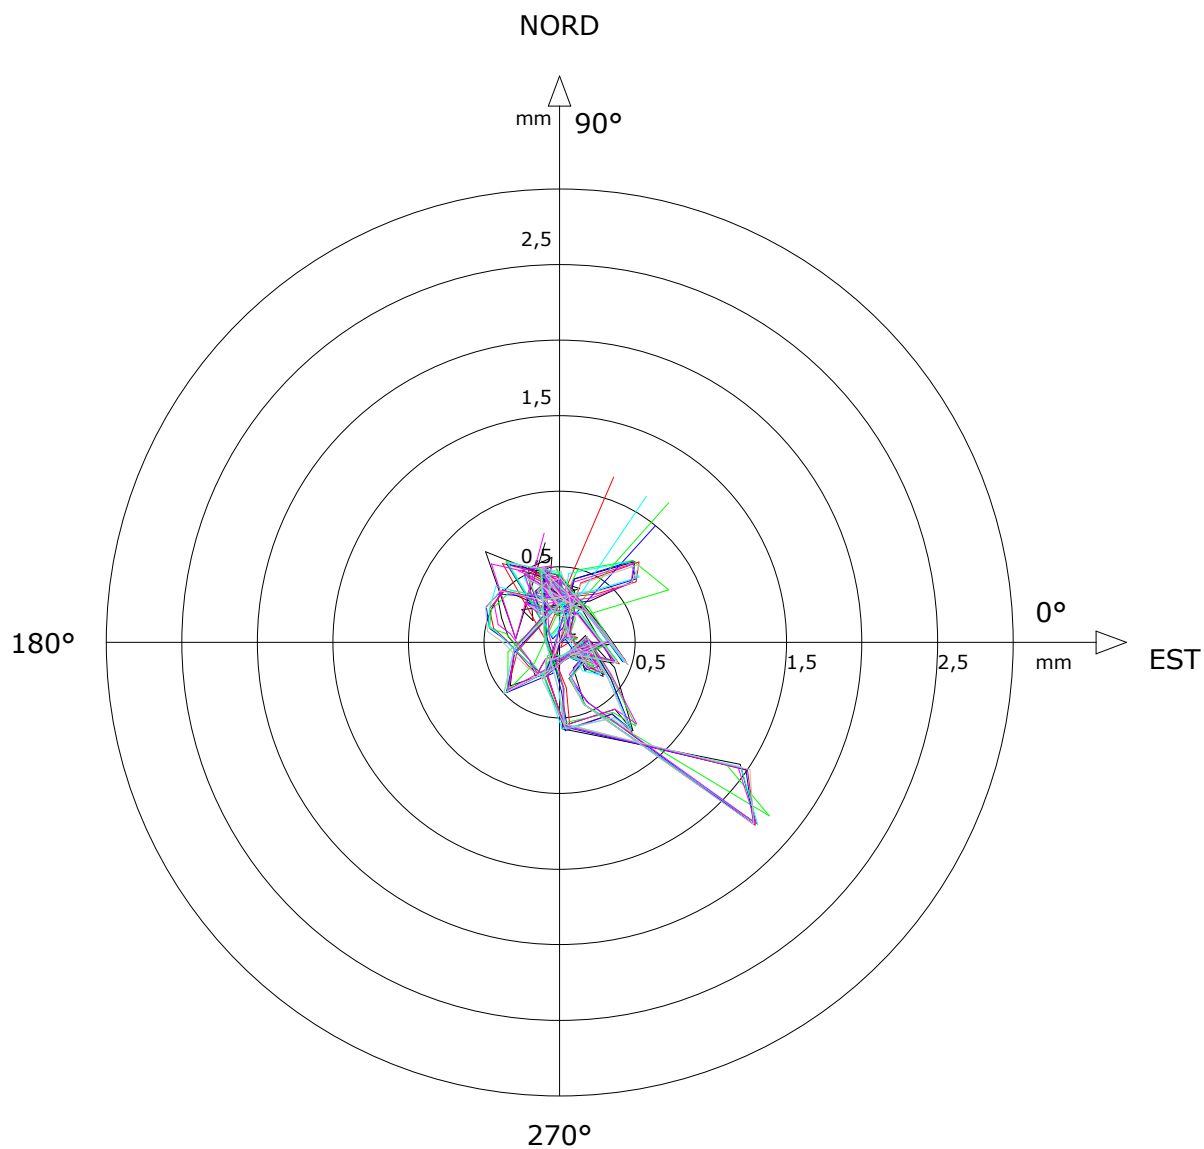
Sito: PMA-FS Tubo: SSI-SP02

Elaborazione differenziale locale dal basso

Diagramma polare della deviazione

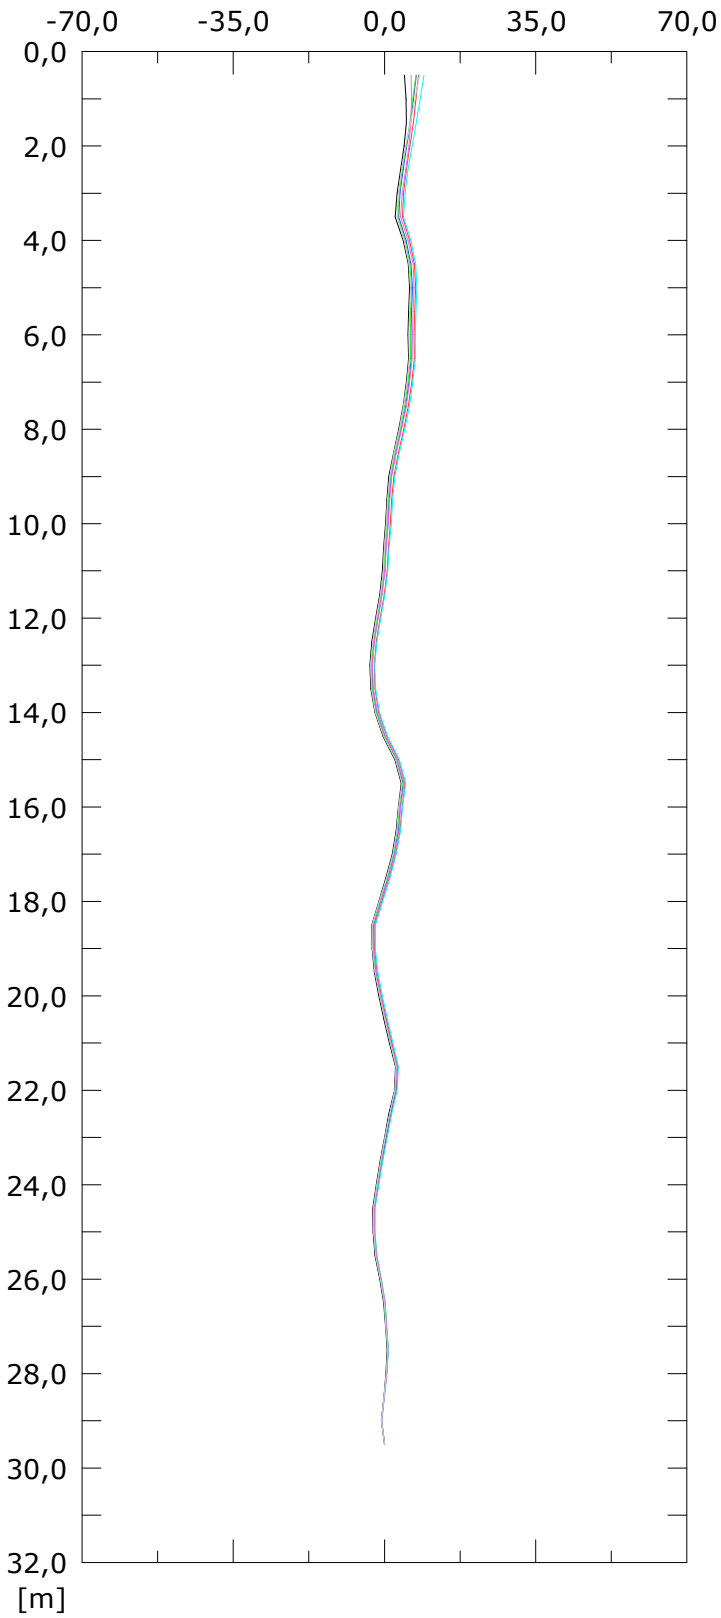
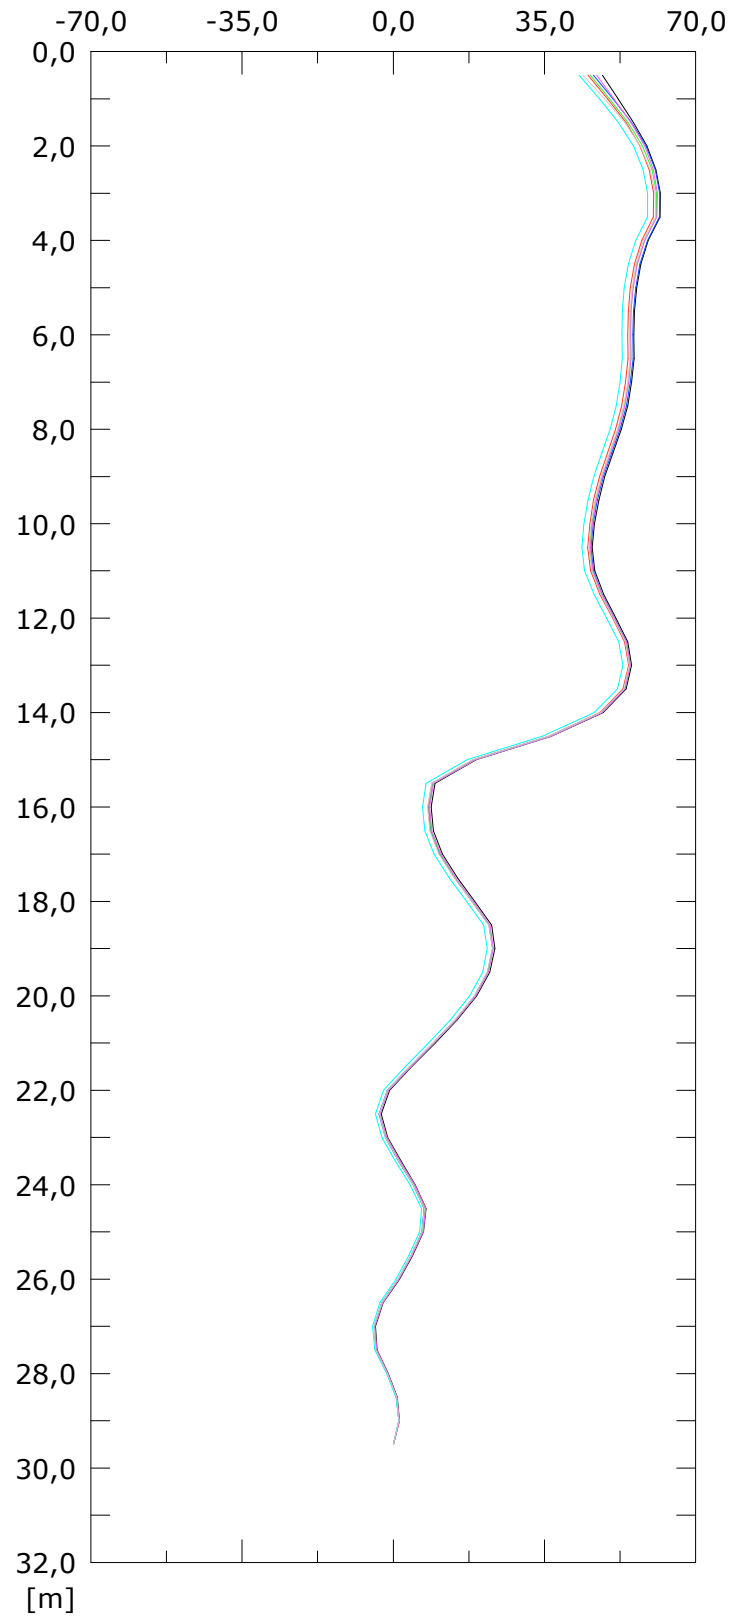
Elaborazione differenziale integrale dal basso

Spost. EST [mm]

Spost. NORD [mm]

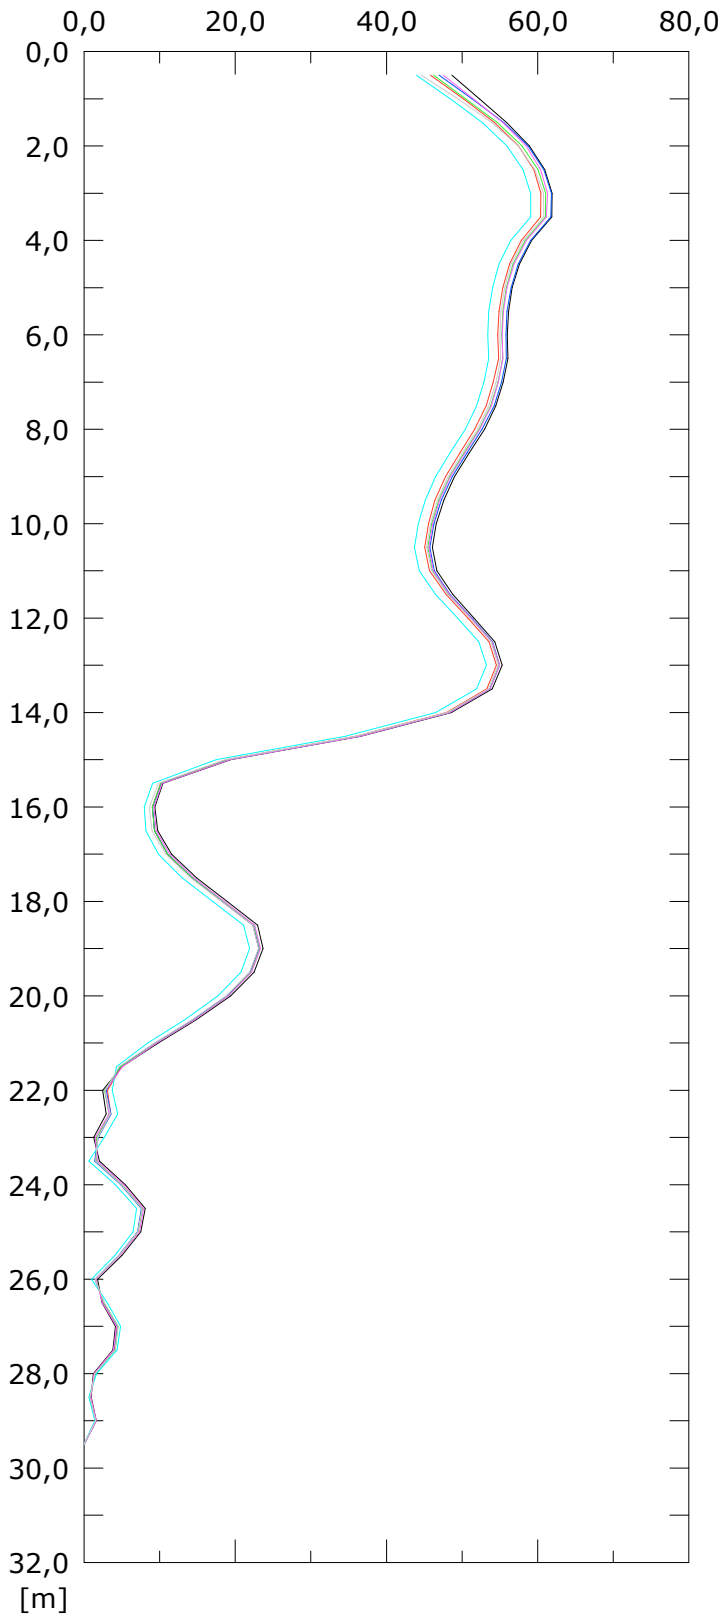
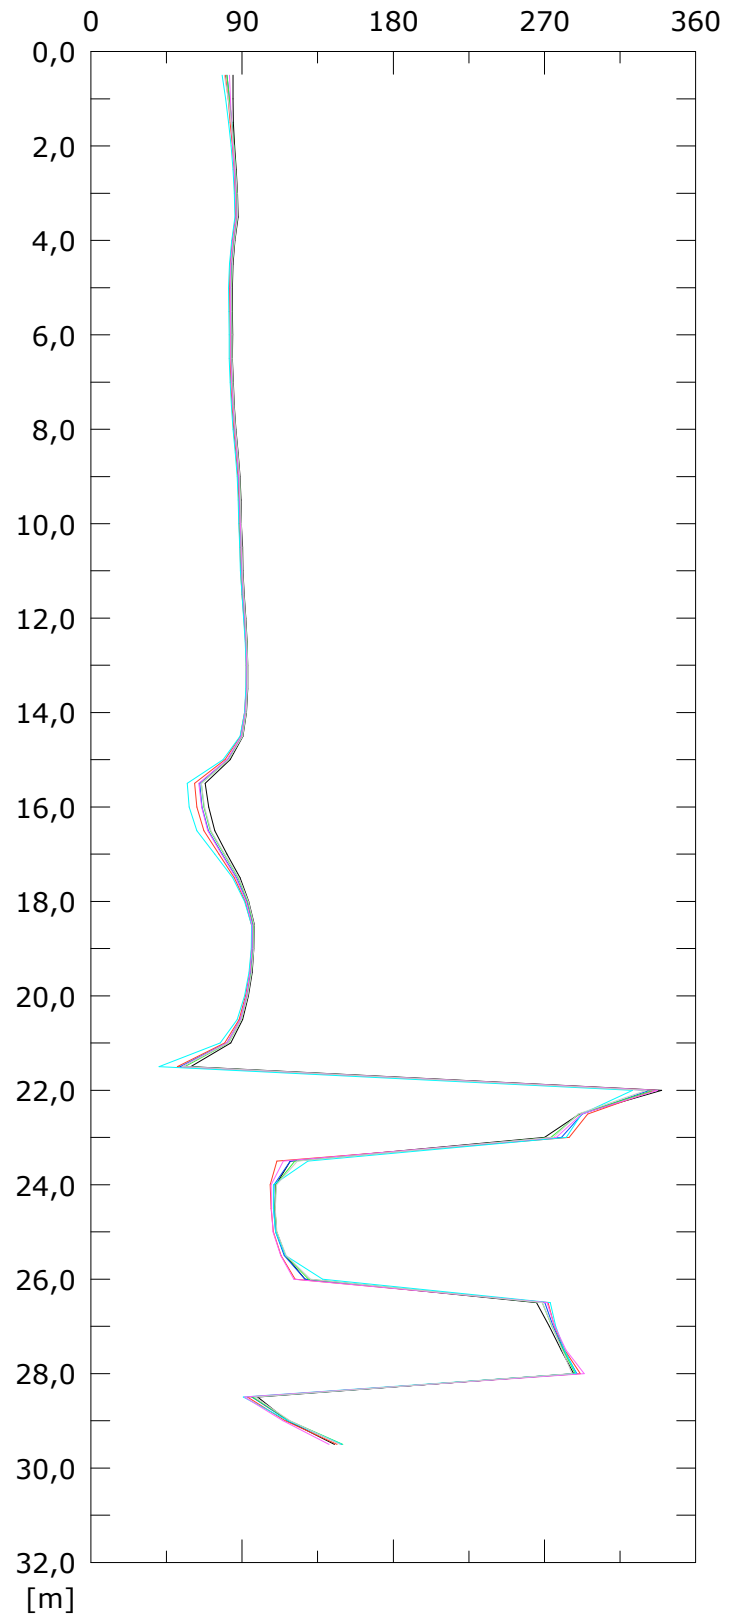
Elaborazione differenziale integrale dal basso

Risultante spost. [mm]

Angolo [gradi]

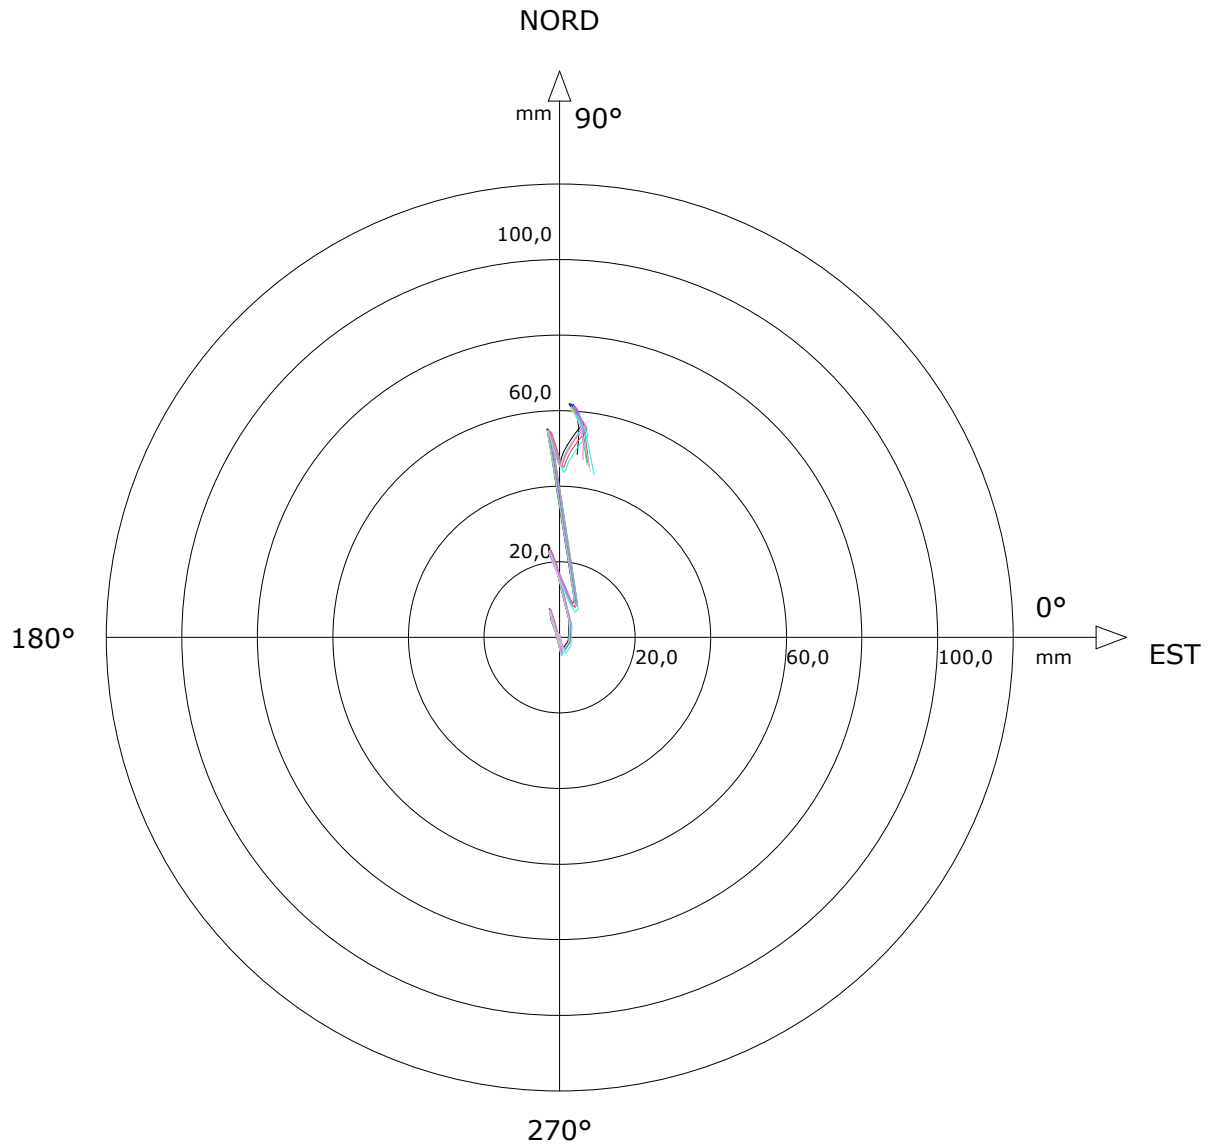
Sito: PMA-FS Tubo: SSI-SP03

Elaborazione differenziale integrale dal basso

Diagramma polare della deviazione

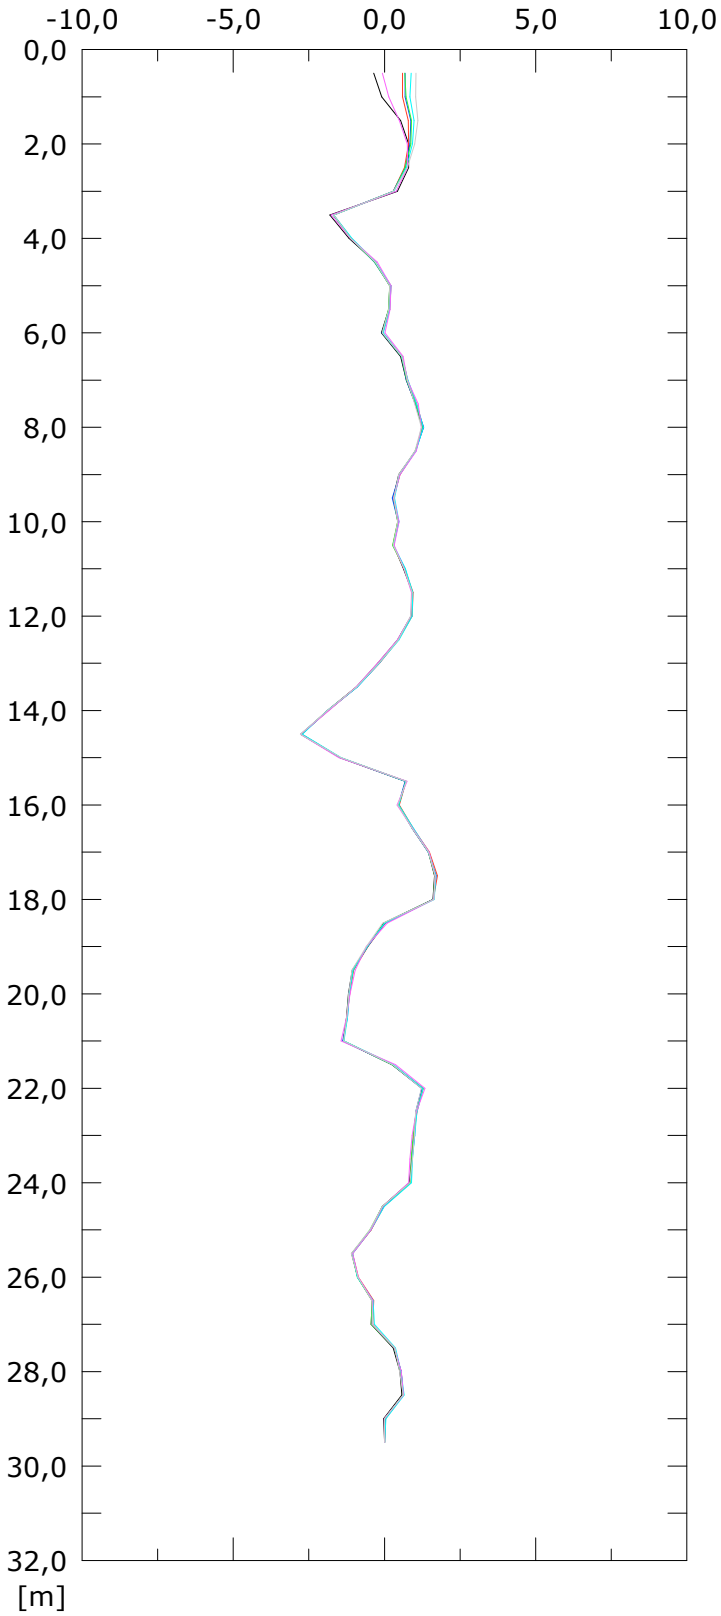
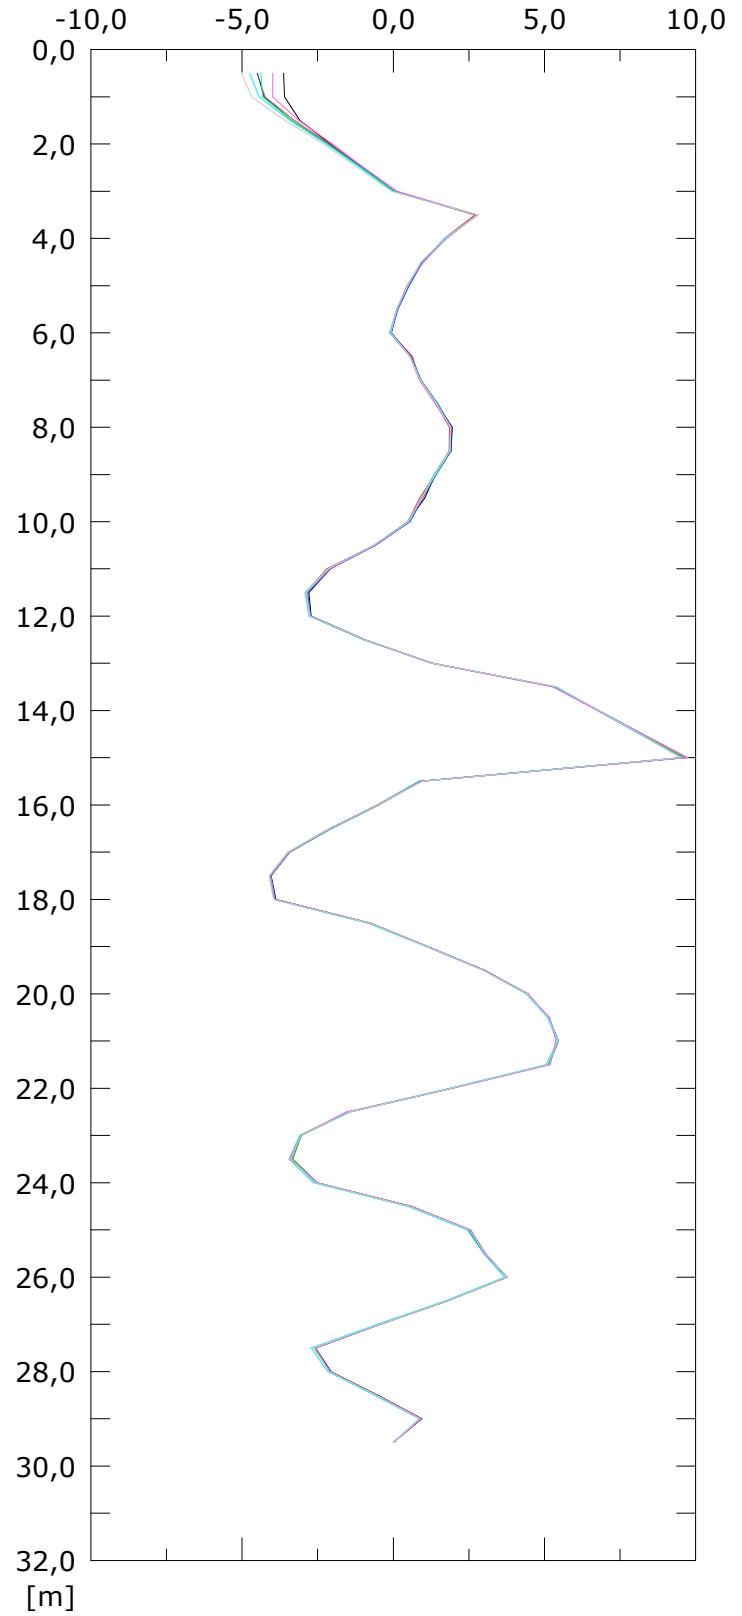
Elaborazione differenziale locale dal basso

Spost. EST [mm]

Spost. NORD [mm]

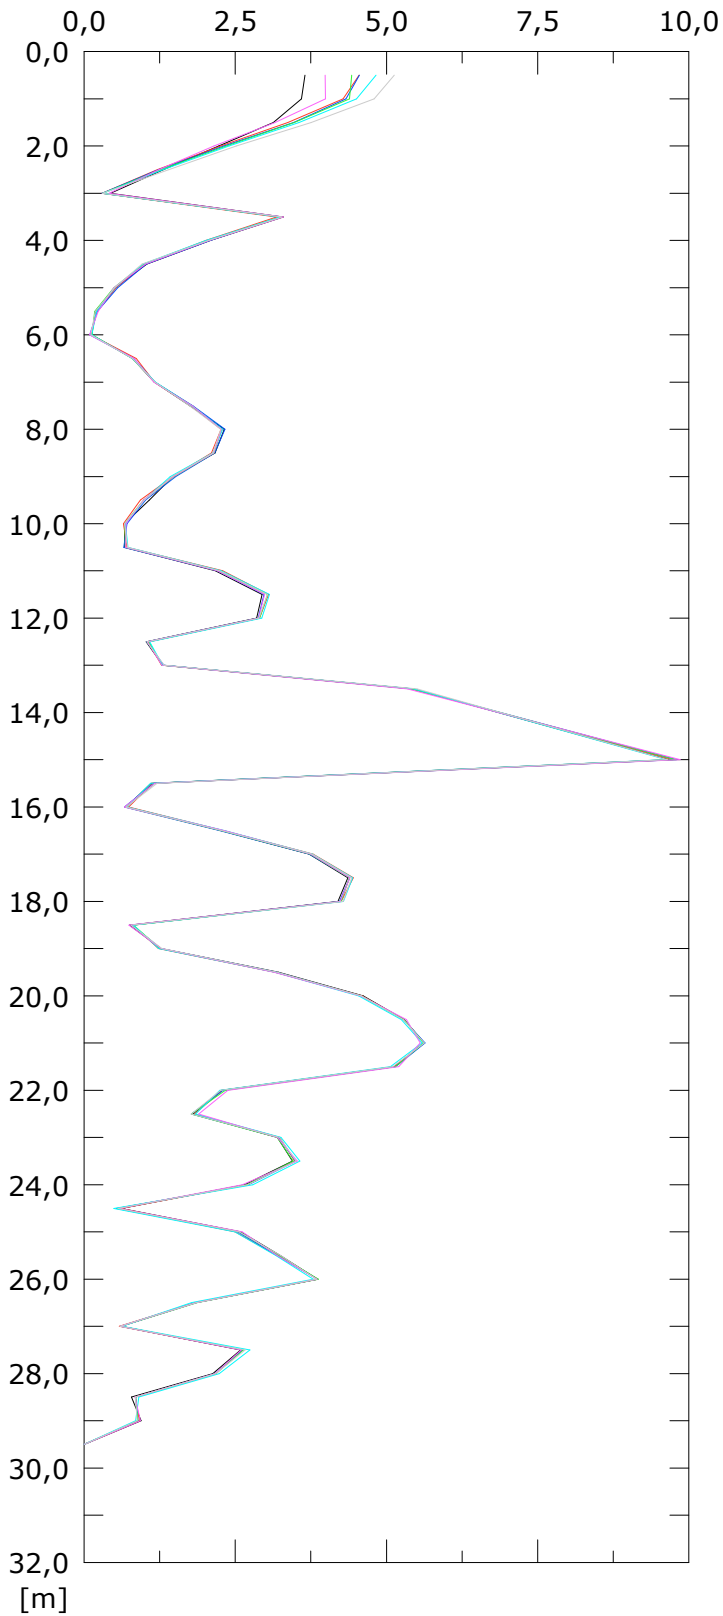
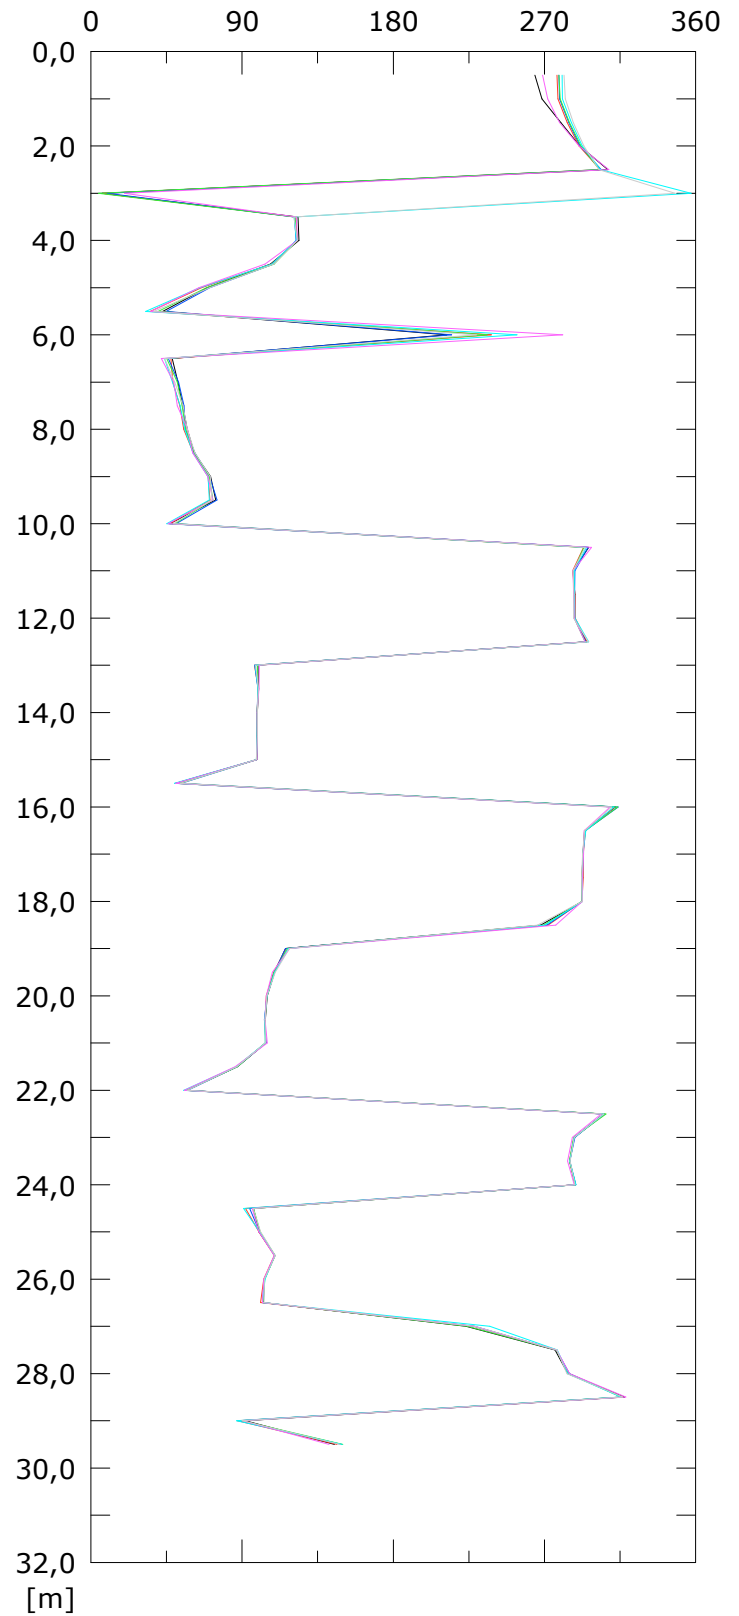
Elaborazione differenziale locale dal basso

Risultante spost. [mm]

Angolo [gradi]
