Elaborazione differenziale integrale dal basso

Riferimento 000:30/10/2017

Sito: PMA-FS Tubo: SSI-SP02

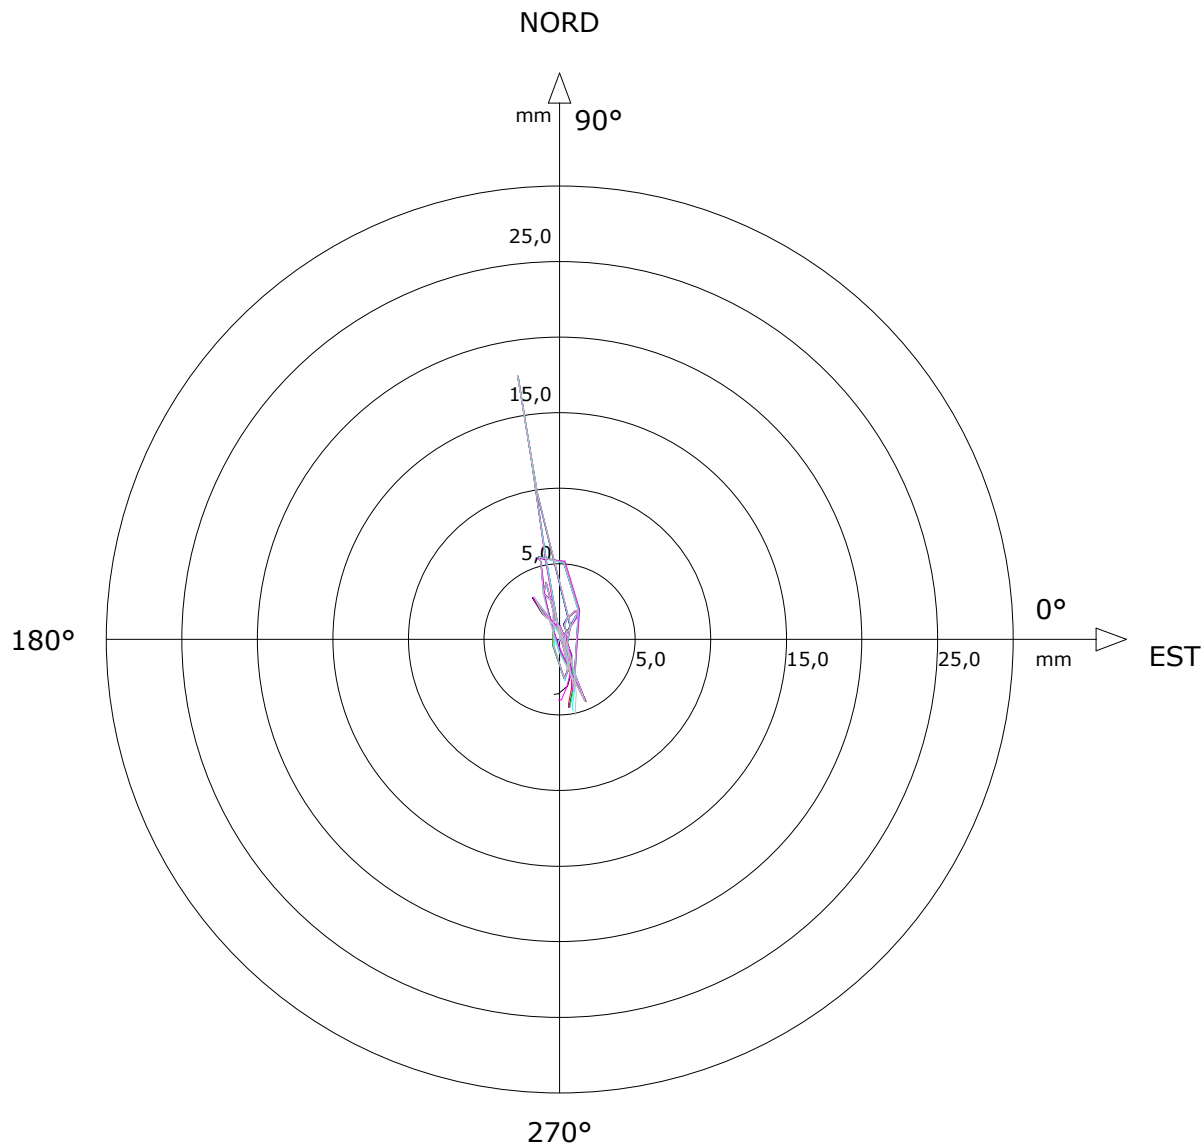
Sito: PMA-FS Tubo: SSI-SP03

Elaborazione differenziale locale dal basso

Diagramma polare della deviazione

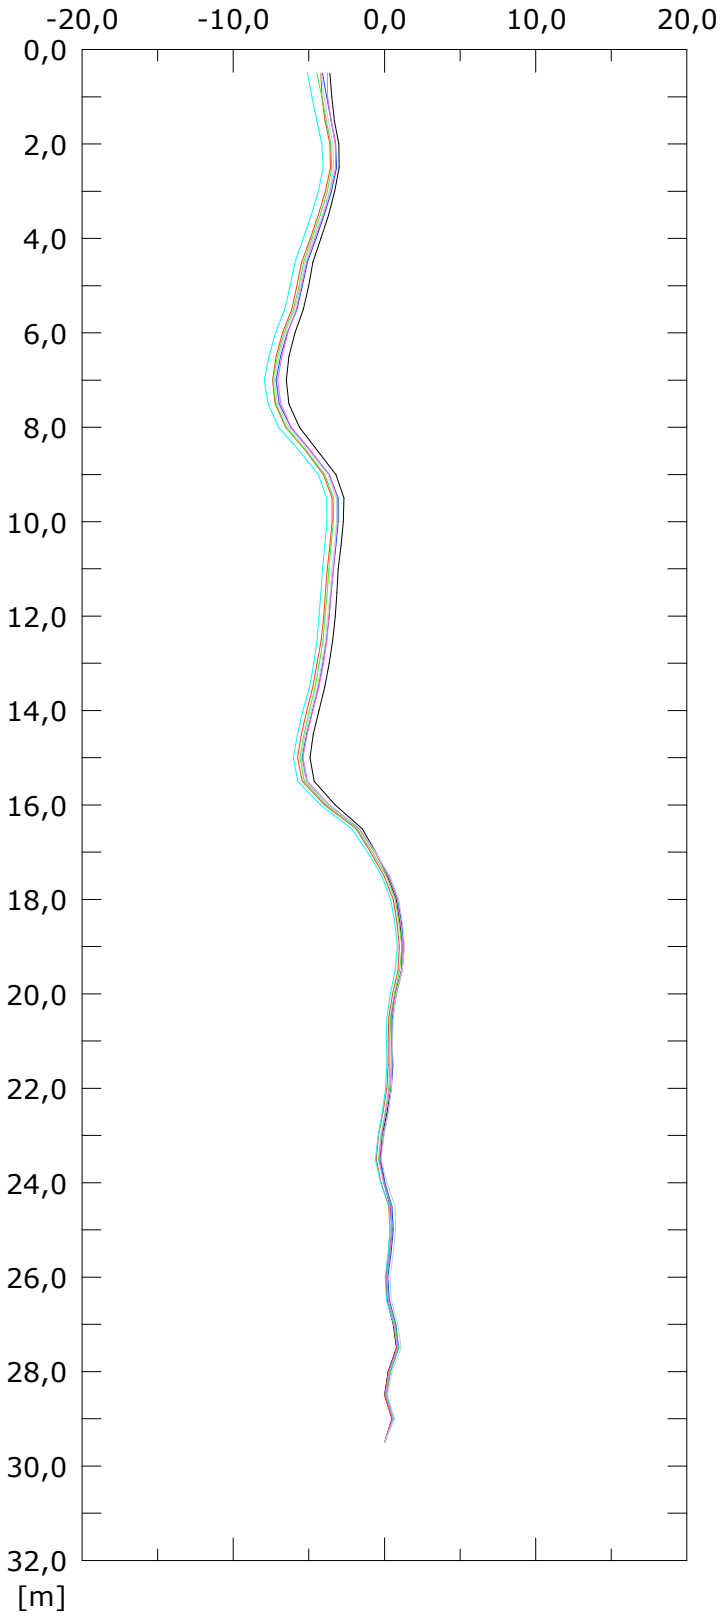
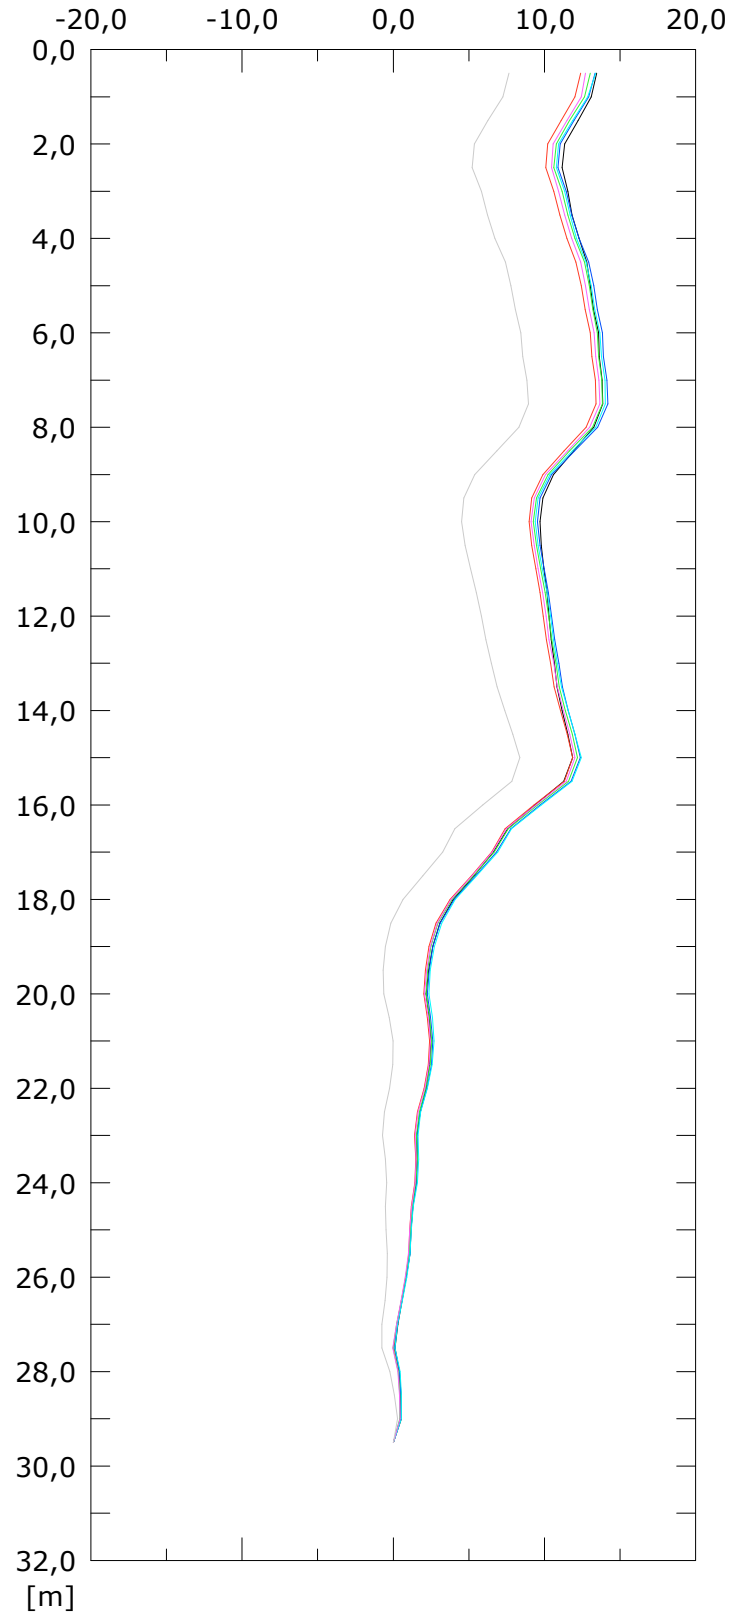
Elaborazione differenziale integrale dal basso

Spost. EST [mm]

Spost. NORD [mm]

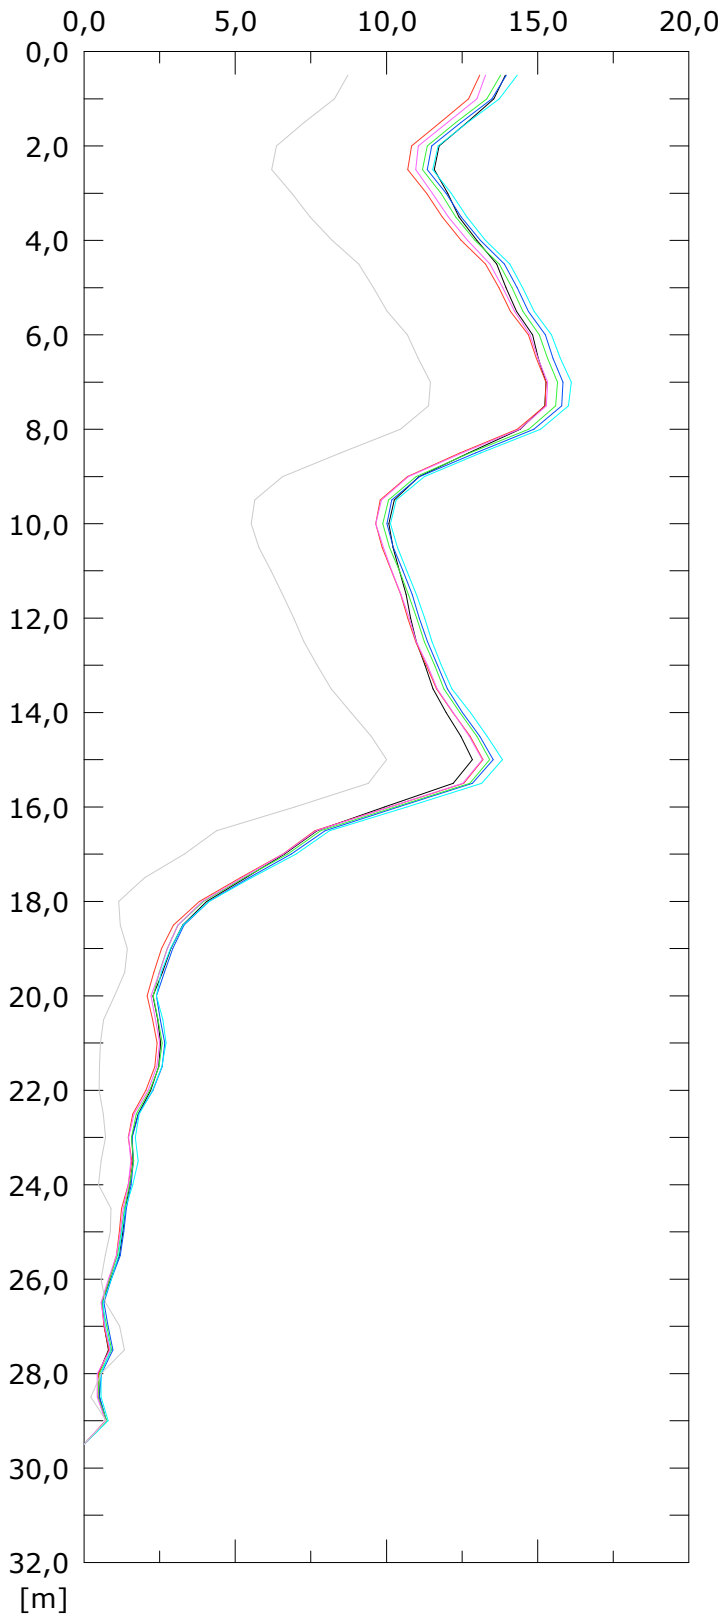
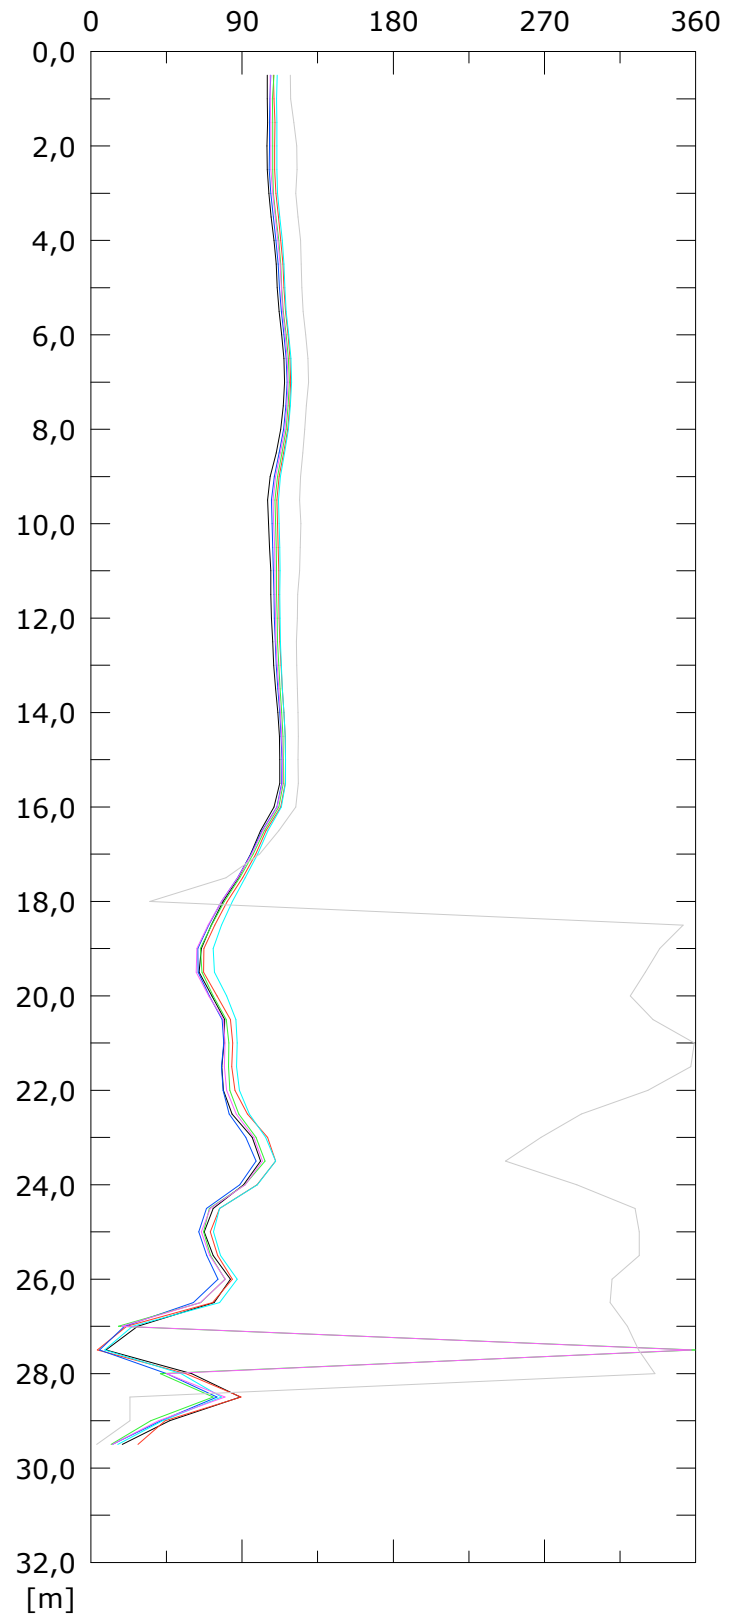
Elaborazione differenziale integrale dal basso

Risultante spost. [mm]

Angolo [gradi]

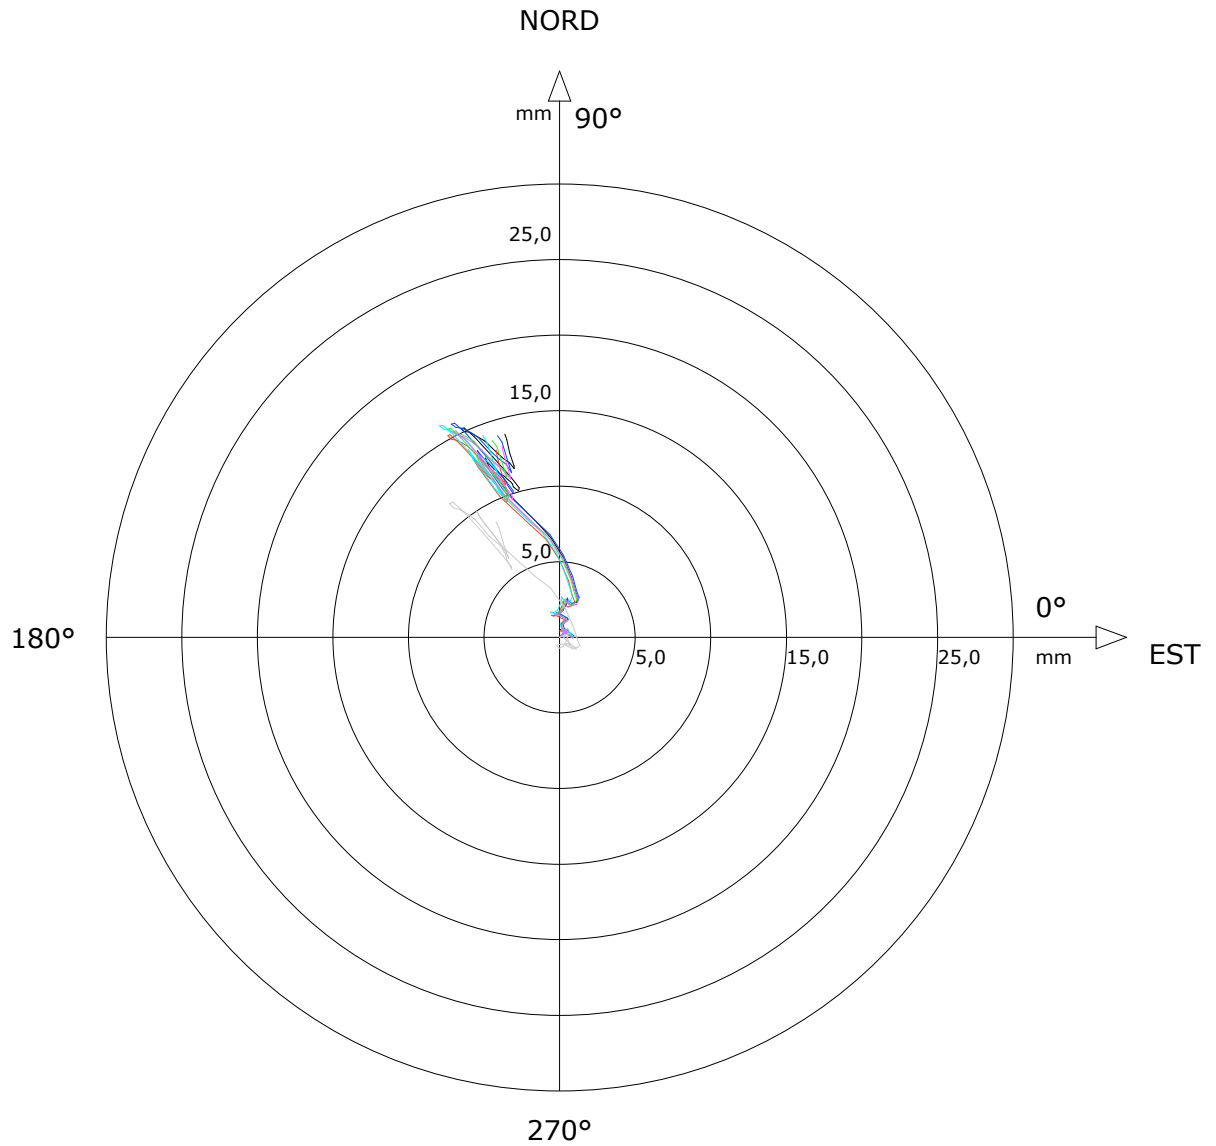
Sito: PMA-FS Tubo: SSI-SP04

Elaborazione differenziale integrale dal basso

Diagramma polare della deviazione

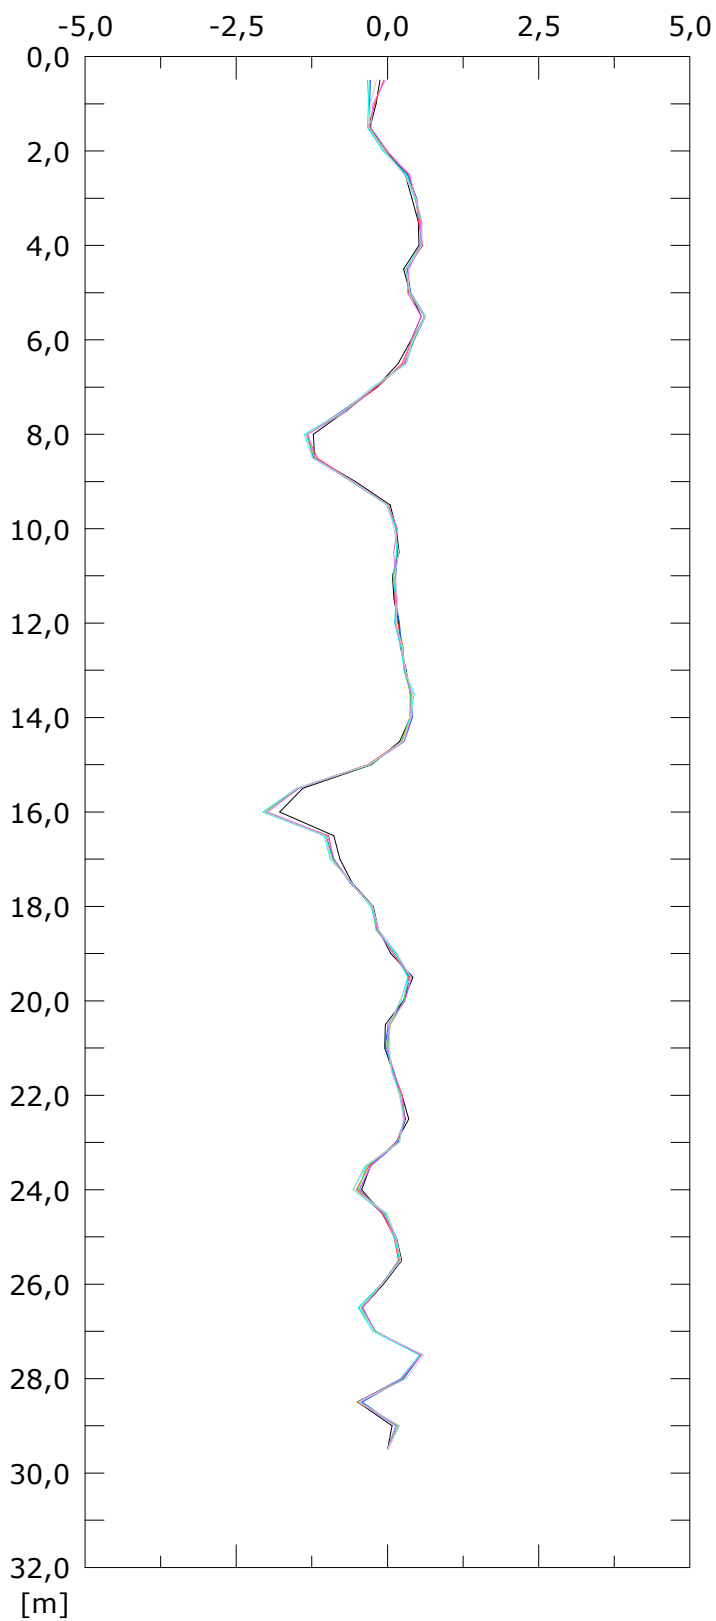
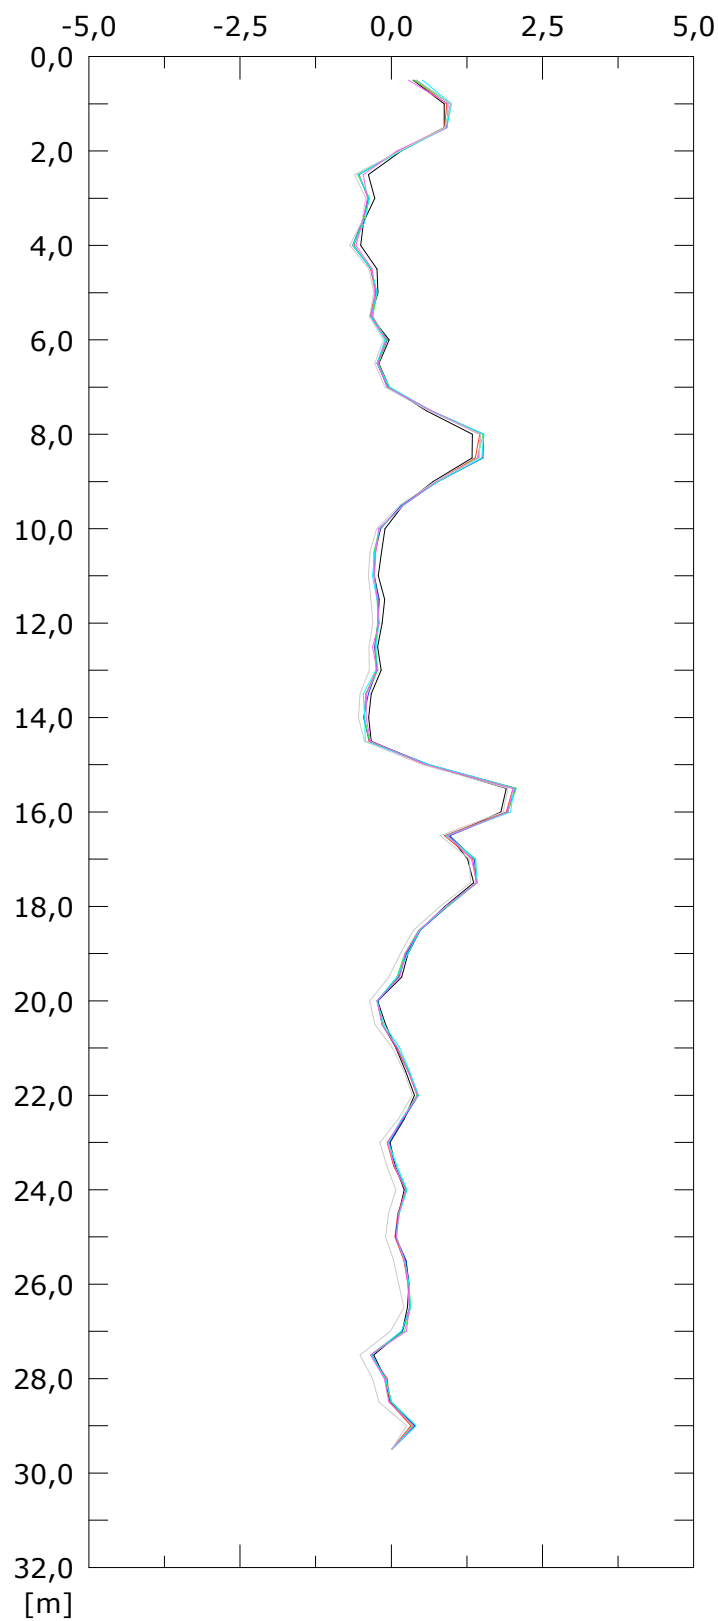
Elaborazione differenziale locale dal basso

Spost. EST [mm]

Spost. NORD [mm]

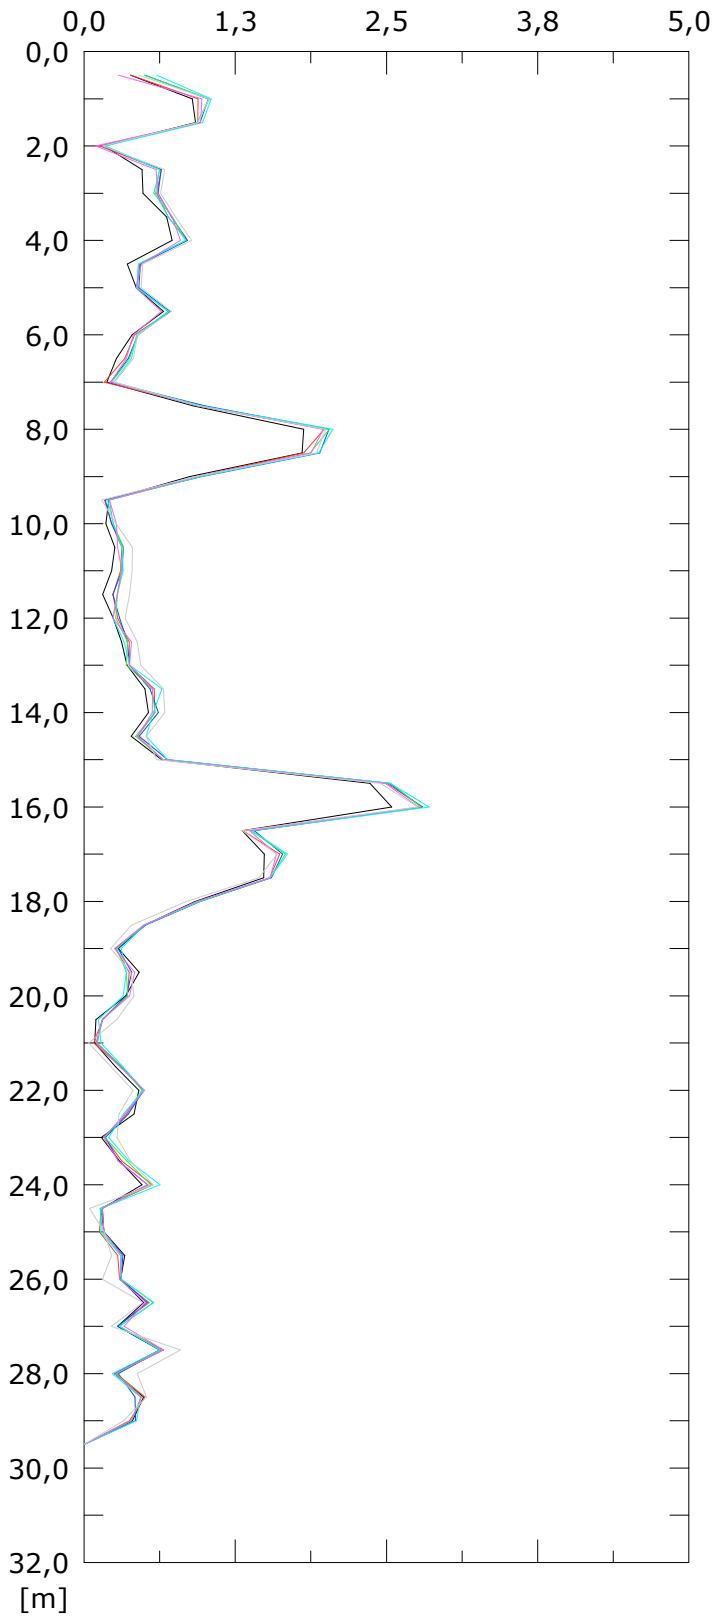
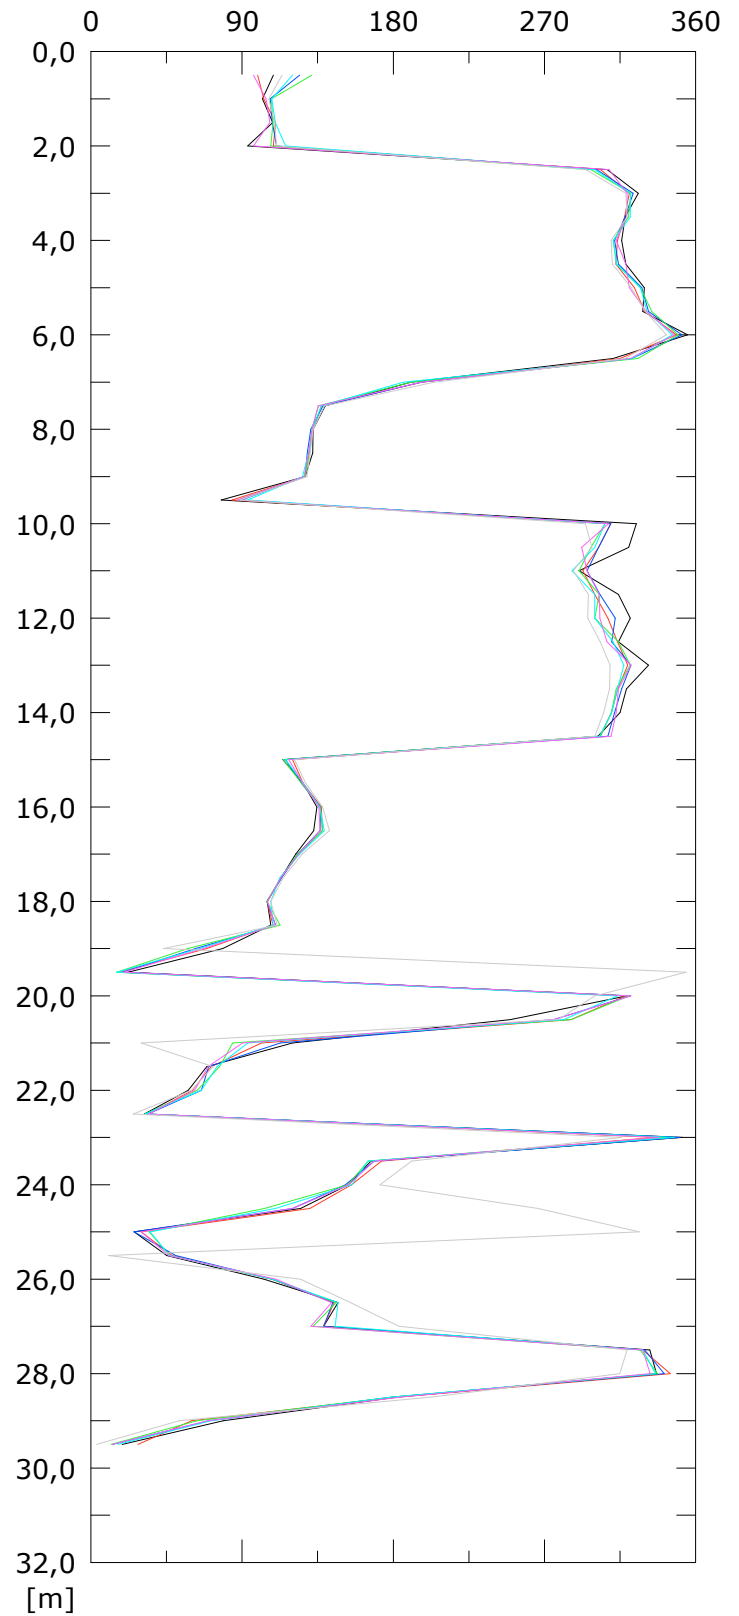
Elaborazione differenziale locale dal basso

Resultante spost. [mm]

Angolo [gradi]

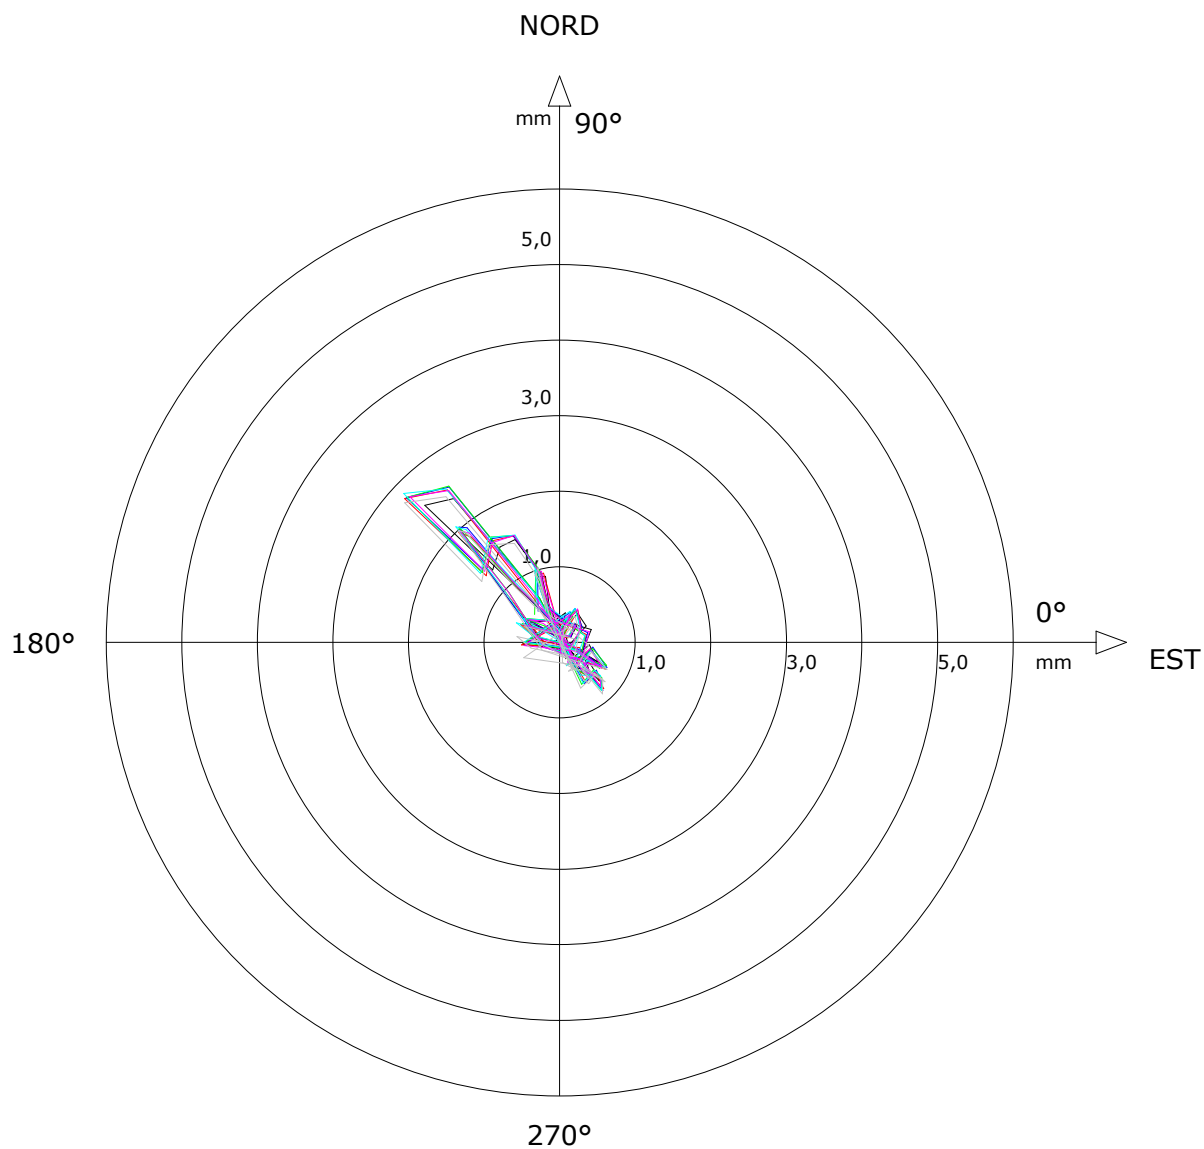
Sito: PMA-FS Tubo: SSI-SP04

Elaborazione differenziale locale dal basso

Diagramma polare della deviazione

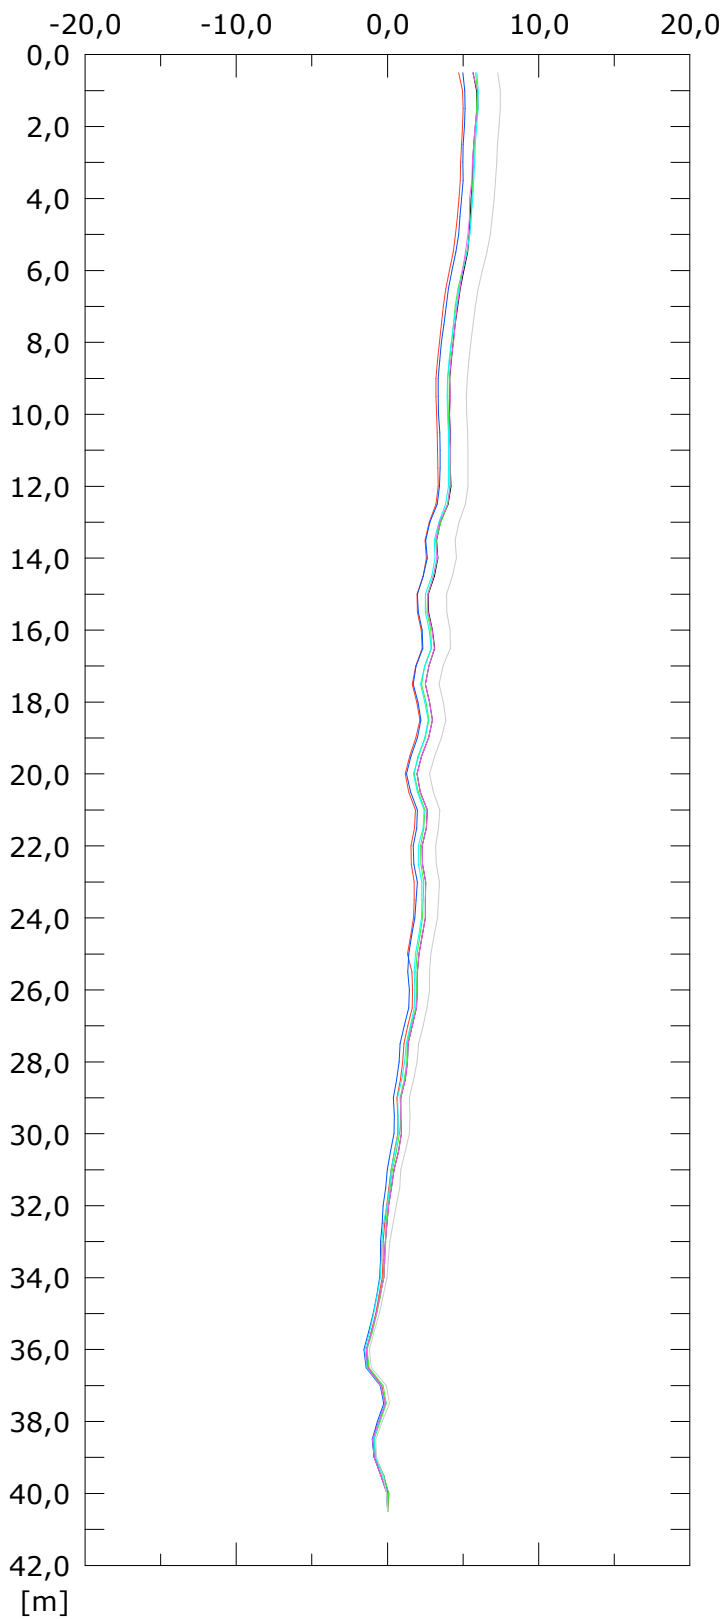
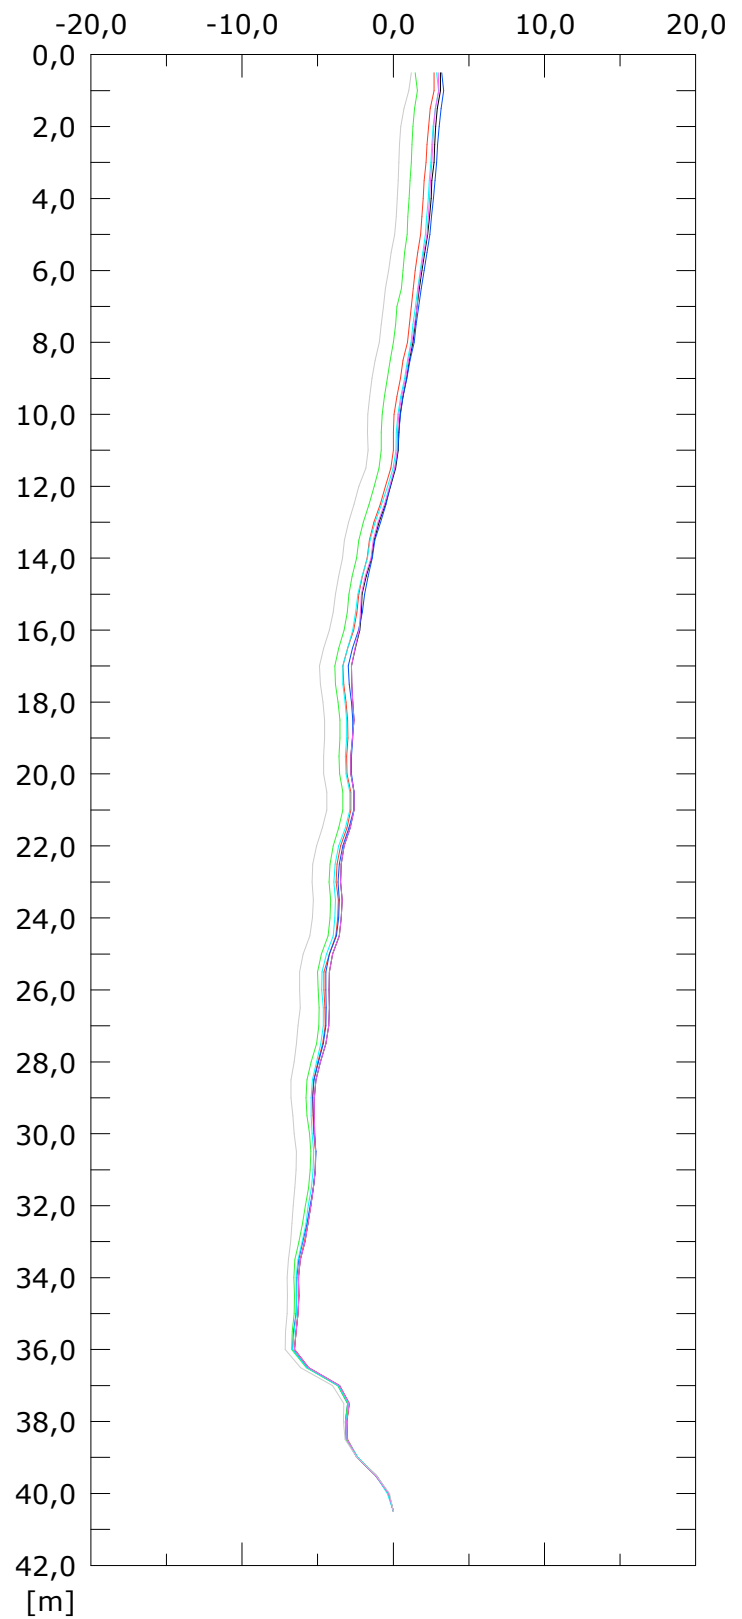
Elaborazione differenziale integrale dal basso

Spost. EST [mm]

Spost. NORD [mm]

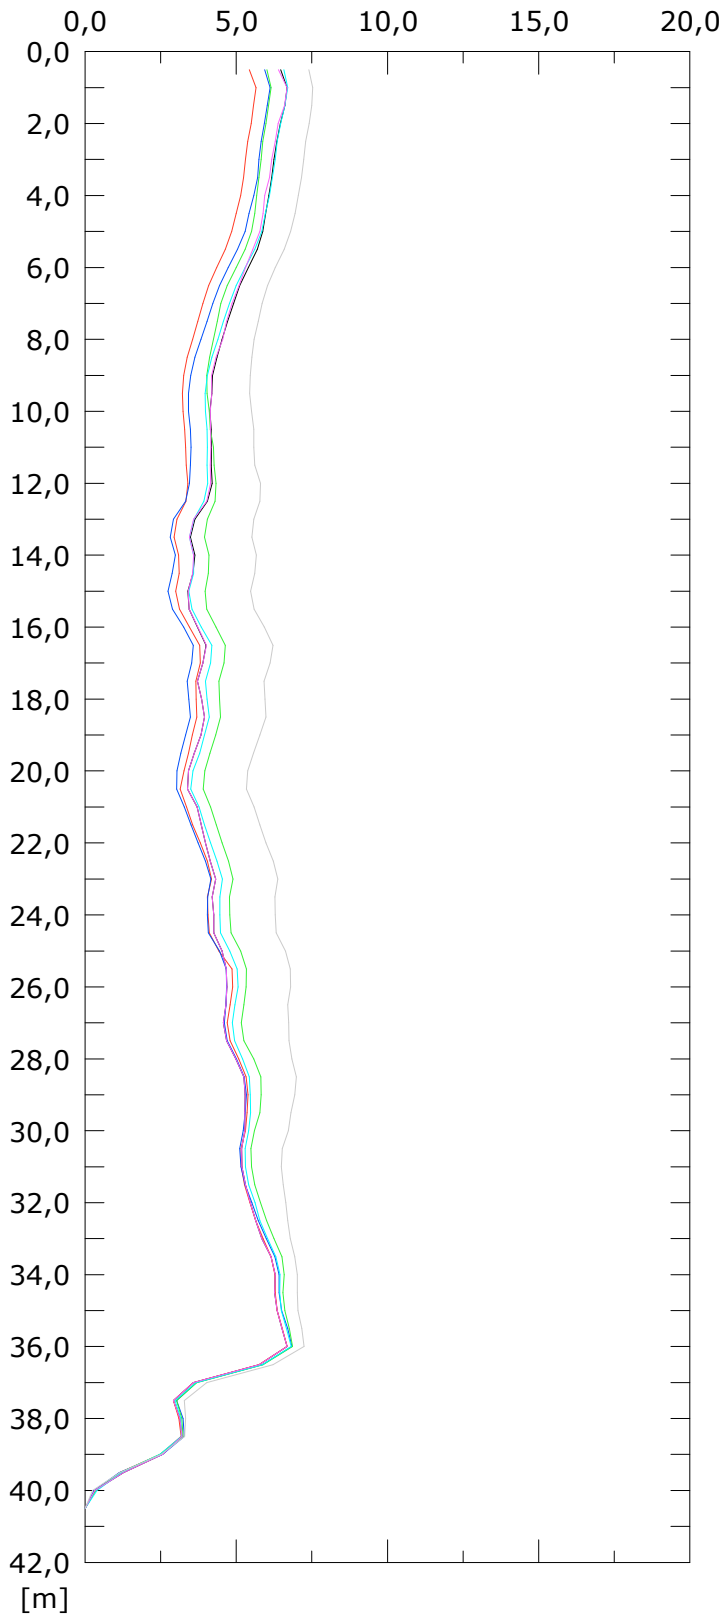
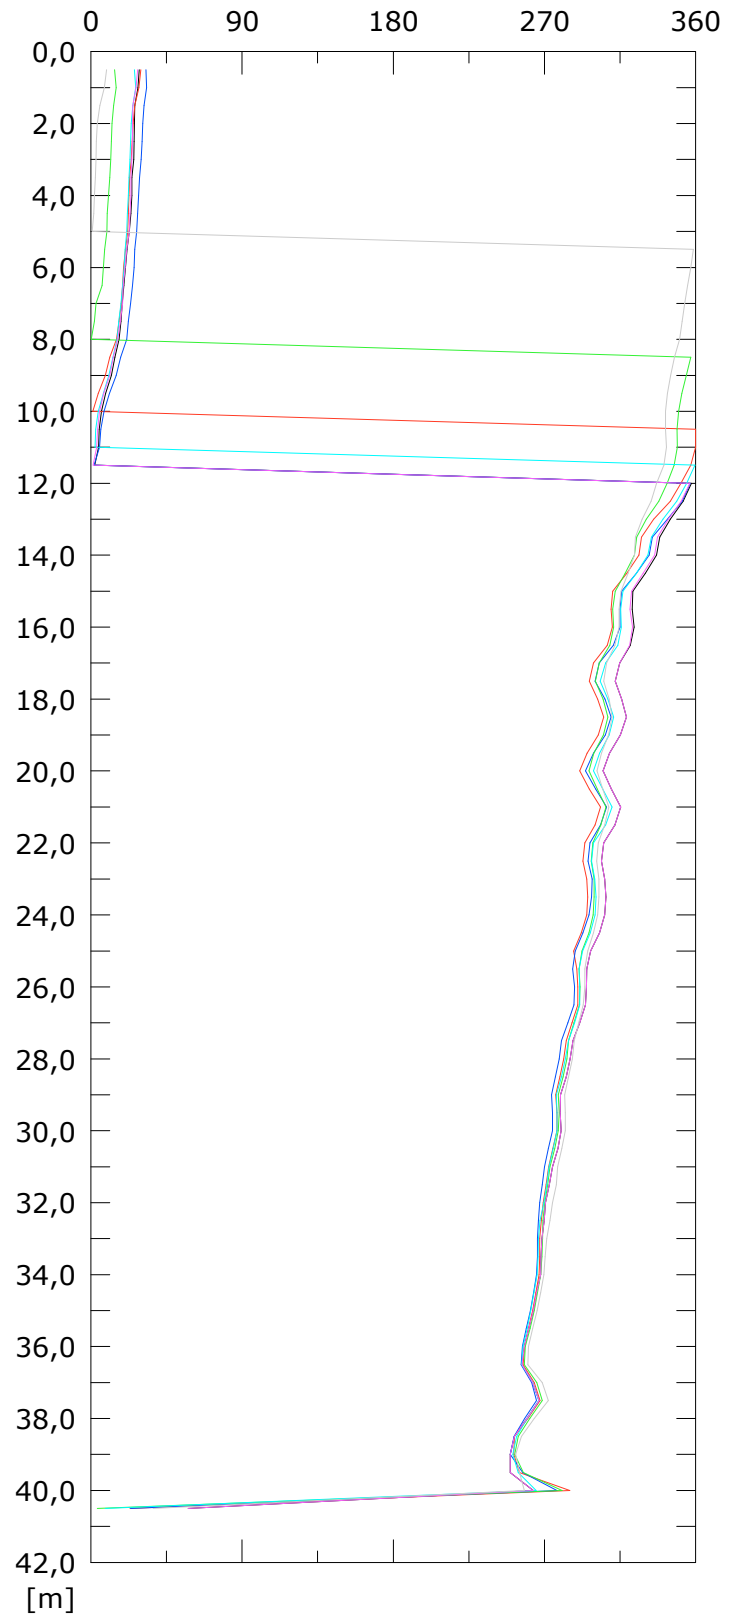
Elaborazione differenziale integrale dal basso

Risultante spost. [mm]

Angolo [gradi]

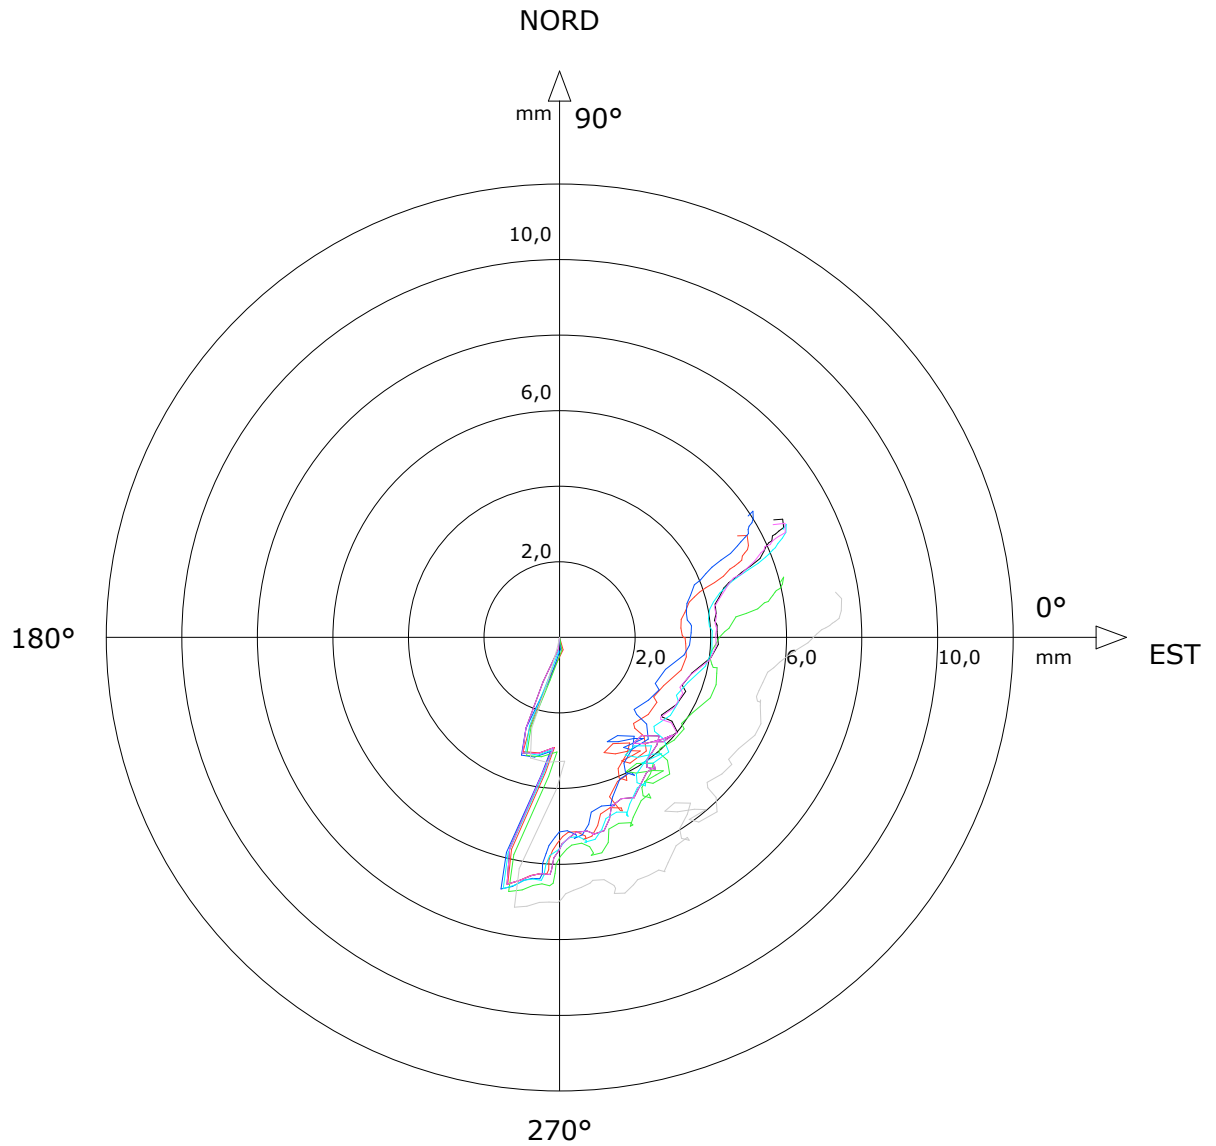
Sito: PMA-FS Tubo: SSI-SP05

Elaborazione differenziale integrale dal basso

Diagramma polare della deviazione

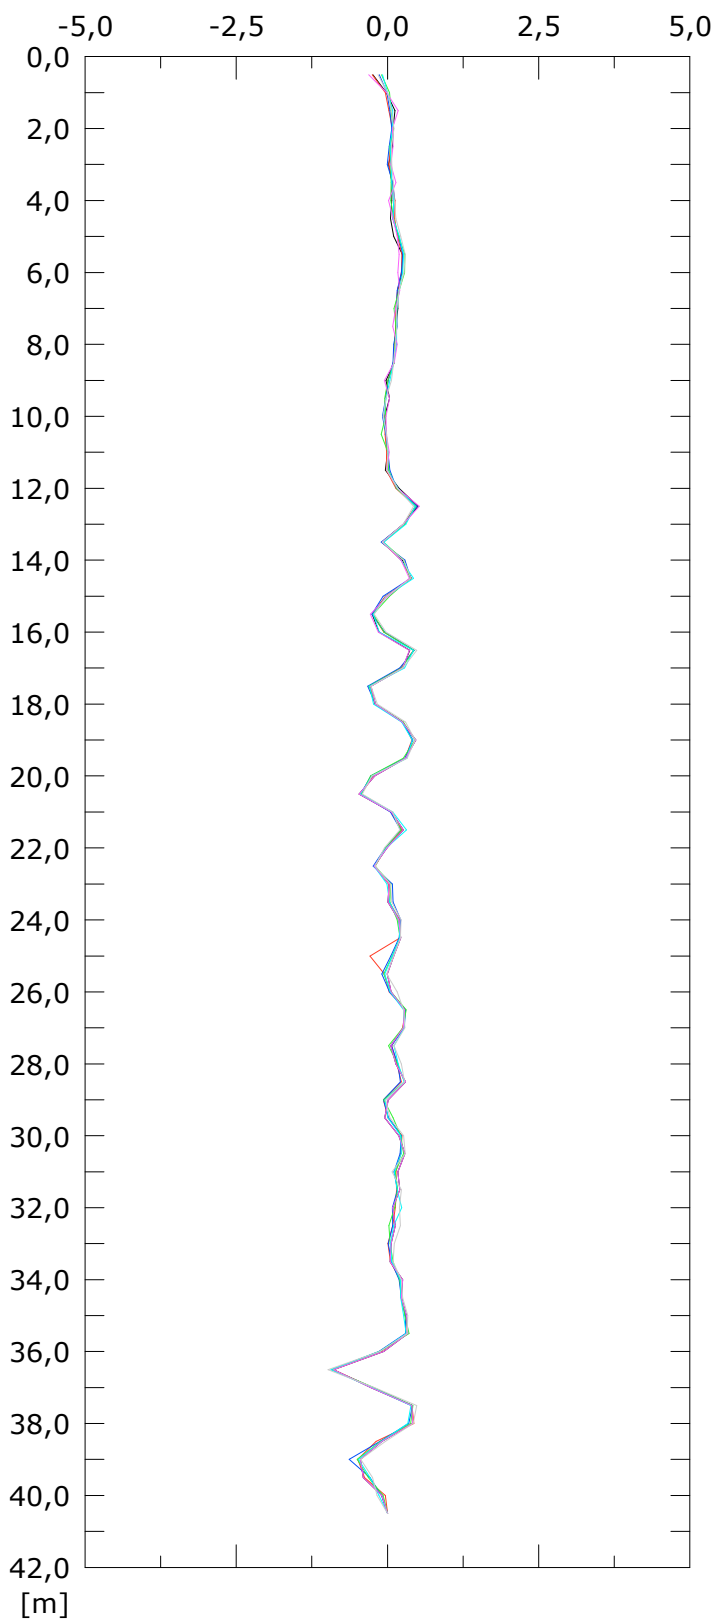
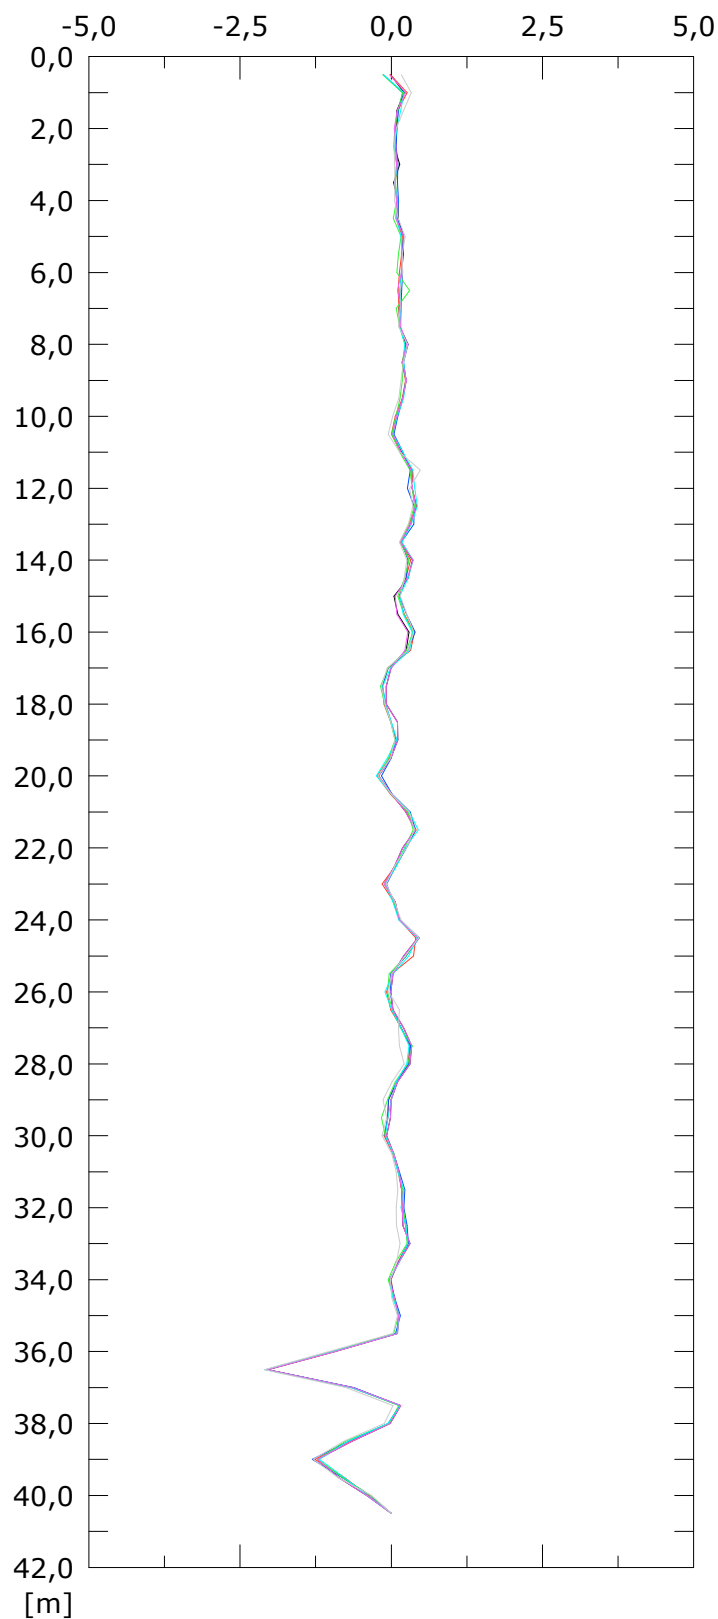
Elaborazione differenziale locale dal basso

Spost. EST [mm]

Spost. NORD [mm]
