Elaborazione differenziale integrale dal basso

Riferimento 000:30/10/2017

Sito: PMA-FS Tubo: SSI-SP02

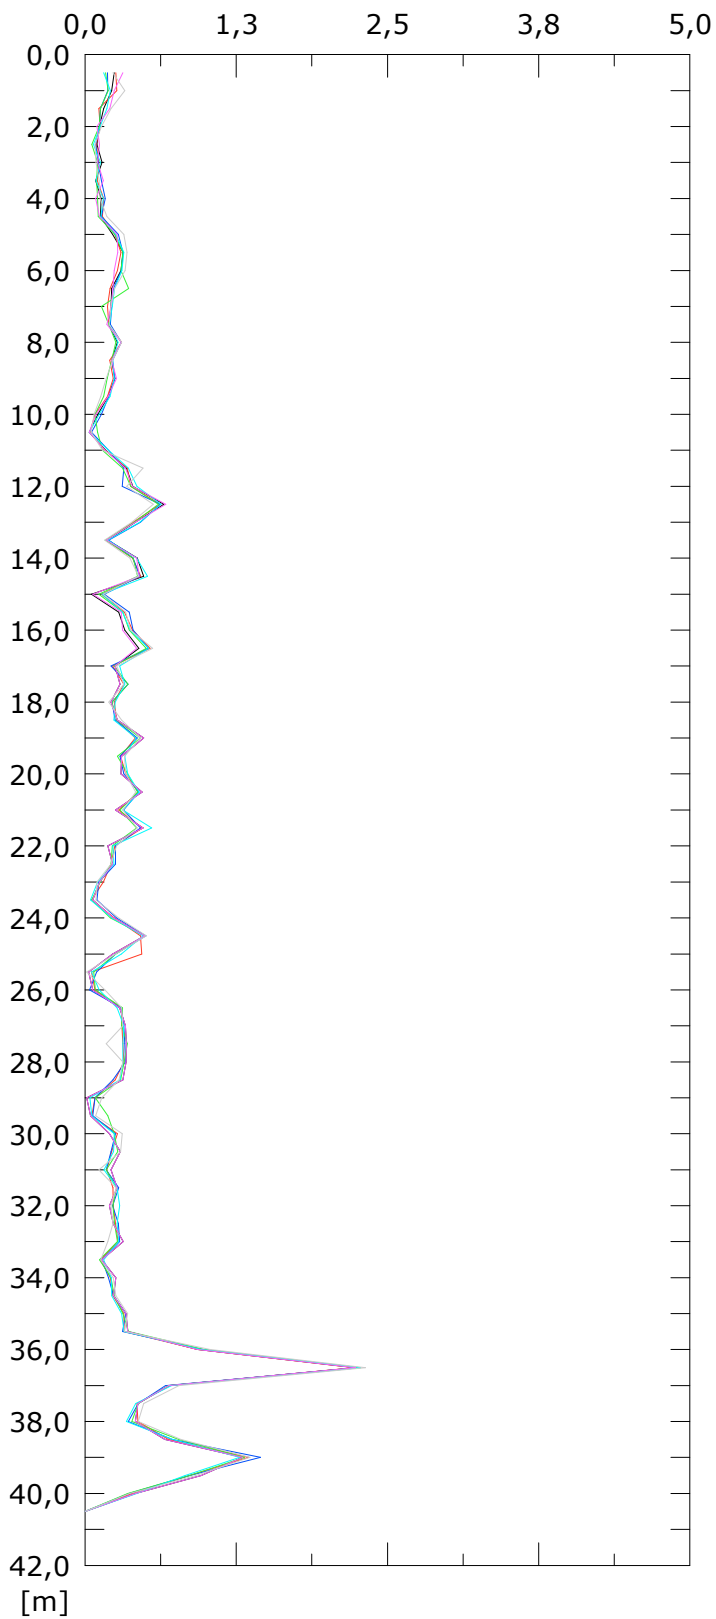
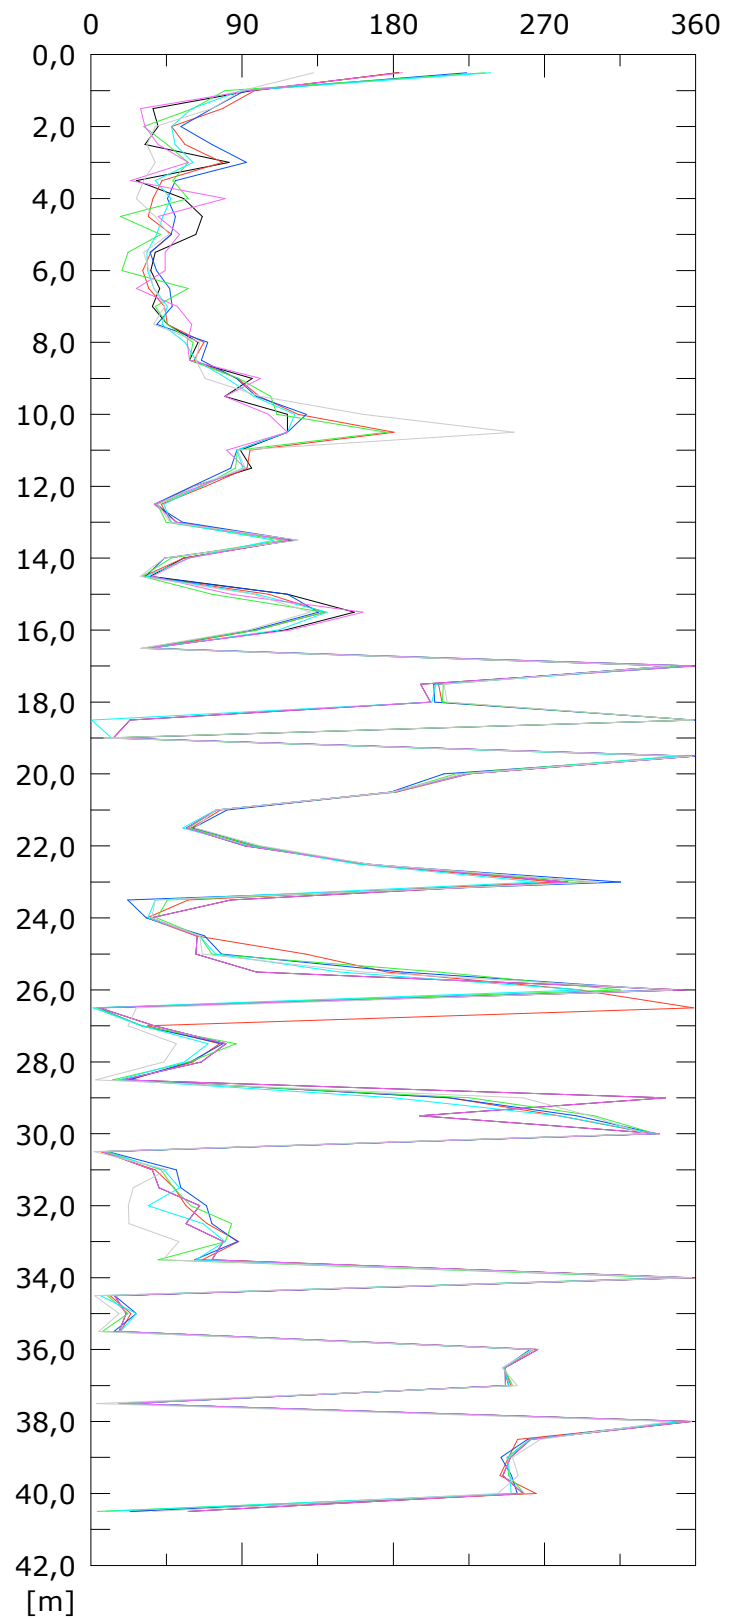
Elaborazione differenziale locale dal basso

Risultante spost. [mm]

Angolo [gradi]

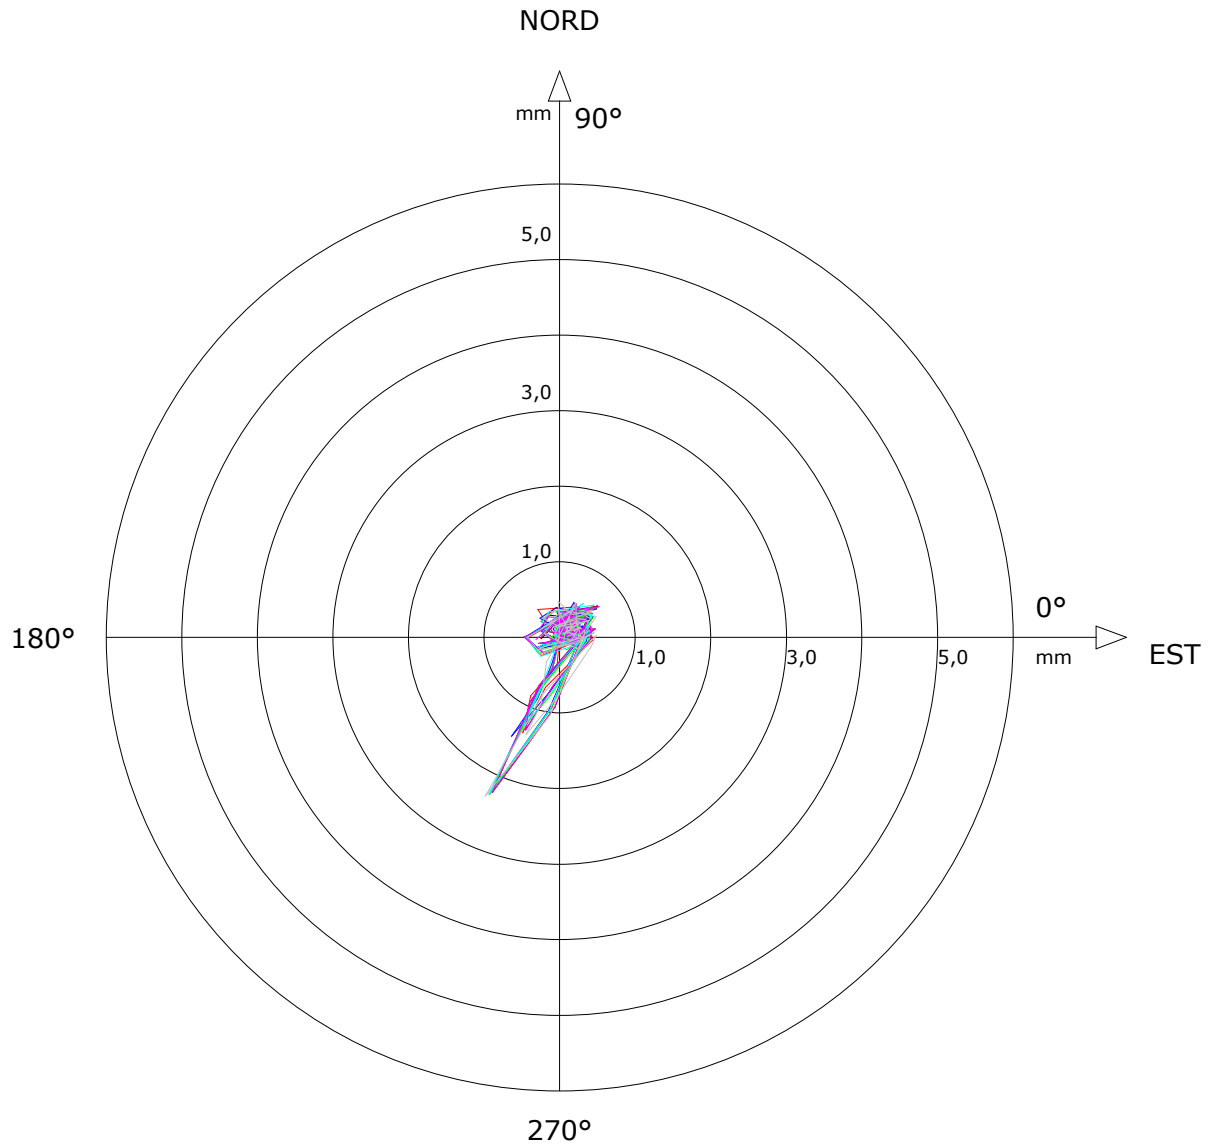
Sito: PMA-FS Tubo: SSI-SP05

Elaborazione differenziale locale dal basso

Diagramma polare della deviazione

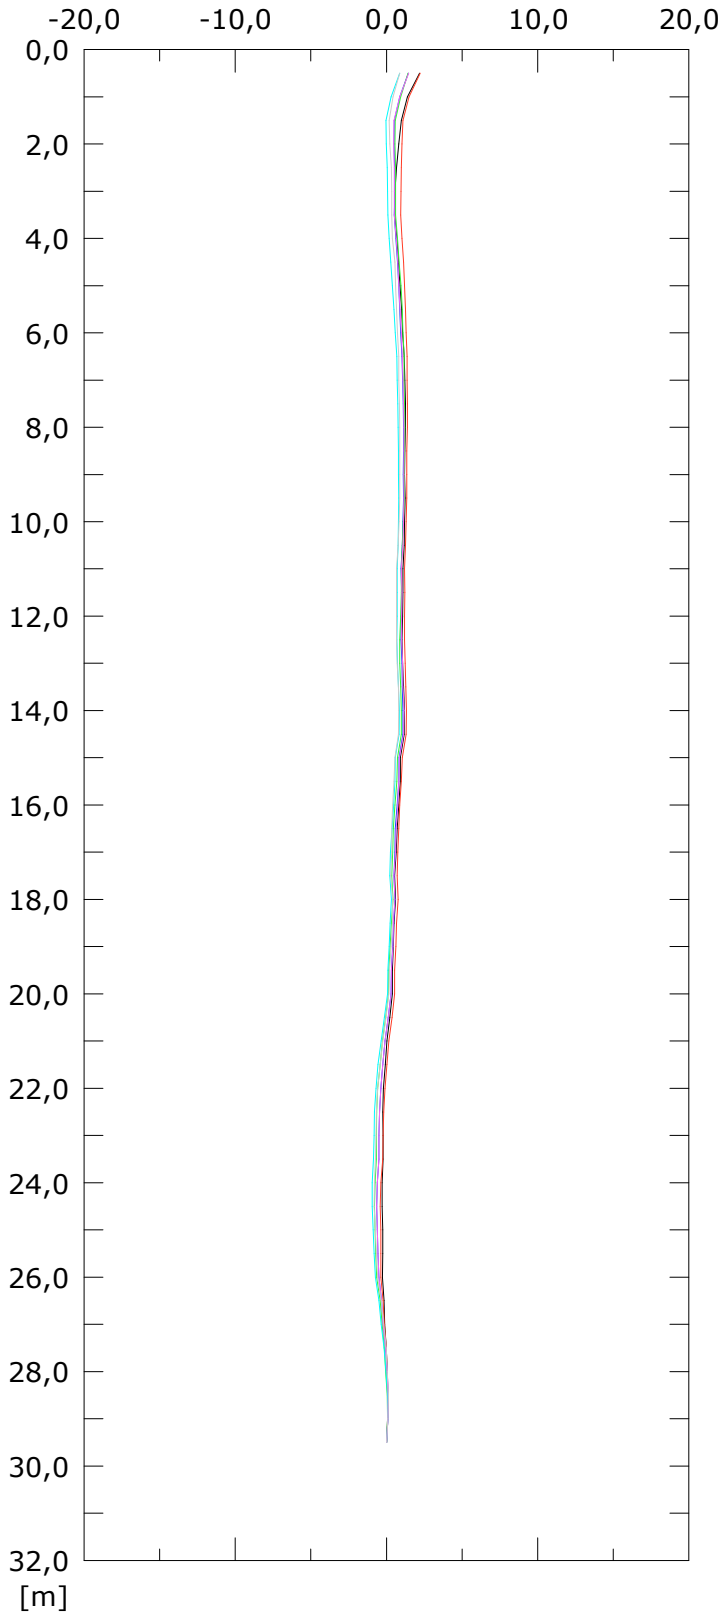
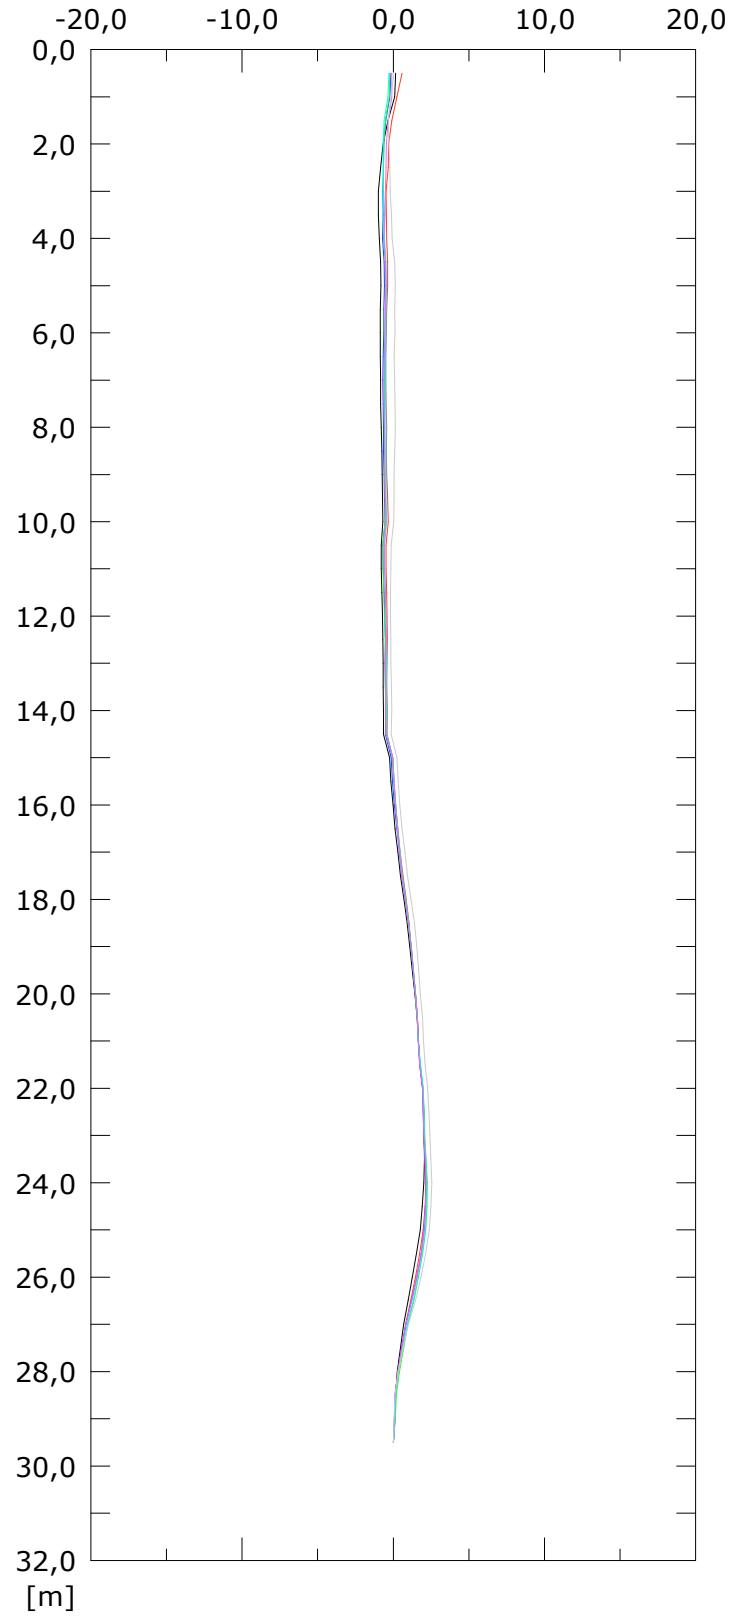
Elaborazione differenziale integrale dal basso

Spost. EST [mm]

Spost. NORD [mm]

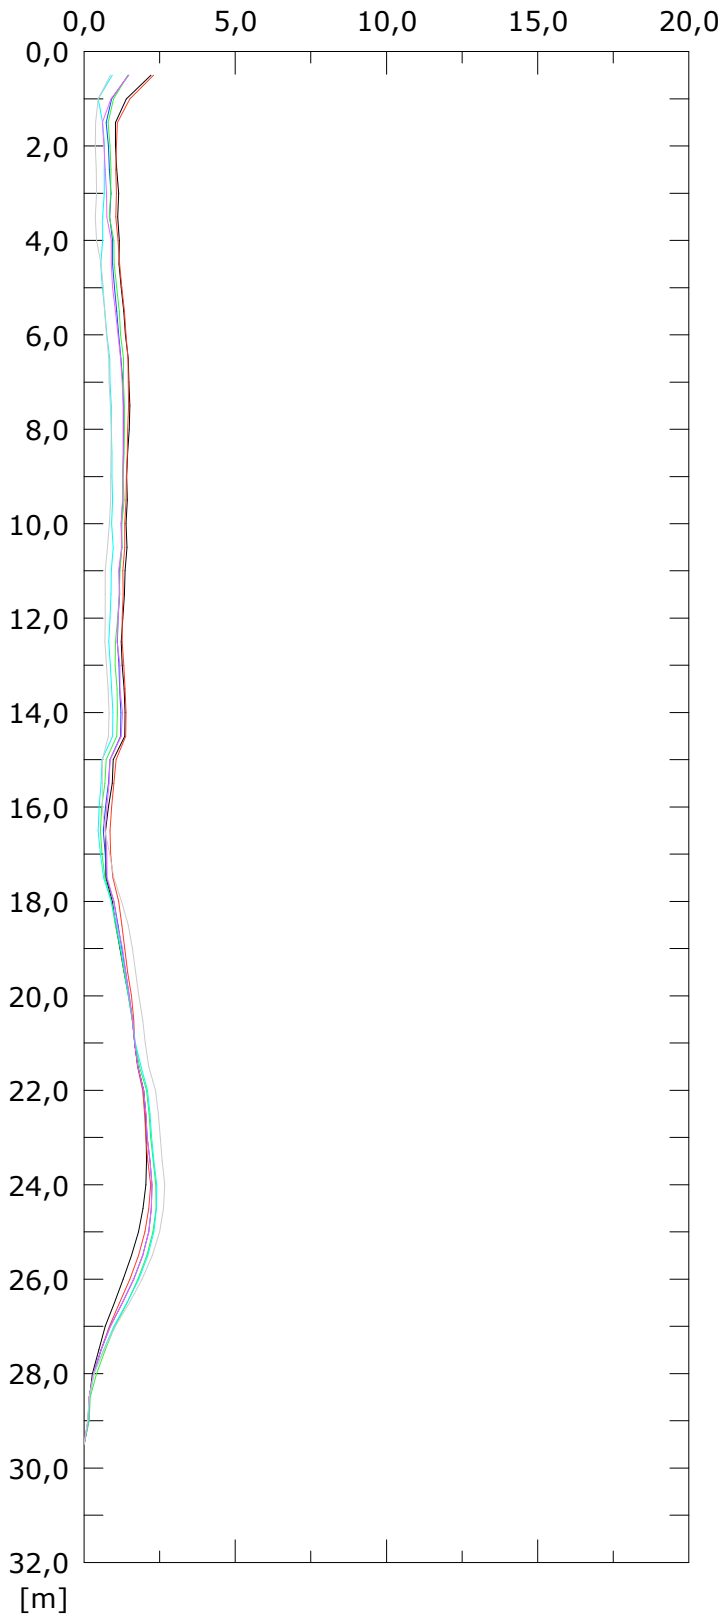
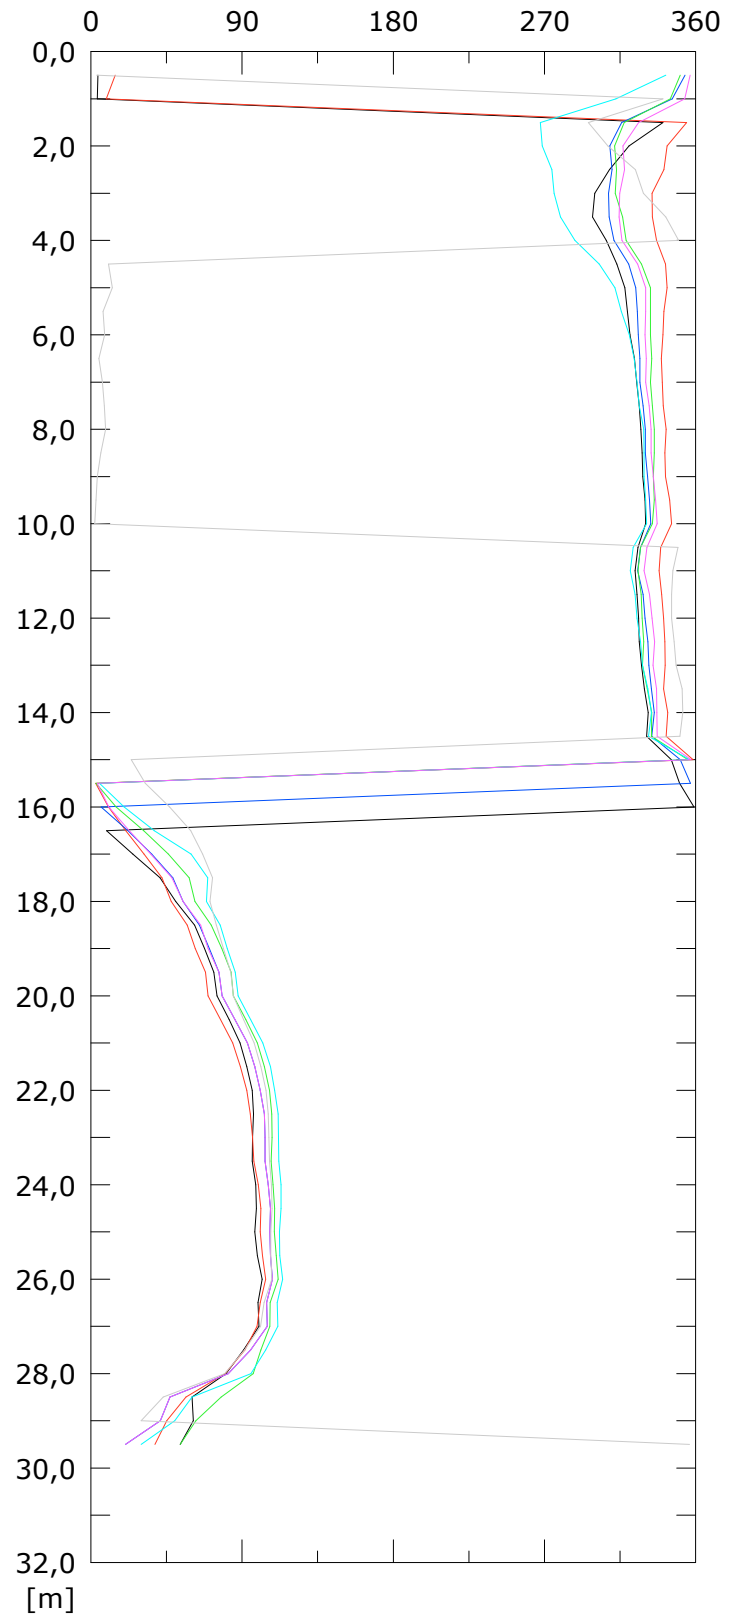
Elaborazione differenziale integrale dal basso

Risultante spost. [mm]

Angolo [gradi]

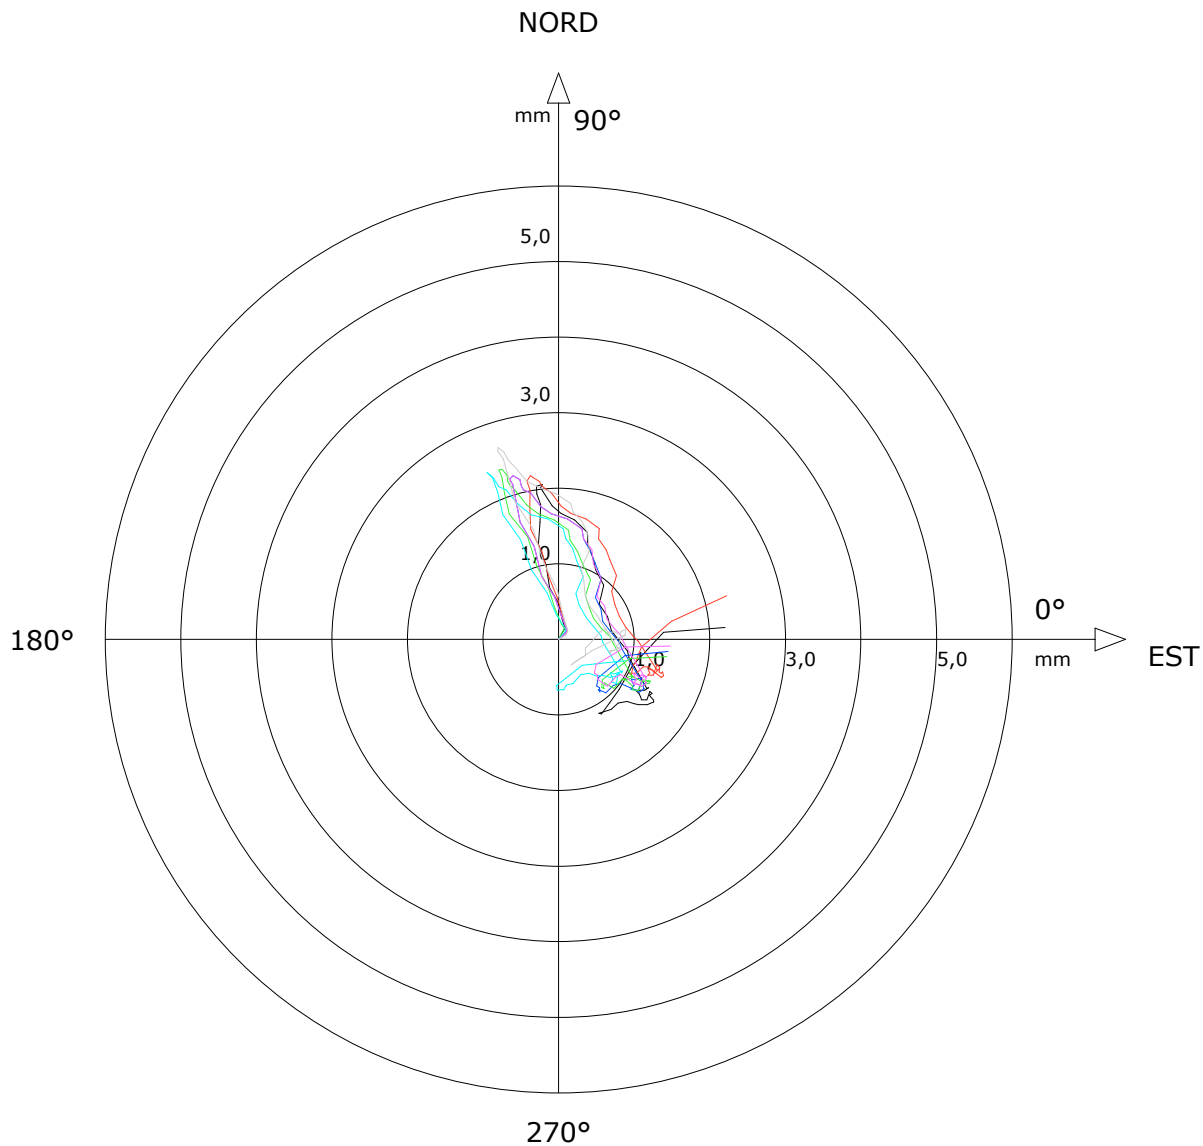
Sito: PMA-FS Tubo: SSI-SP06

Elaborazione differenziale integrale dal basso

Diagramma polare della deviazione

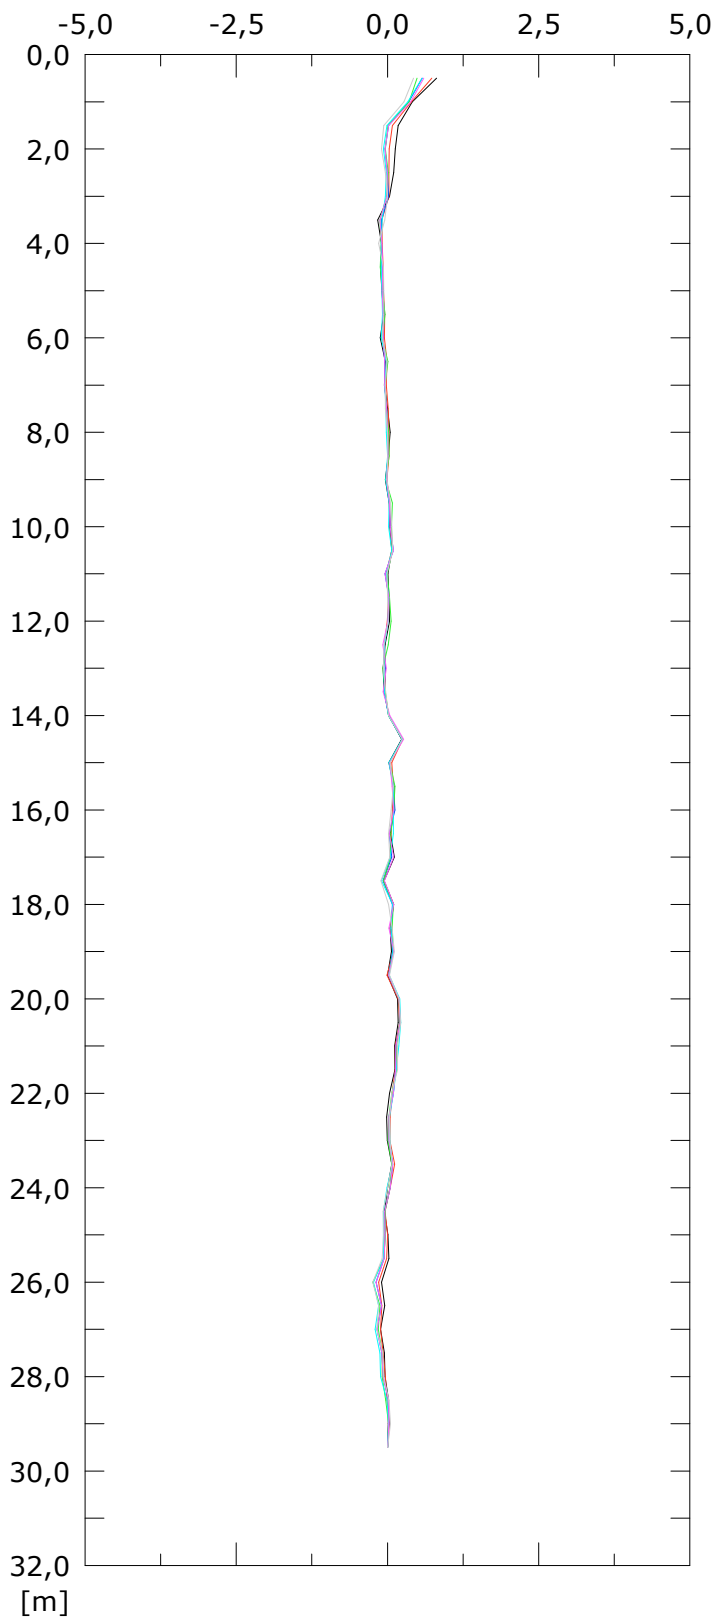
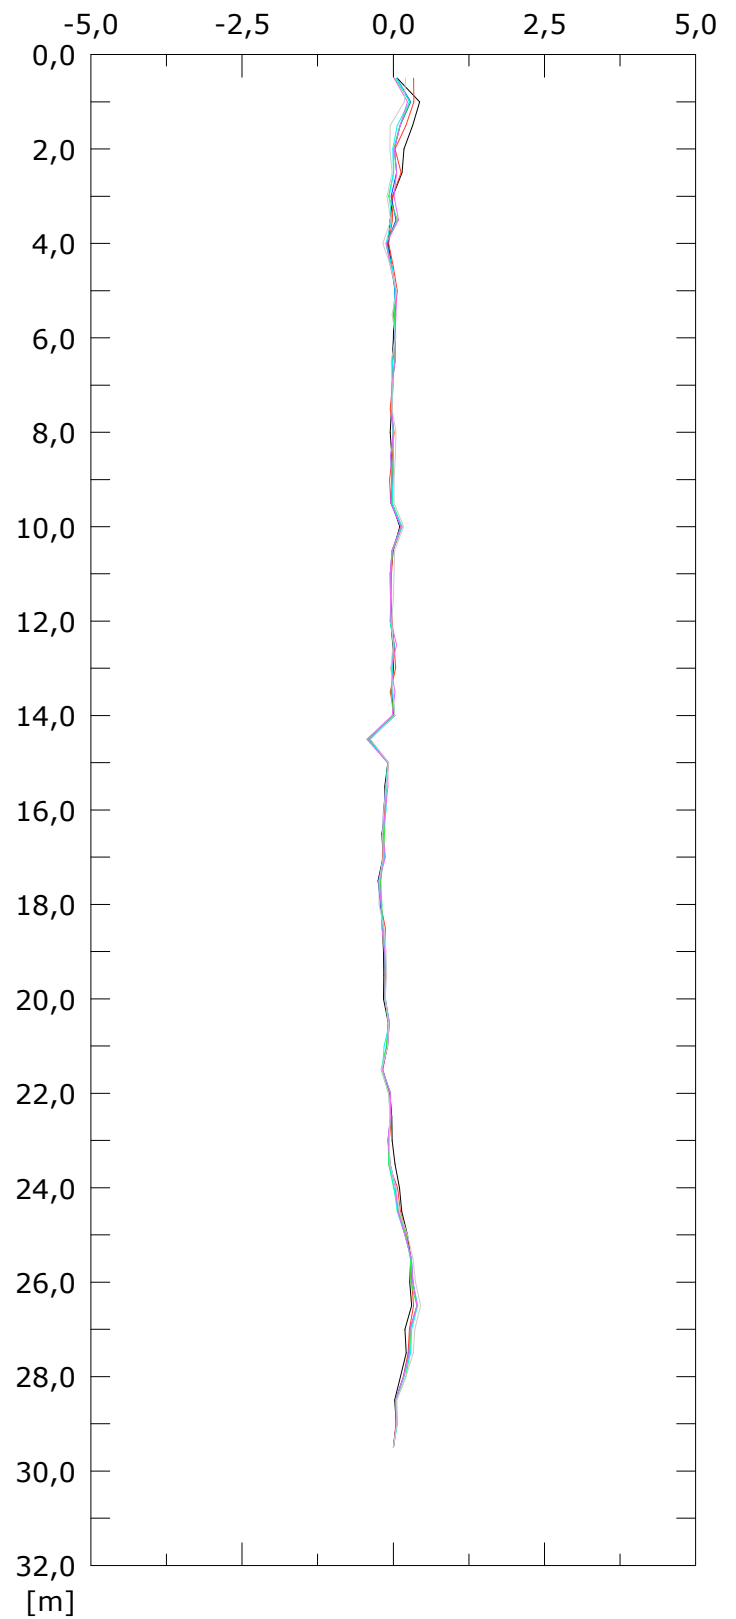
Elaborazione differenziale locale dal basso

Spost. EST [mm]

Spost. NORD [mm]

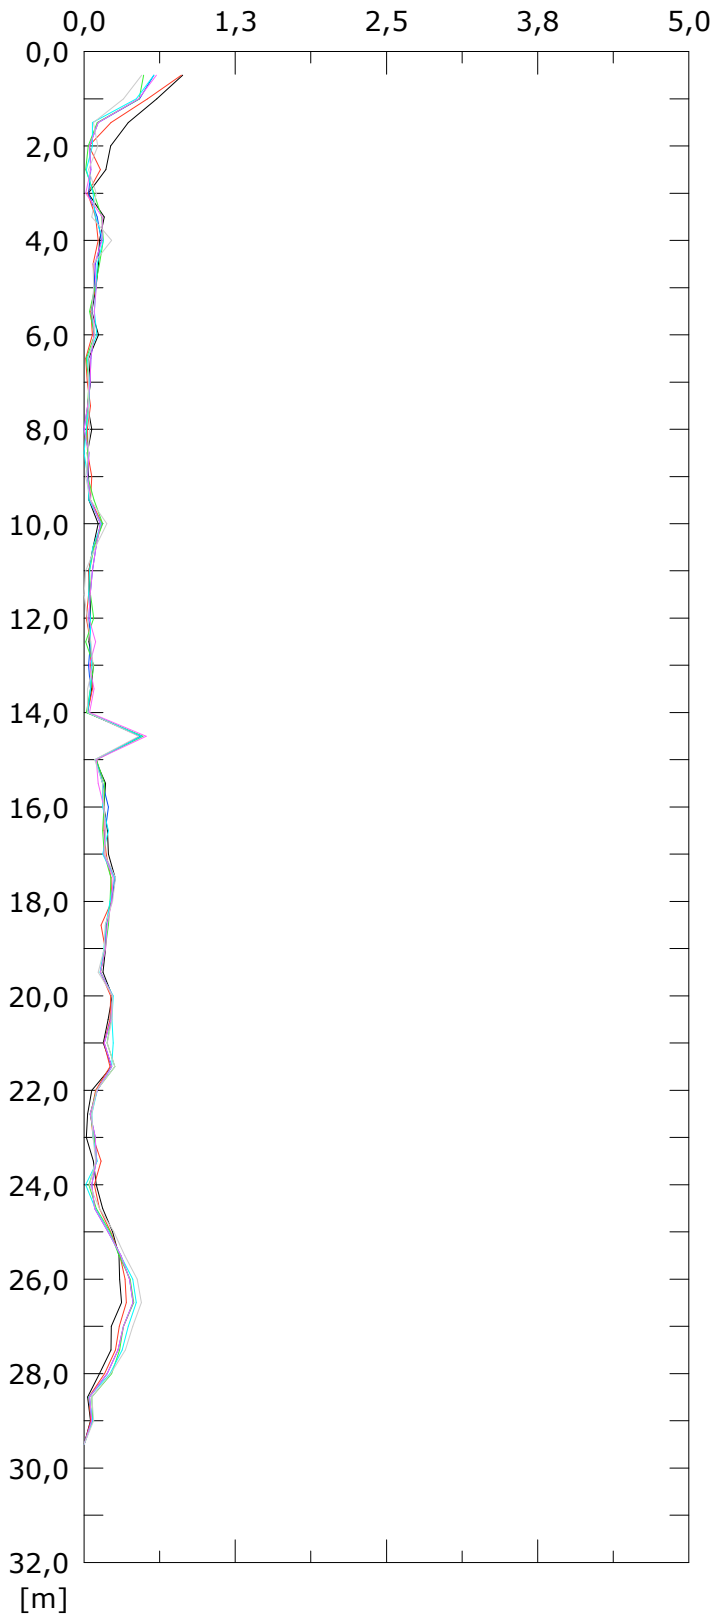
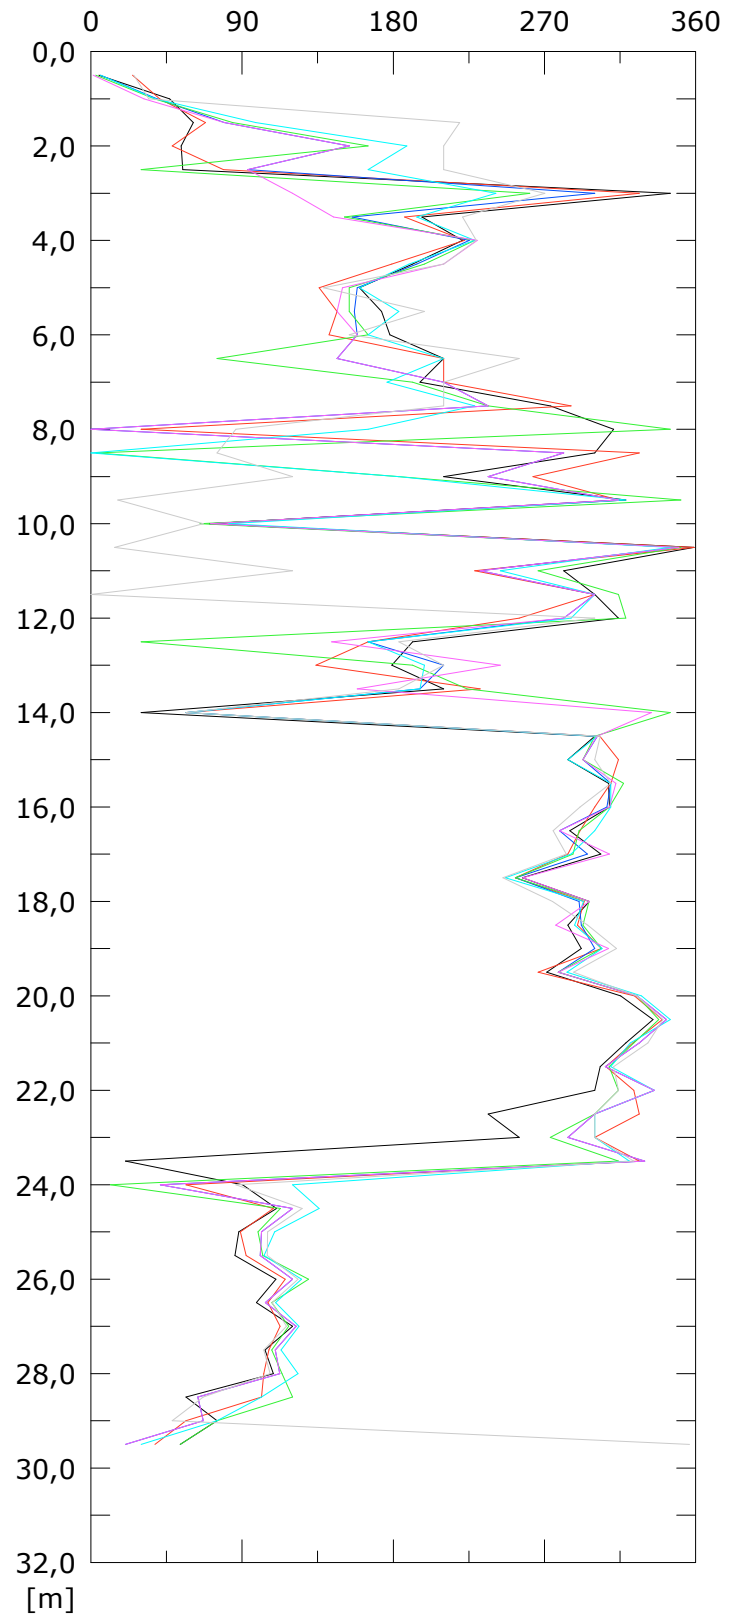
Elaborazione differenziale locale dal basso

Risultante spost. [mm]

Angolo [gradi]

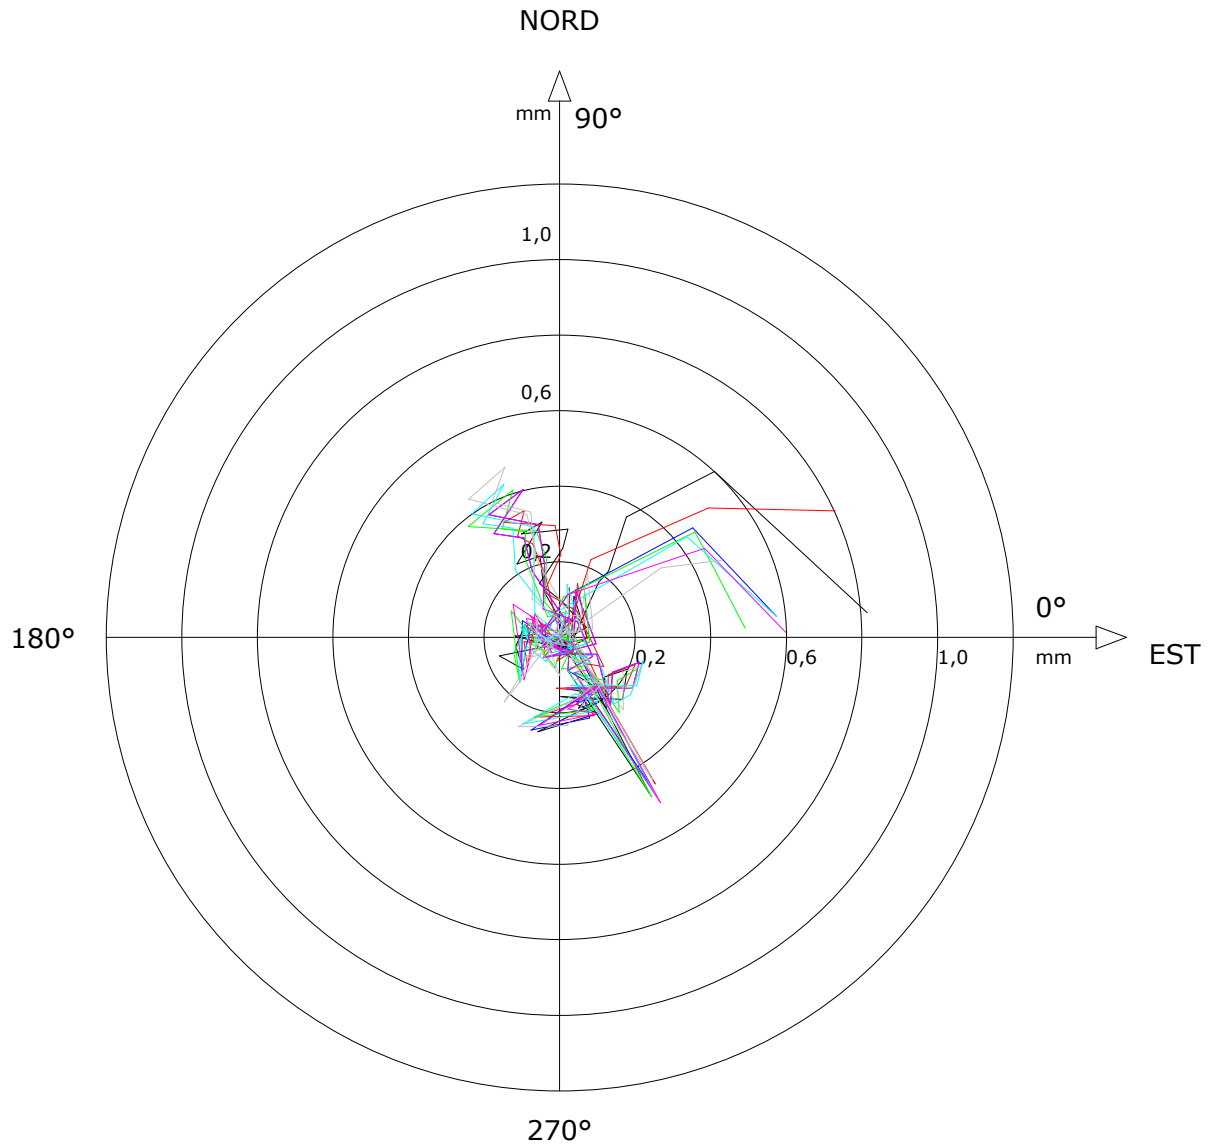
Sito: PMA-FS Tubo: SSI-SP06

Elaborazione differenziale locale dal basso

Diagramma polare della deviazione

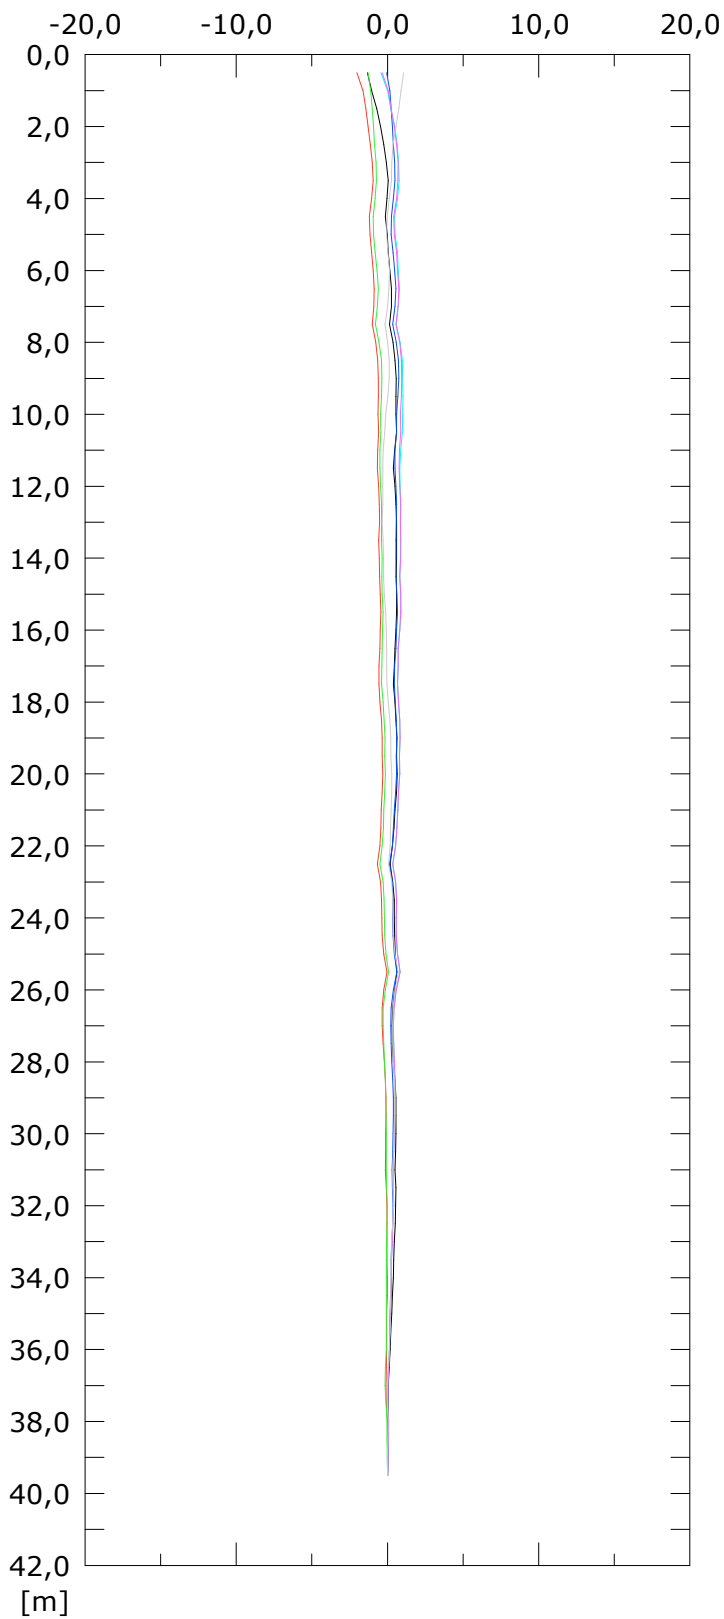
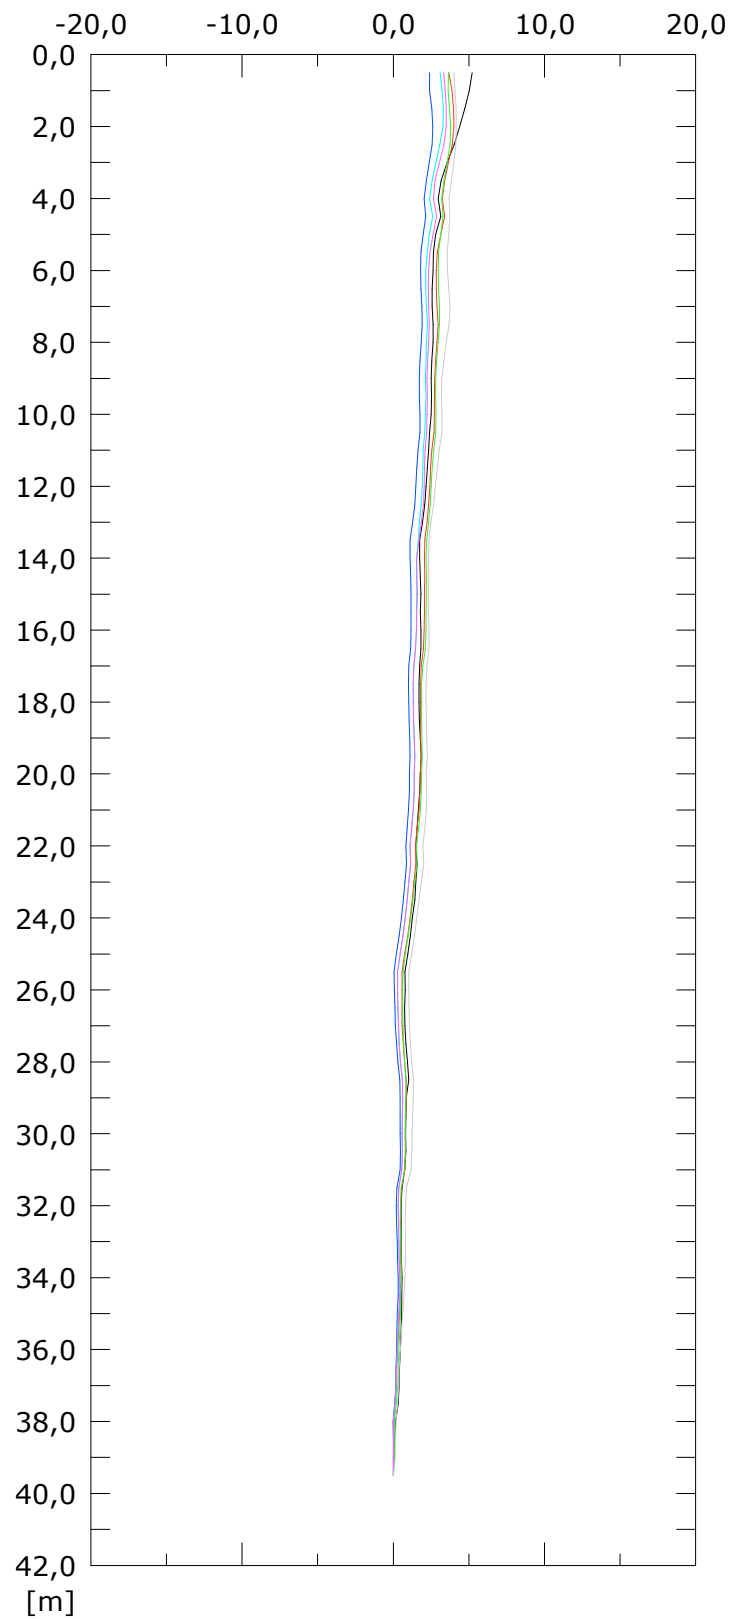
Elaborazione differenziale integrale dal basso

Spost. EST [mm]

Spost. NORD [mm]

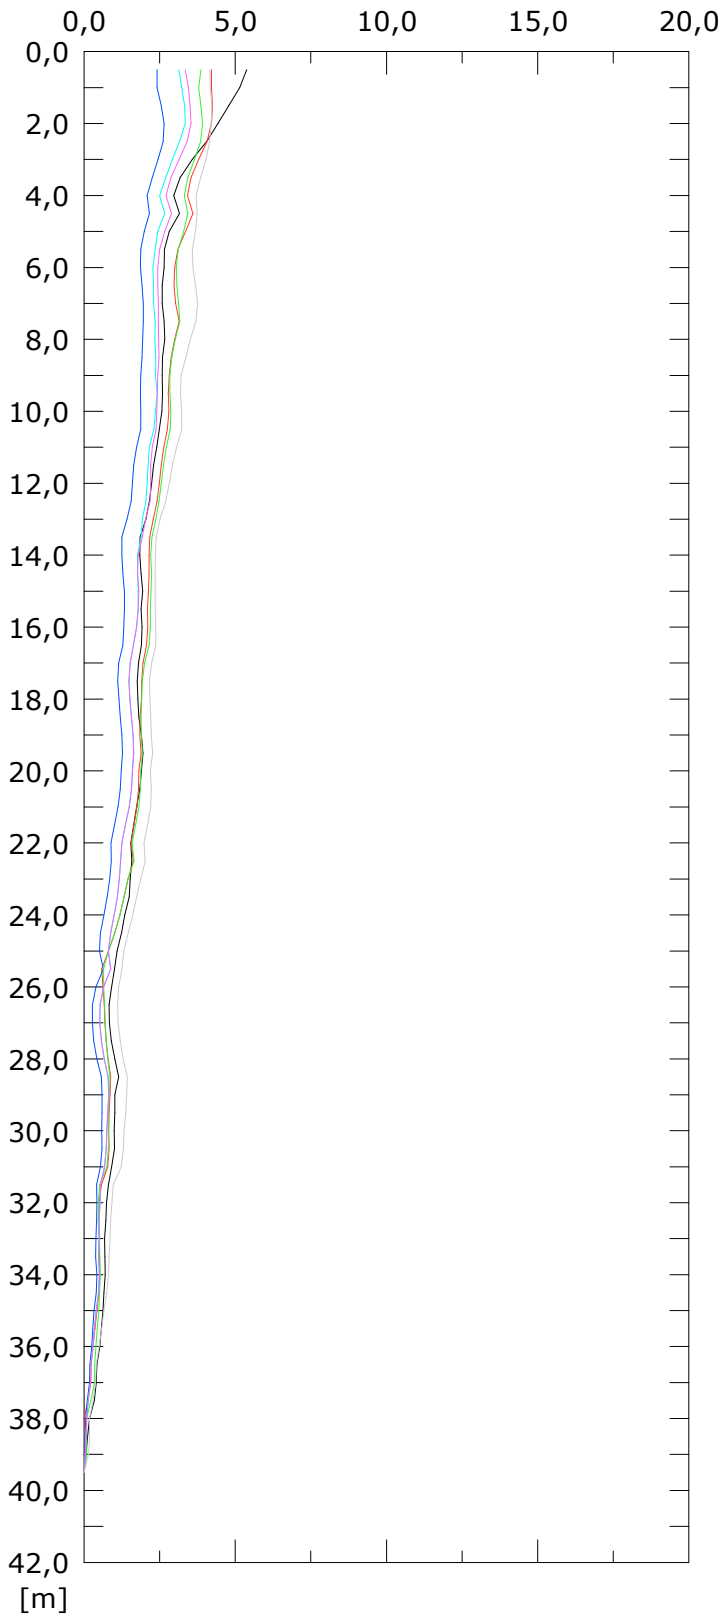
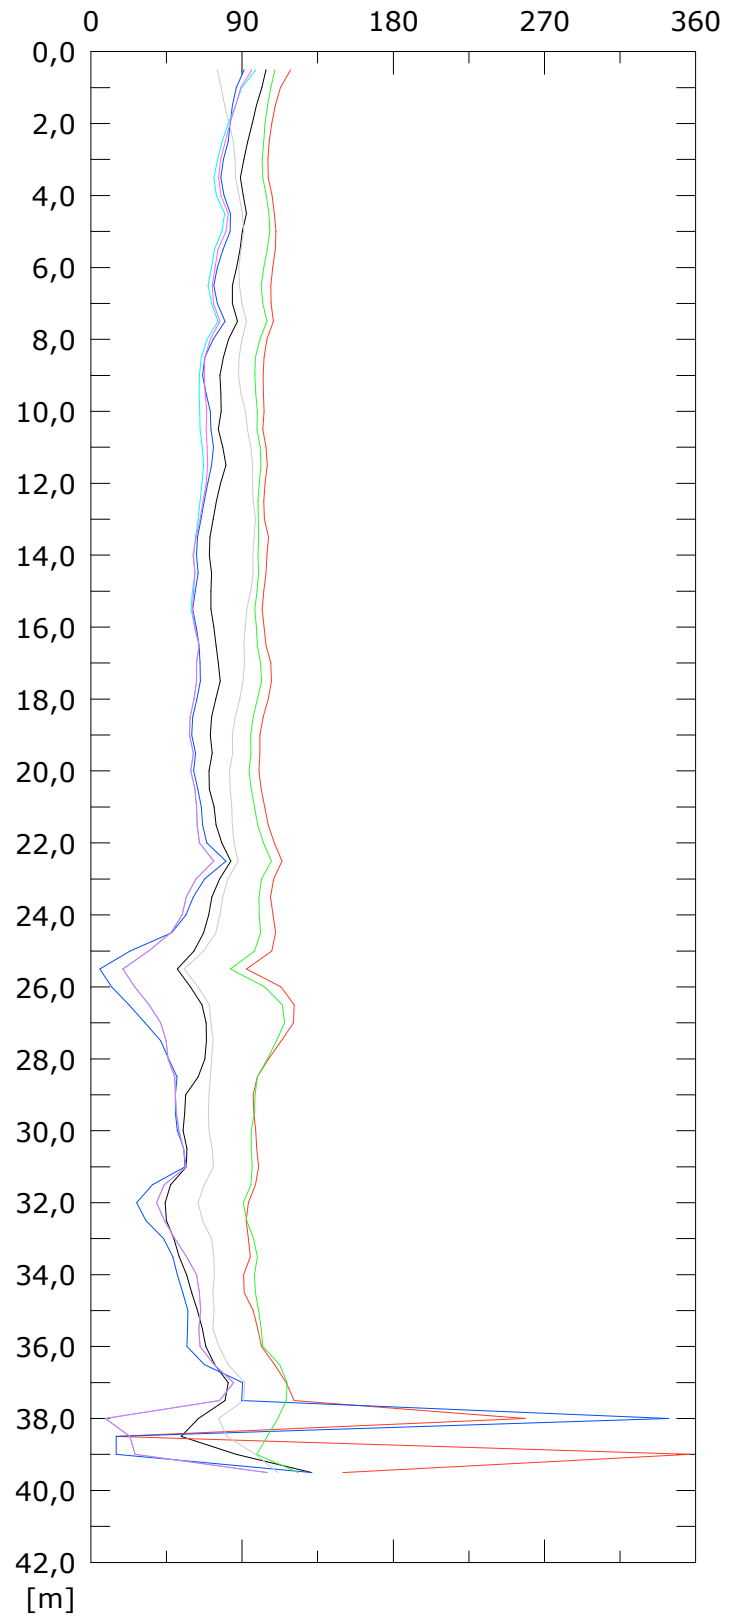
Elaborazione differenziale integrale dal basso

Risultante spost. [mm]

Angolo [gradi]

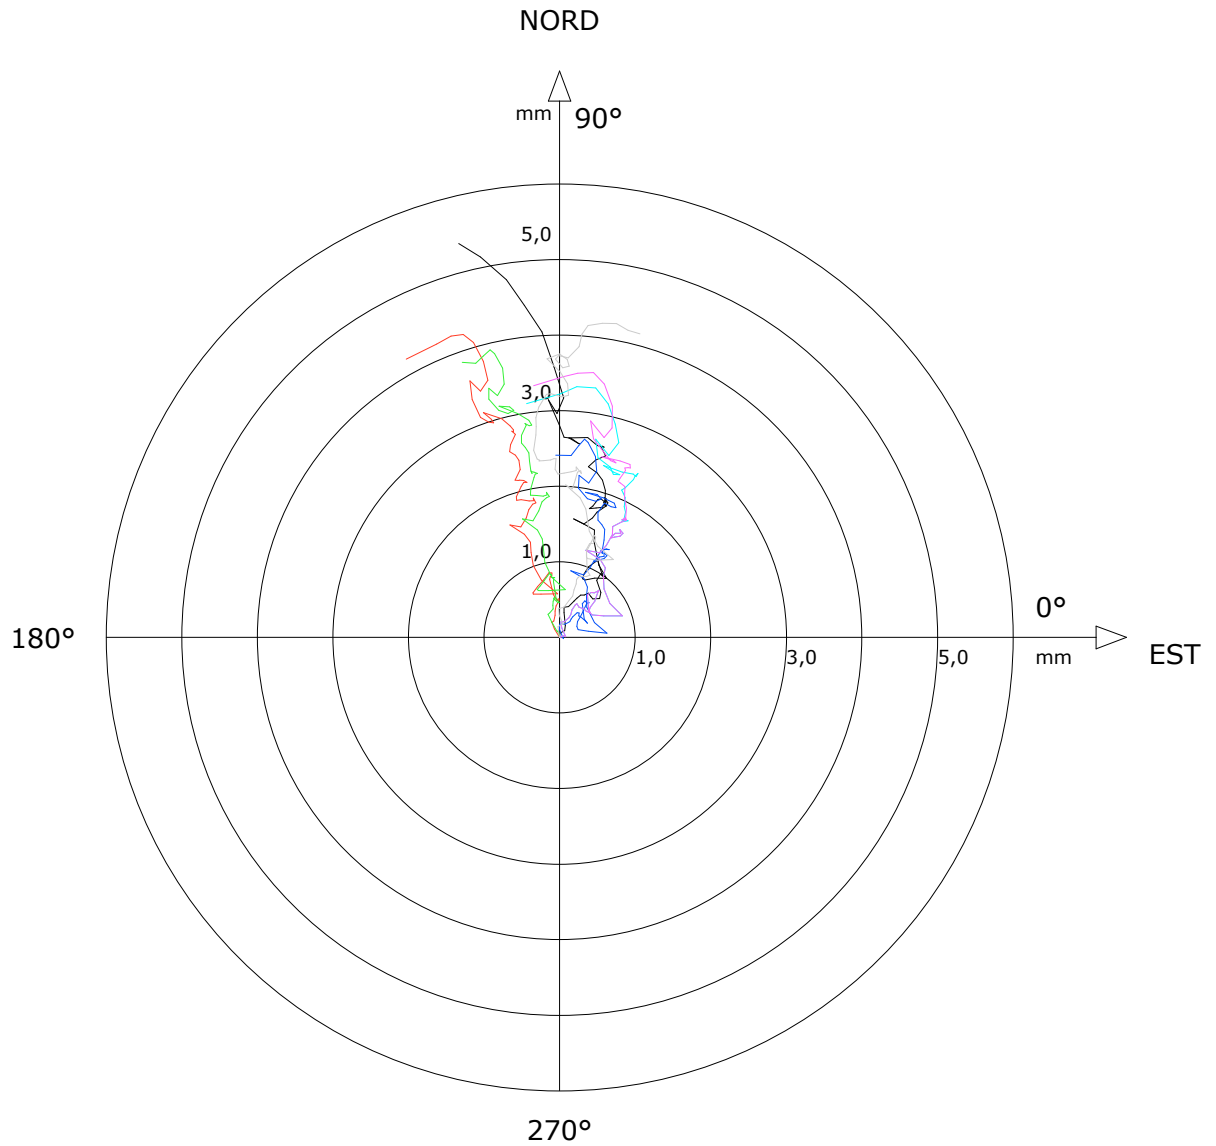
Sito: PMA-FS Tubo: SSI-SP07

Elaborazione differenziale integrale dal basso

Diagramma polare della deviazione
