Elaborazione differenziale integrale dal basso

Riferimento 000:30/10/2017

Sito: PMA-FS Tubo: SSI-SP02

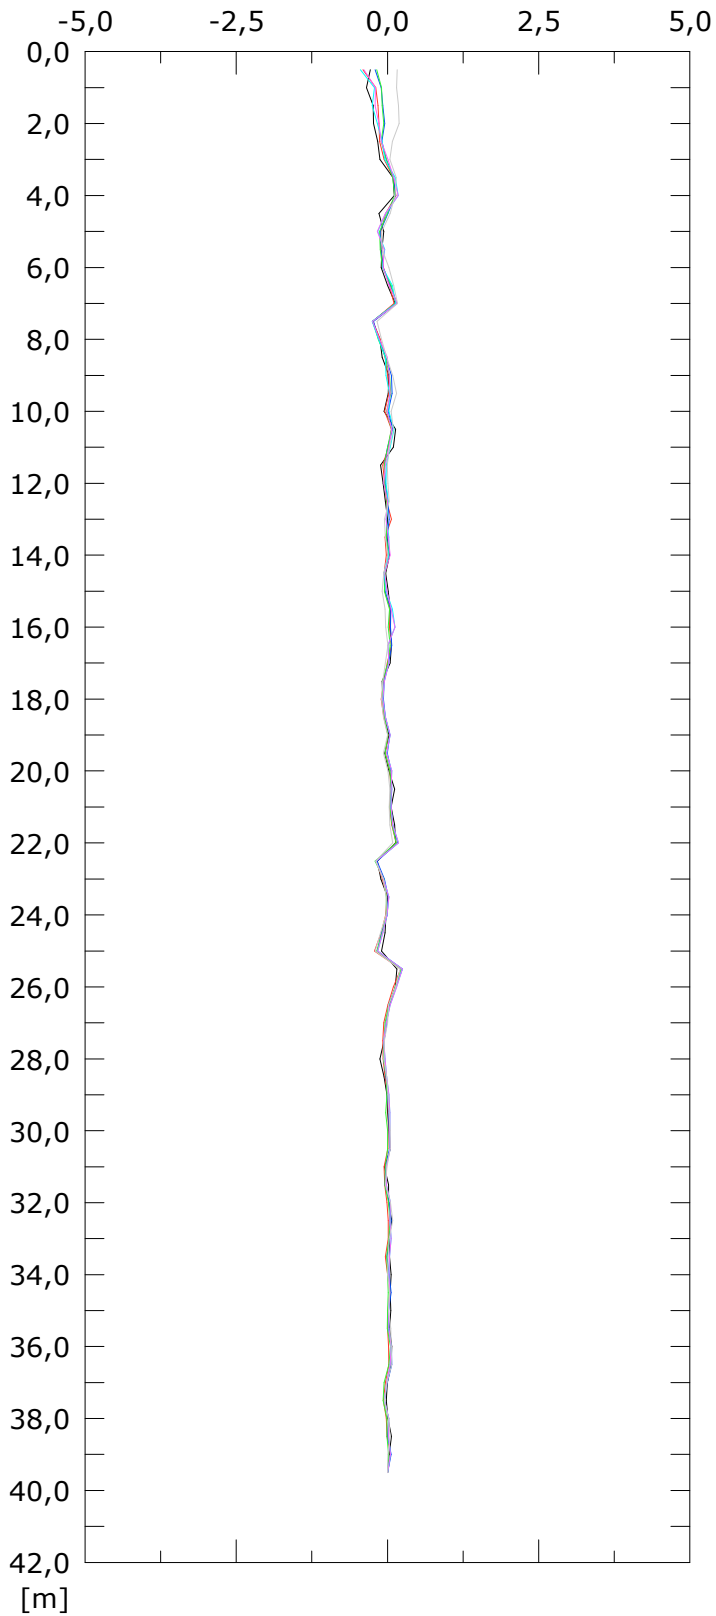
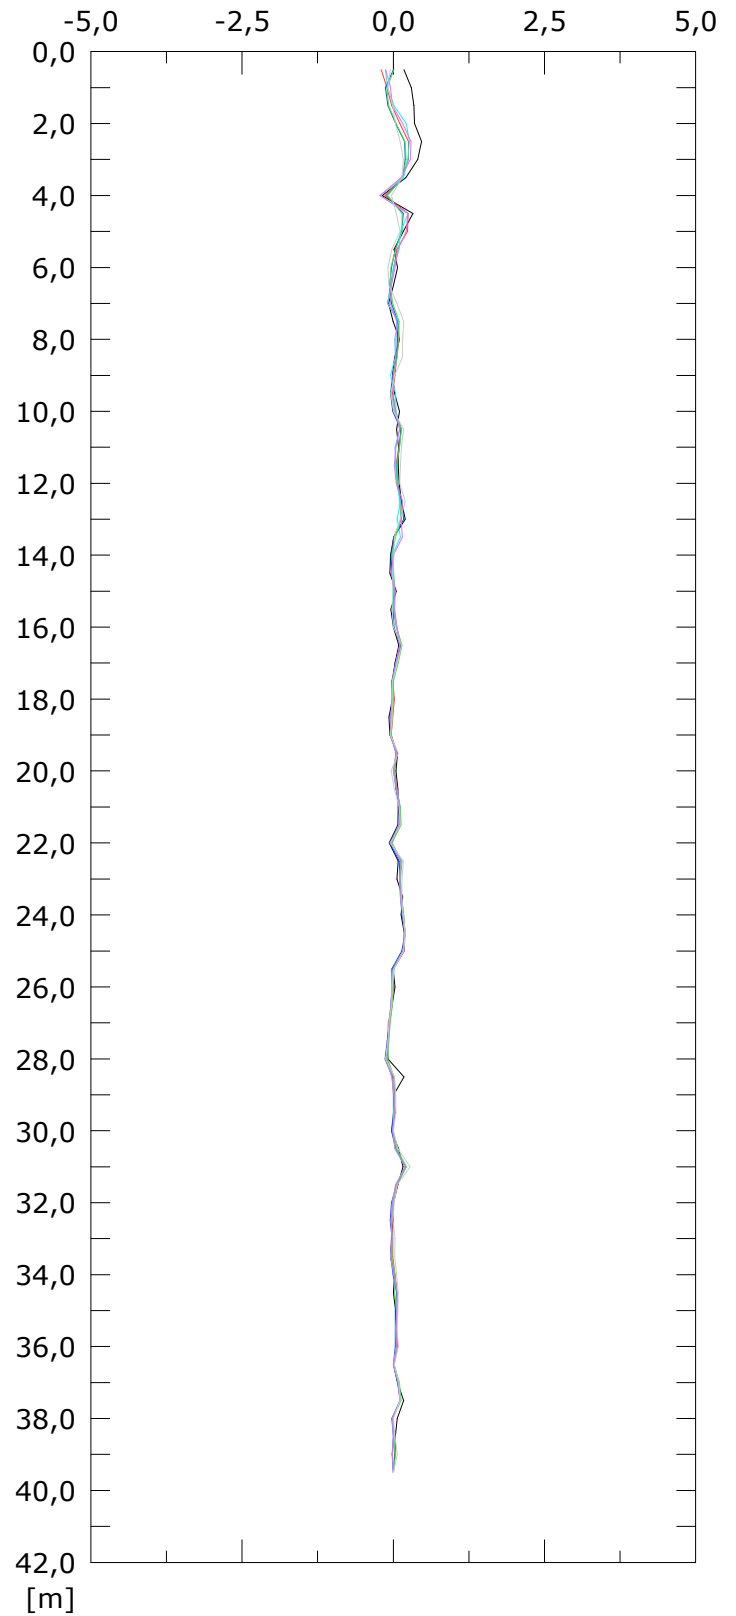
Elaborazione differenziale locale dal basso

Spost. EST [mm]

Spost. NORD [mm]

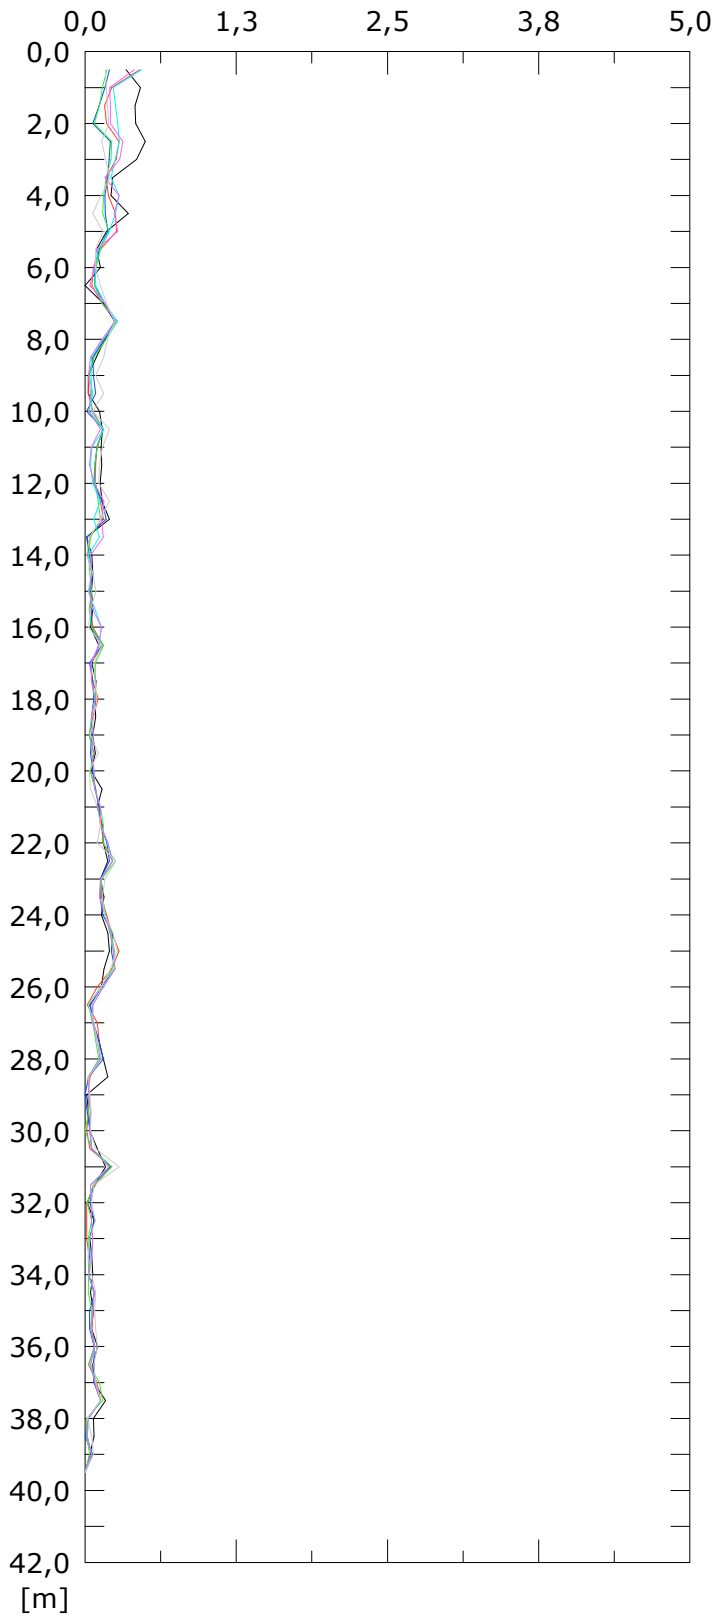
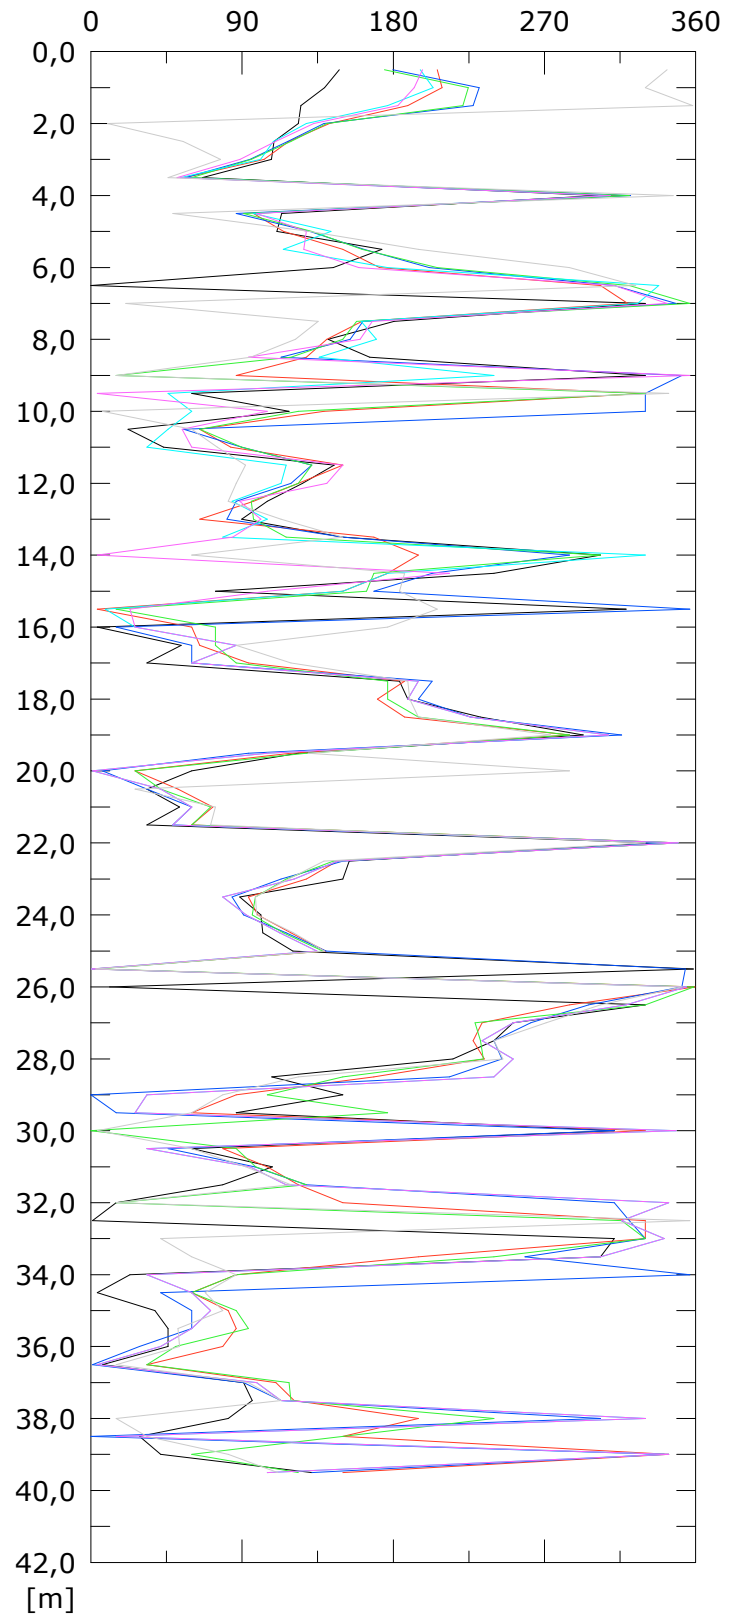
Elaborazione differenziale locale dal basso

Risultante spost. [mm]

Angolo [gradi]

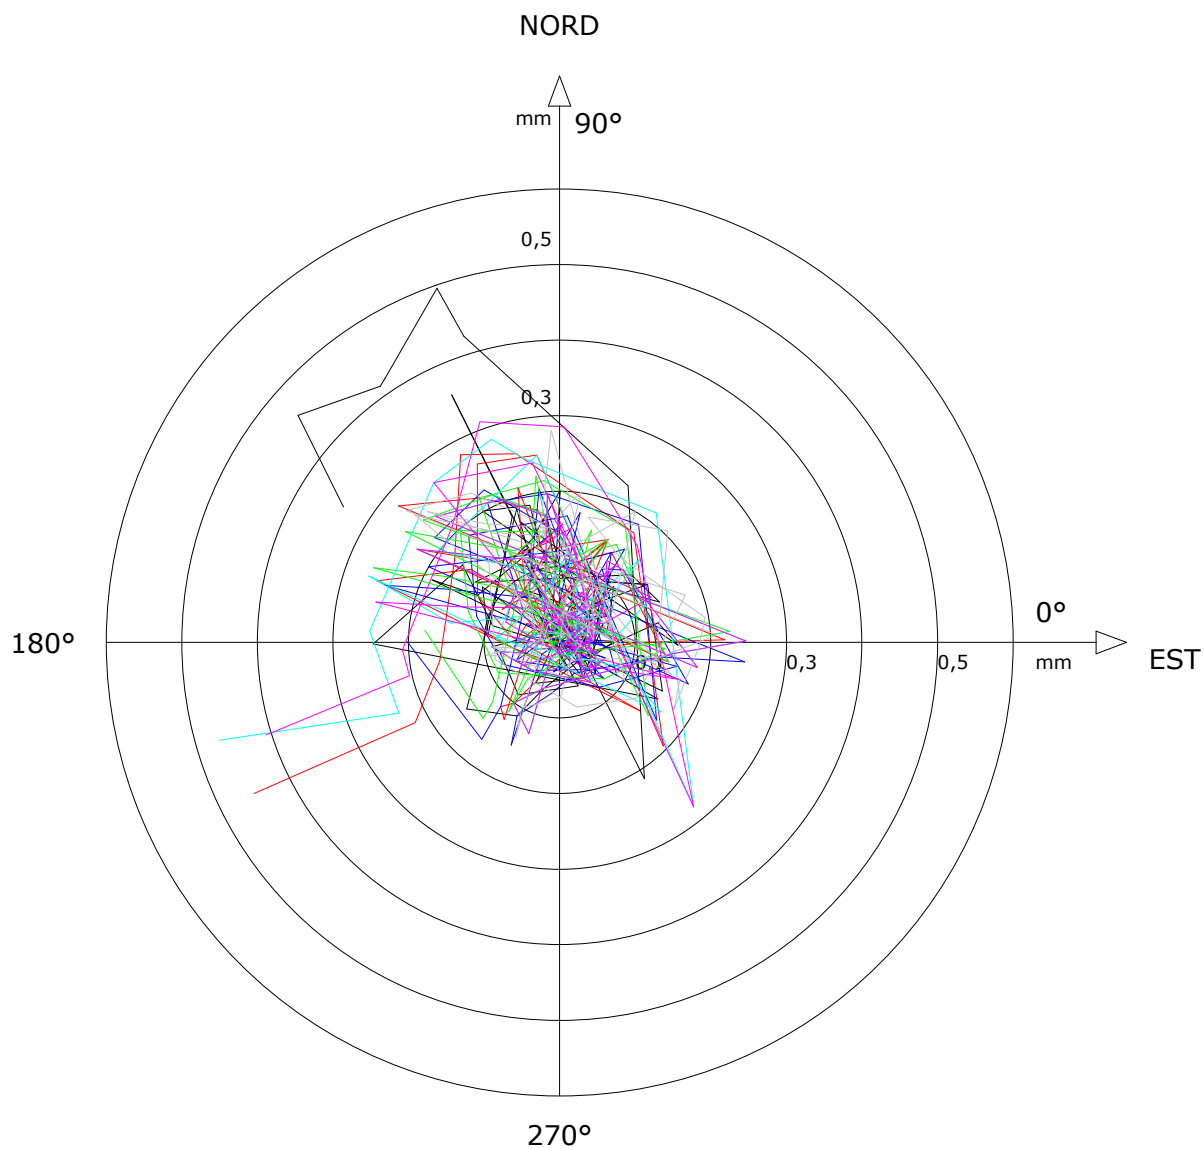
Sito: PMA-FS Tubo: SSI-SP07

Elaborazione differenziale locale dal basso

Diagramma polare della deviazione

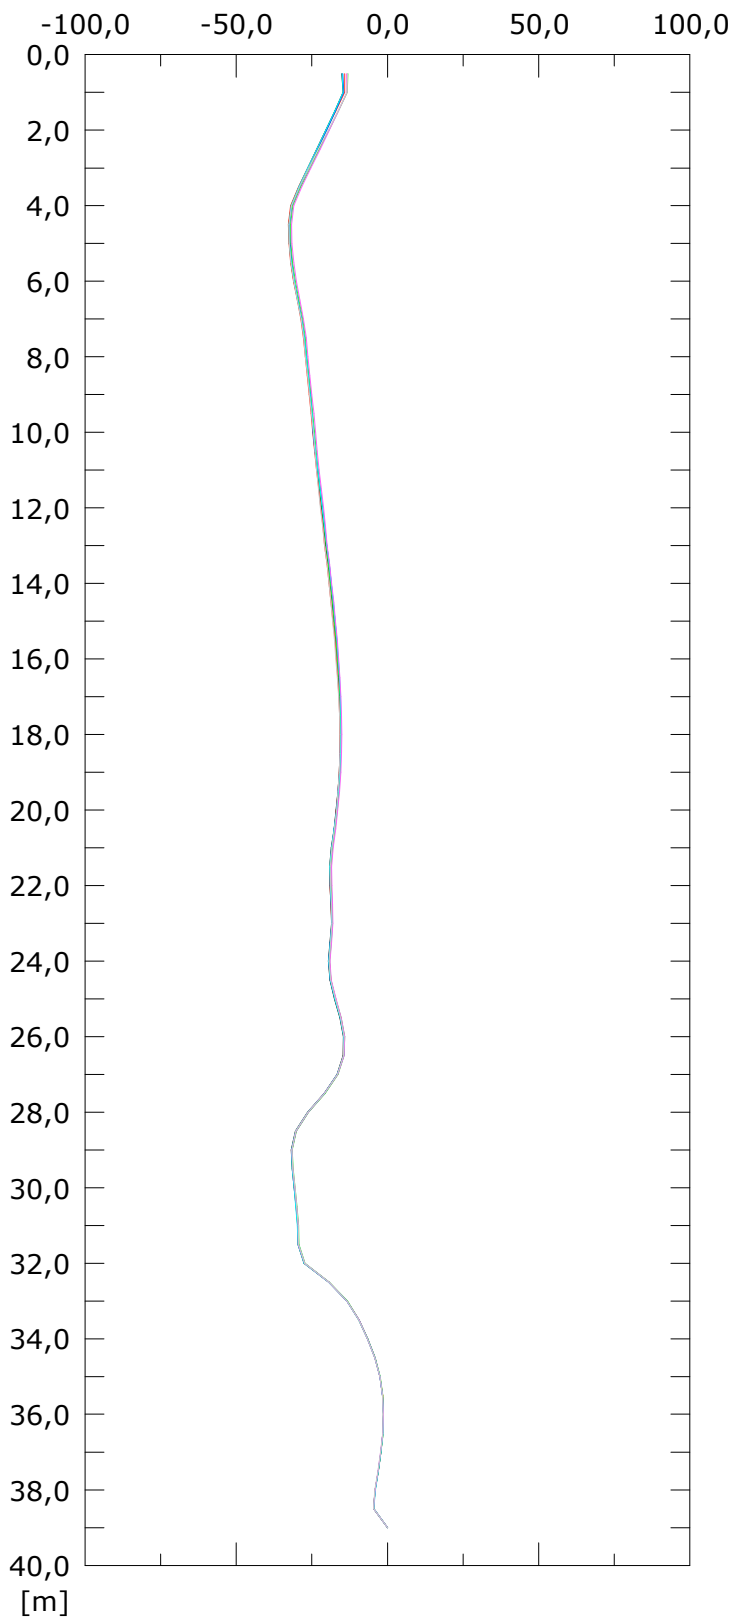
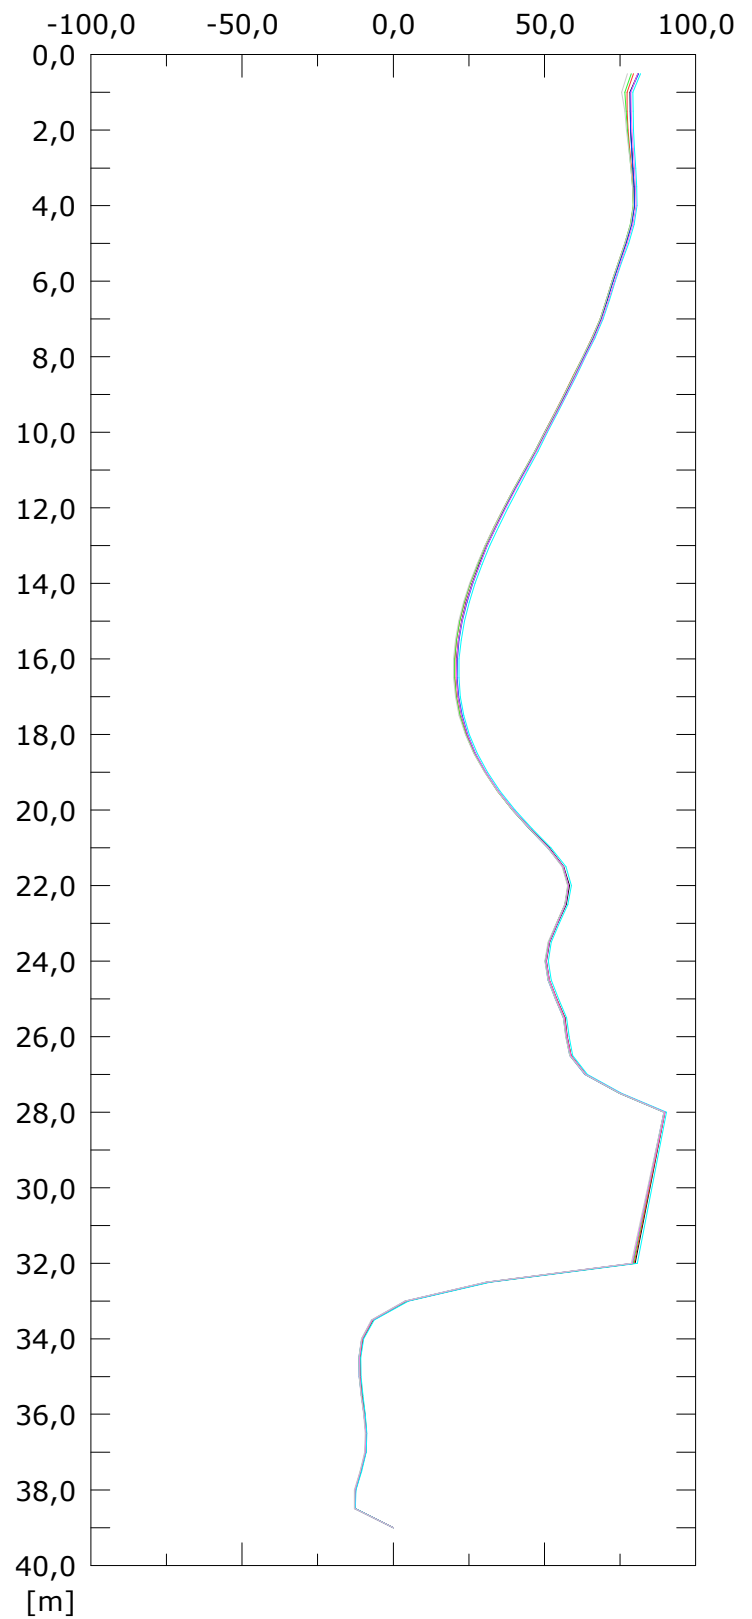
Elaborazione differenziale integrale dal basso

Spost. EST [mm]

Spost. NORD [mm]

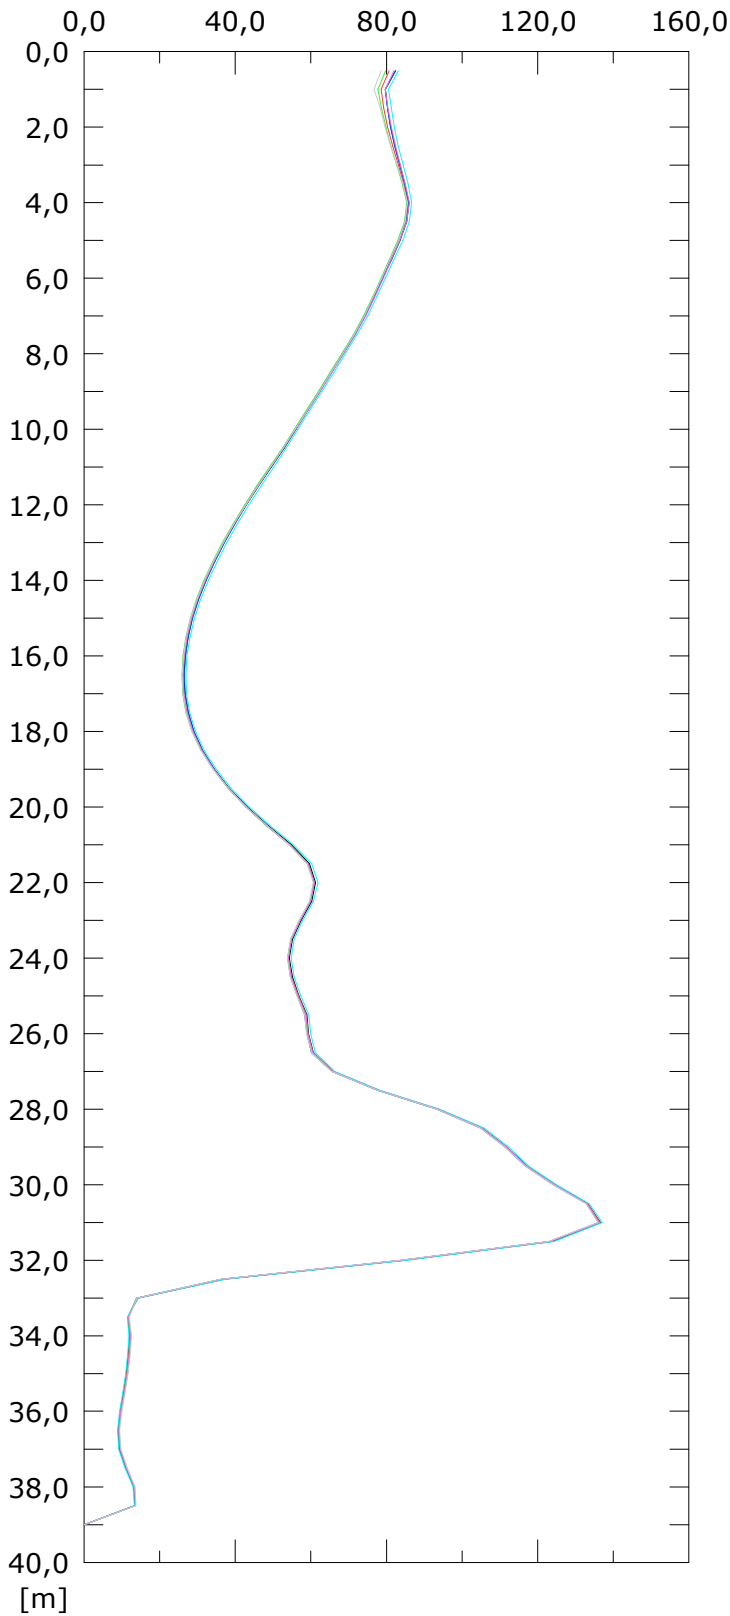
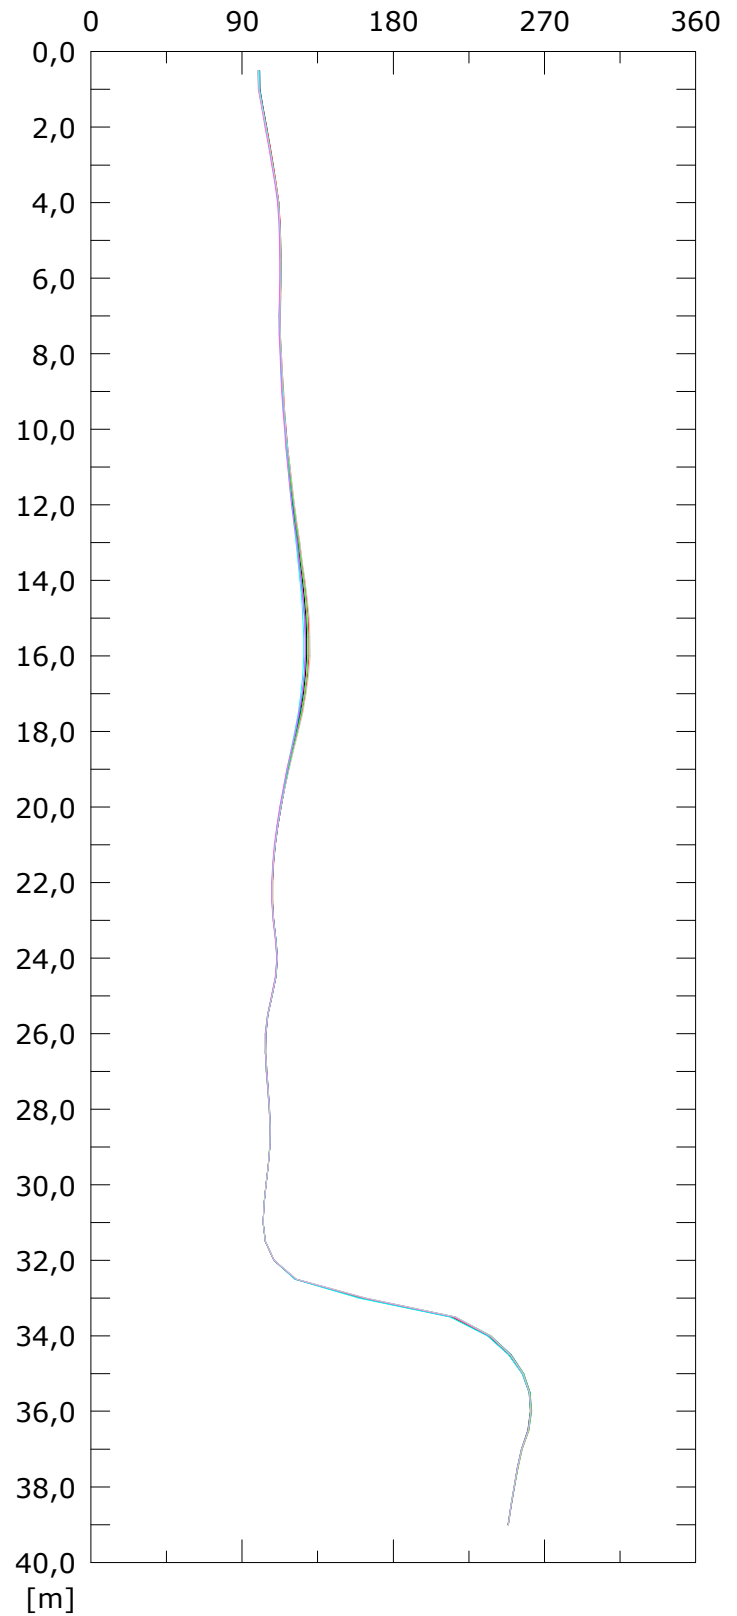
Elaborazione differenziale integrale dal basso

Risultante spost. [mm]

Angolo [gradi]

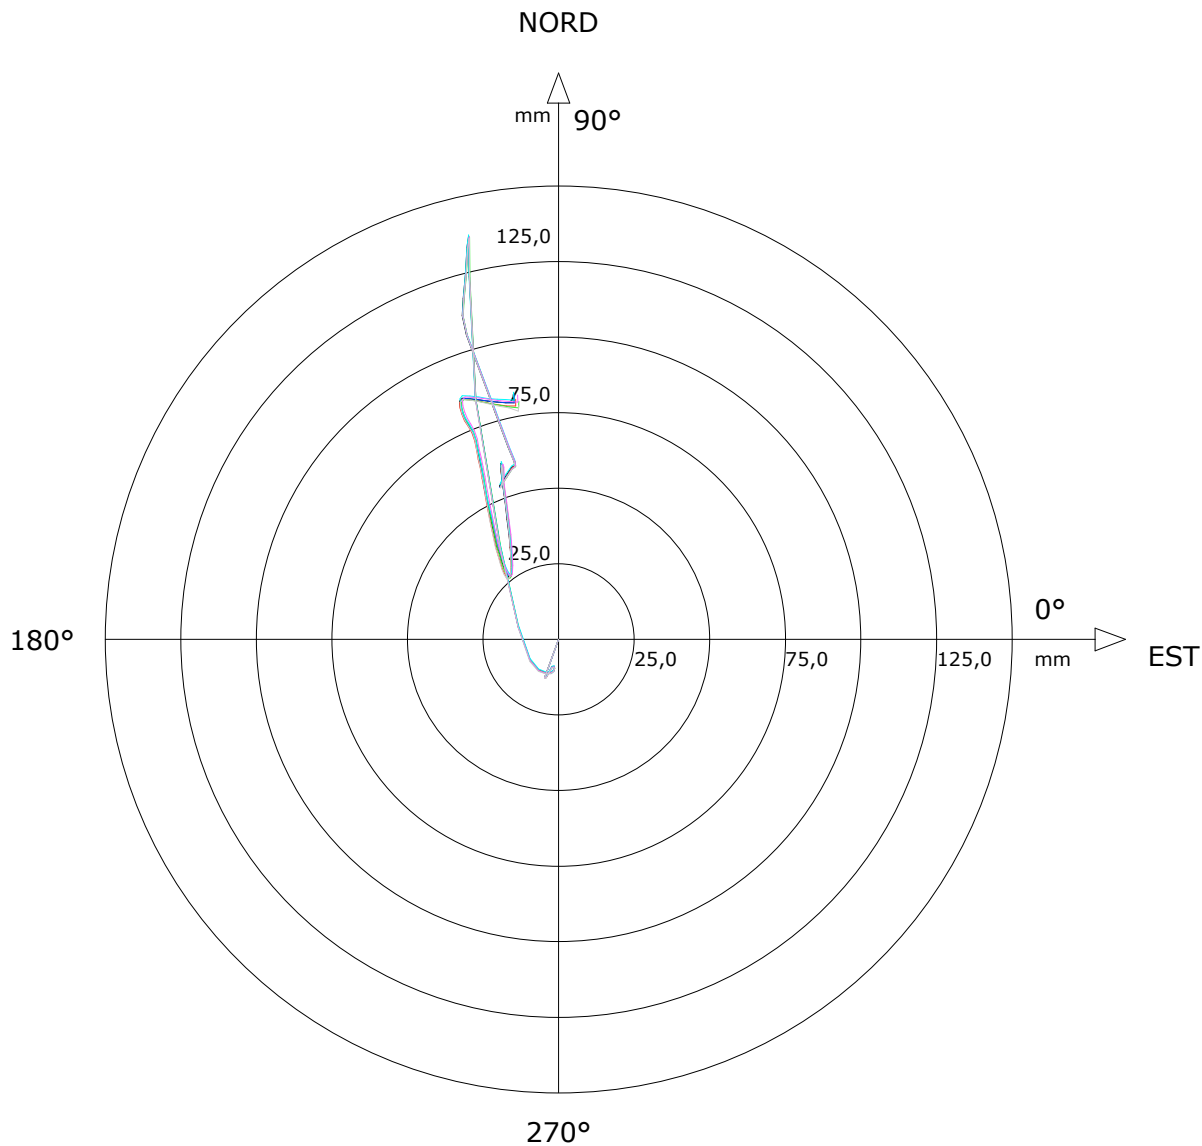
Sito: PMA-FS Tubo: SSI-SP08

Elaborazione differenziale integrale dal basso

Diagramma polare della deviazione

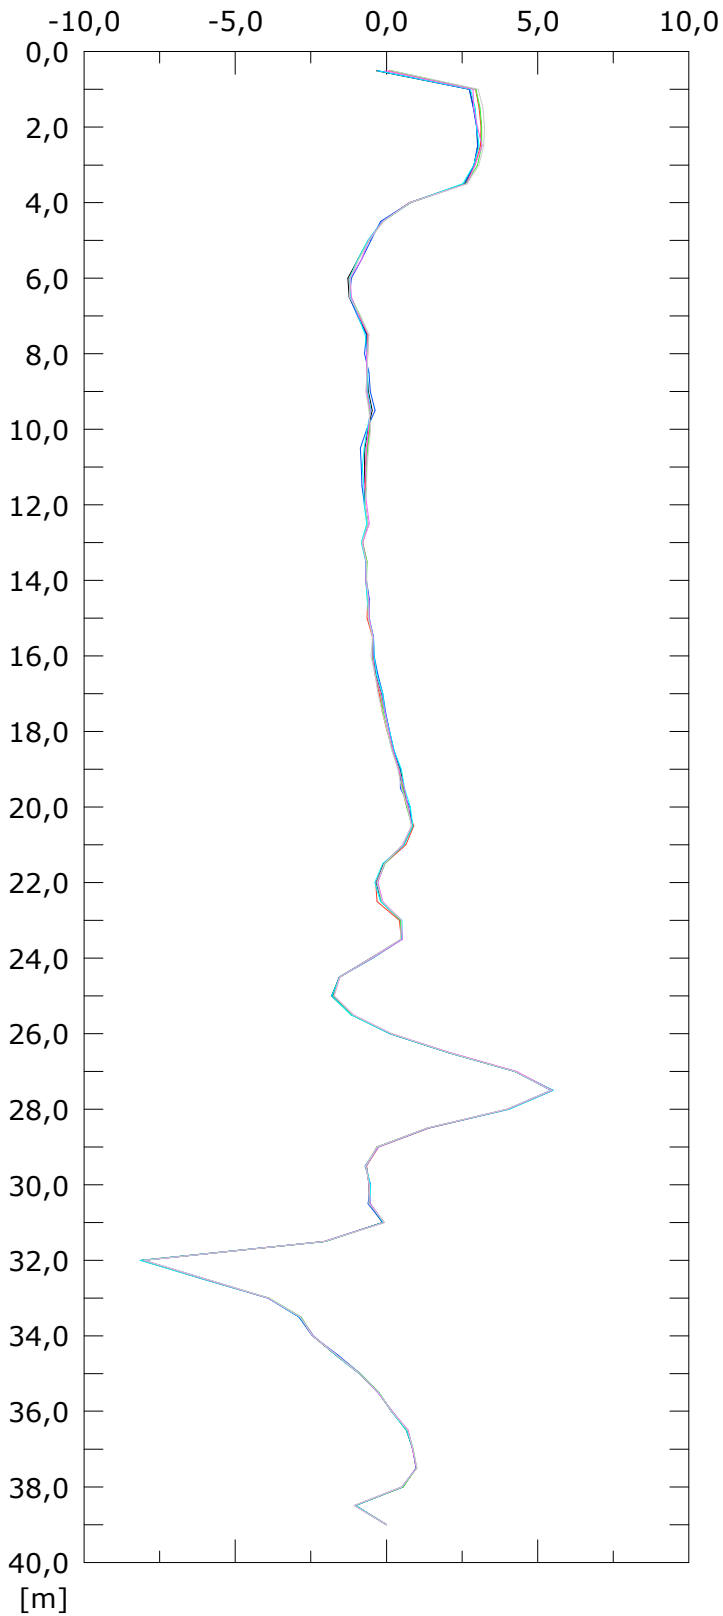
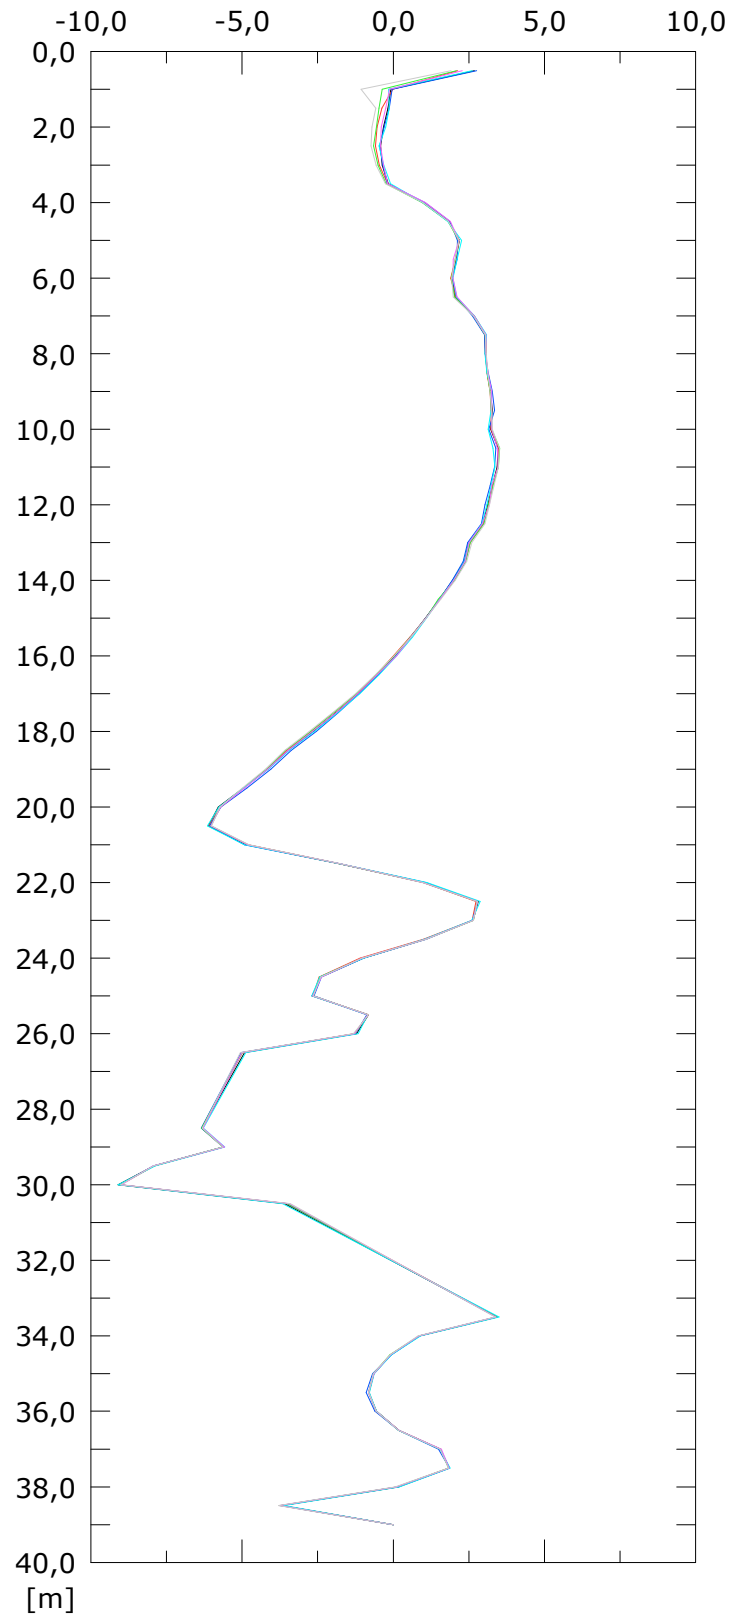
Elaborazione differenziale locale dal basso

Spost. EST [mm]

Spost. NORD [mm]

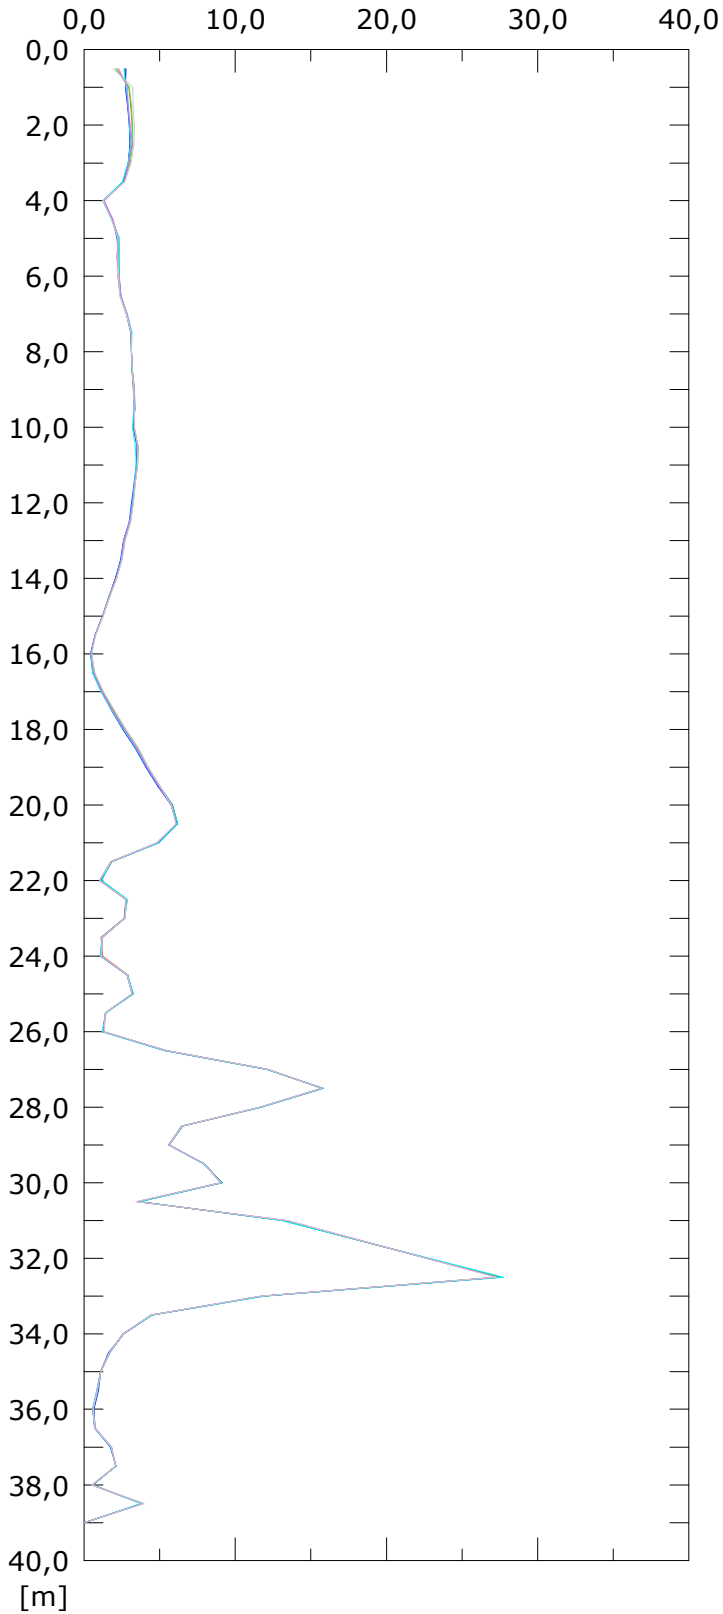
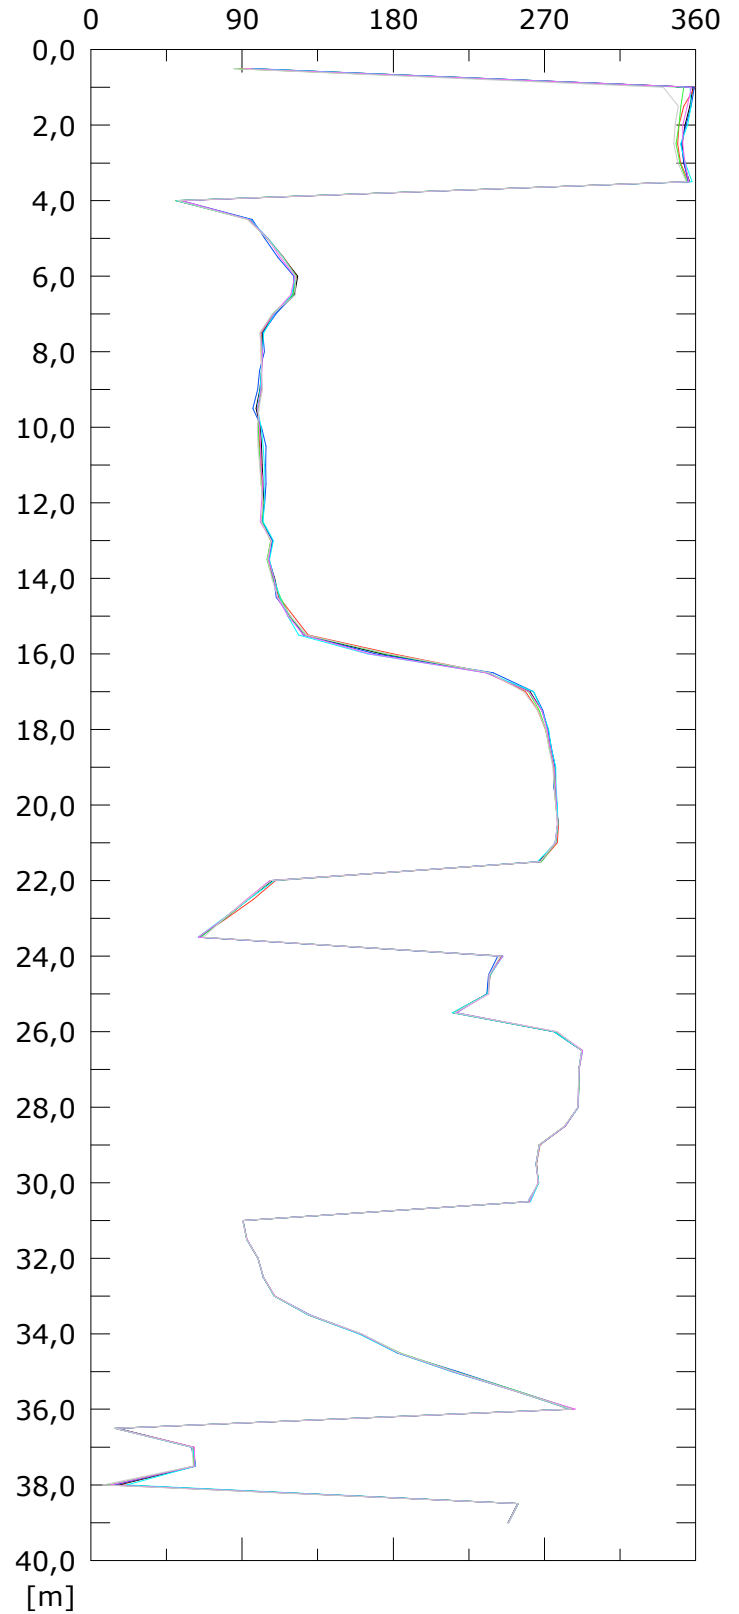
Elaborazione differenziale locale dal basso

Risultante spost. [mm]

Angolo [gradi]

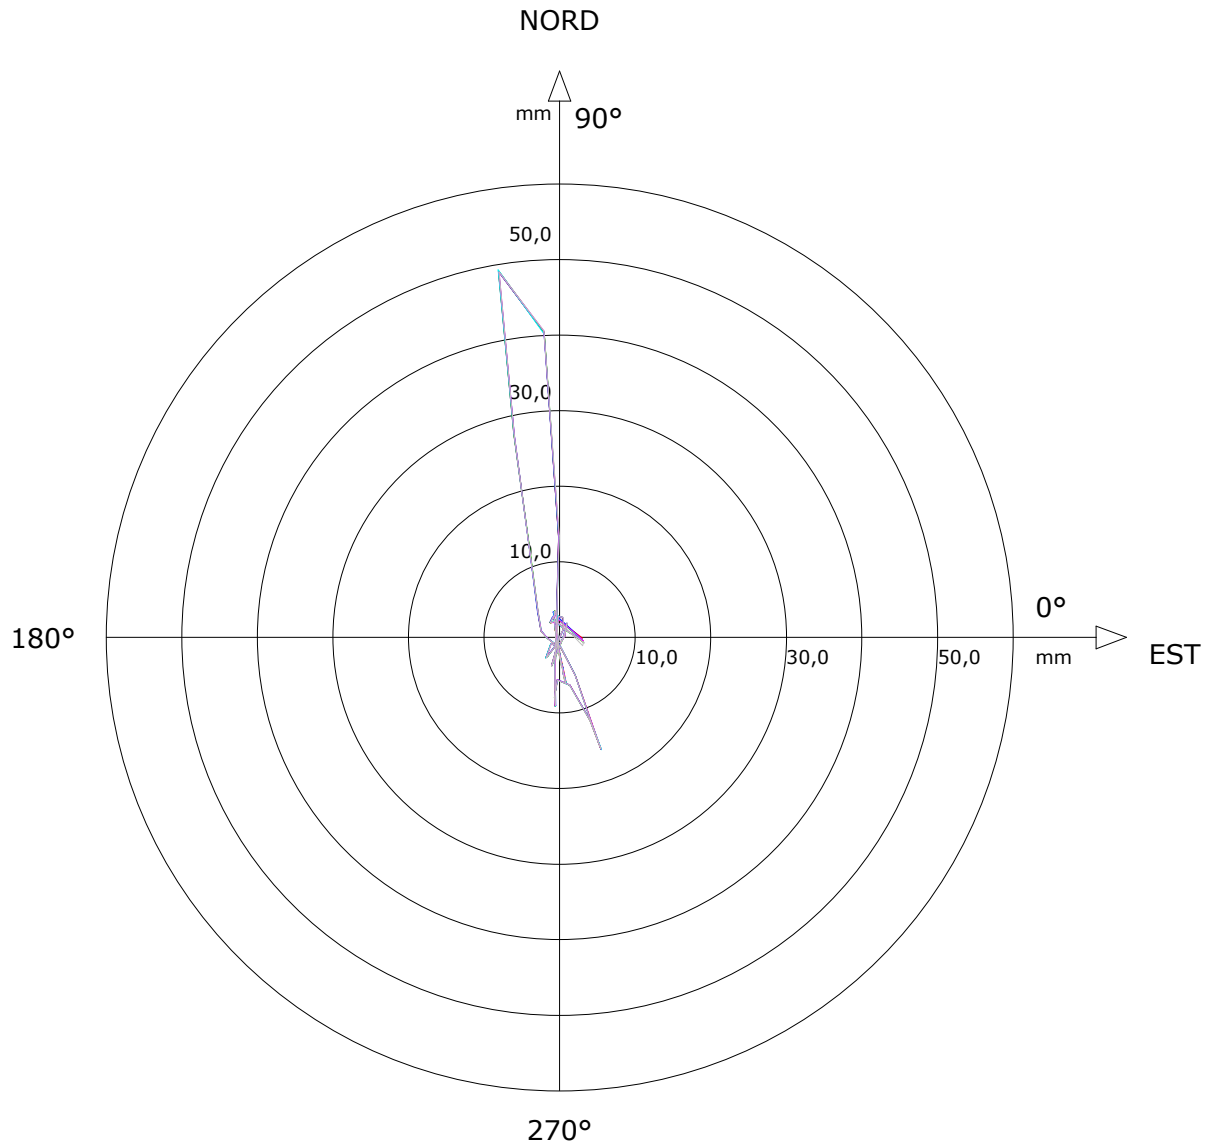
Sito: PMA-FS Tubo: SSI-SP08

Elaborazione differenziale locale dal basso

Diagramma polare della deviazione
