Elaborazione differenziale integrale dal basso

Riferimento 000:22/12/2016

Sito: PMA-FS Tubo: SSI-SP01

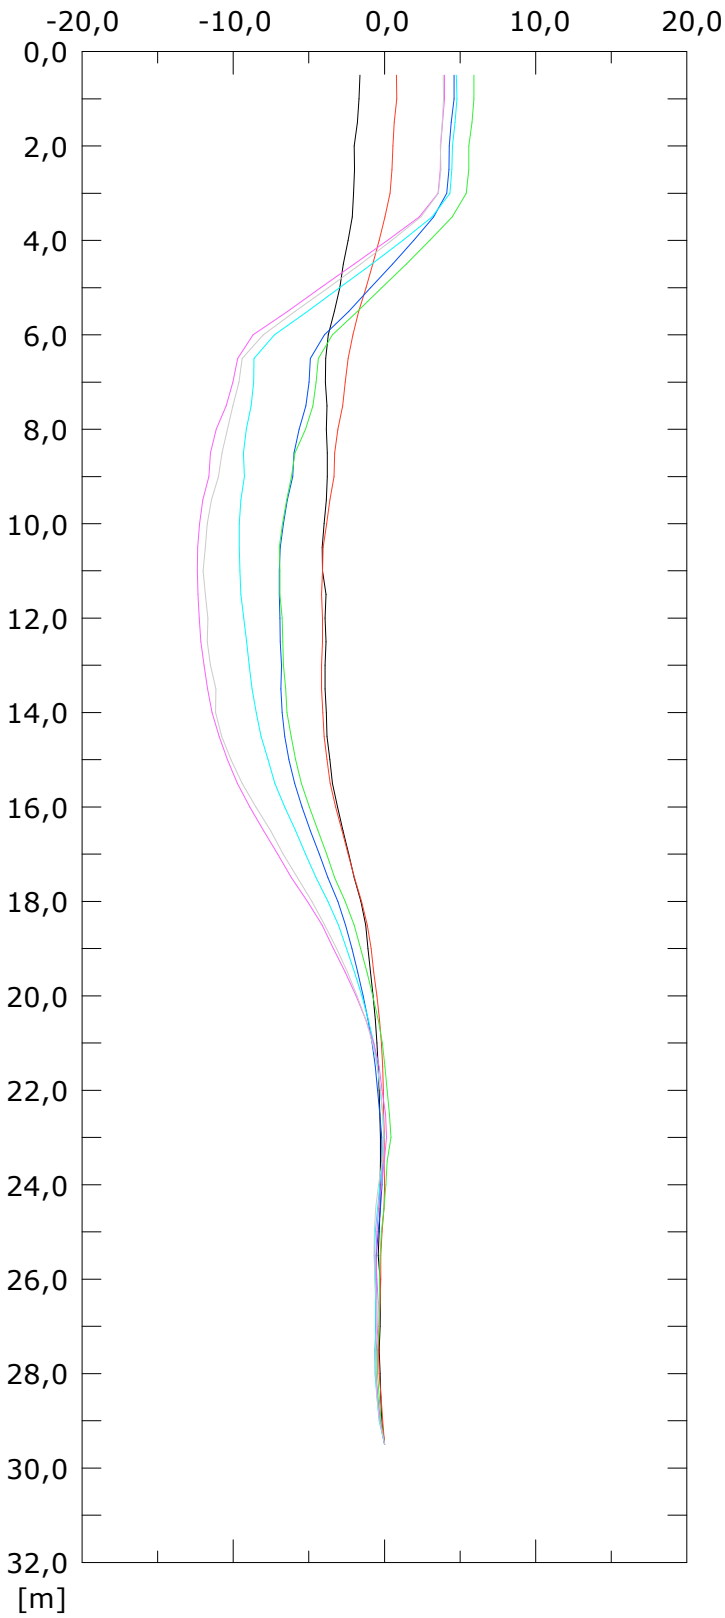
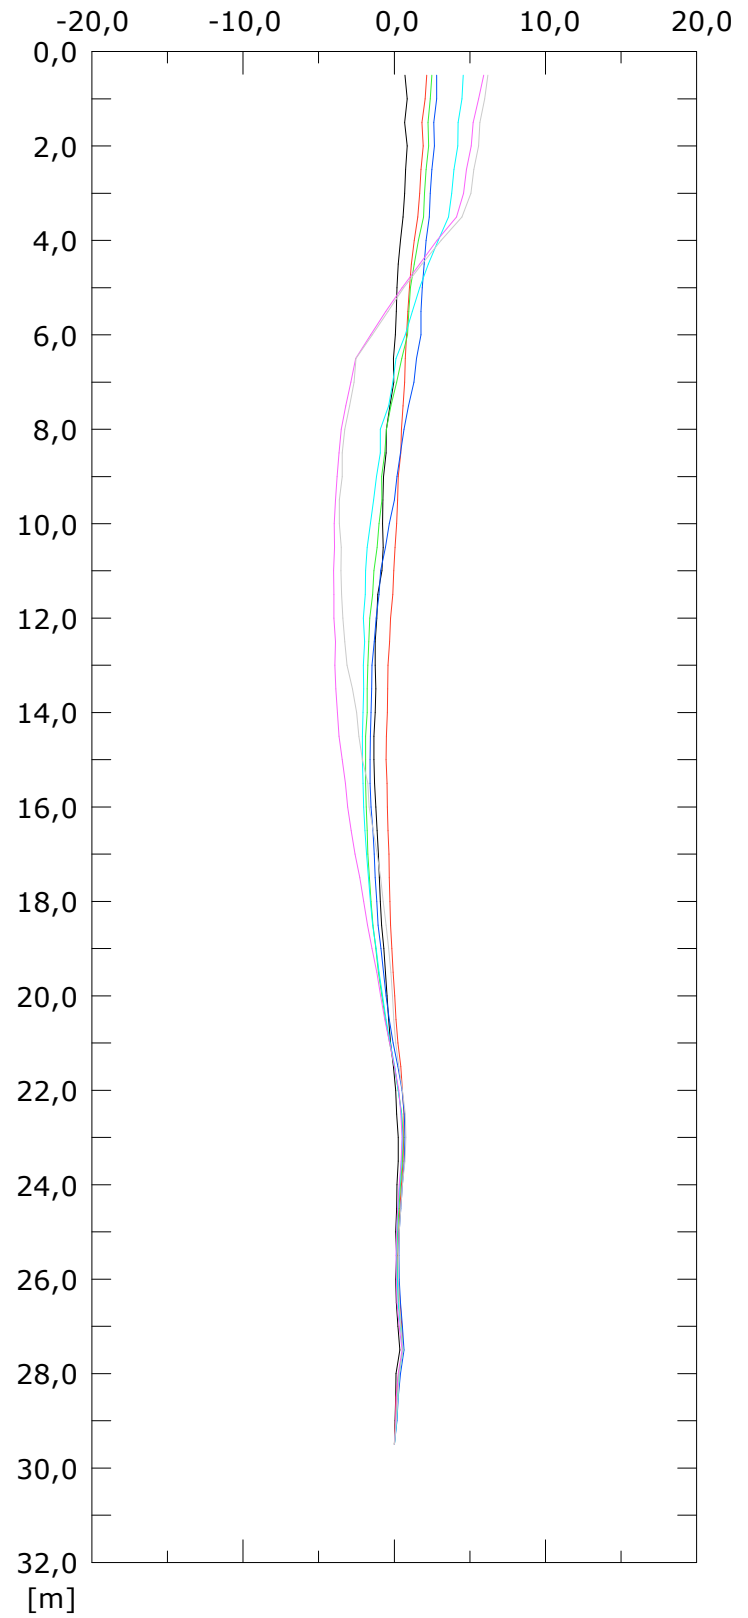
Spost. EST [mm]

Spost. NORD [mm]

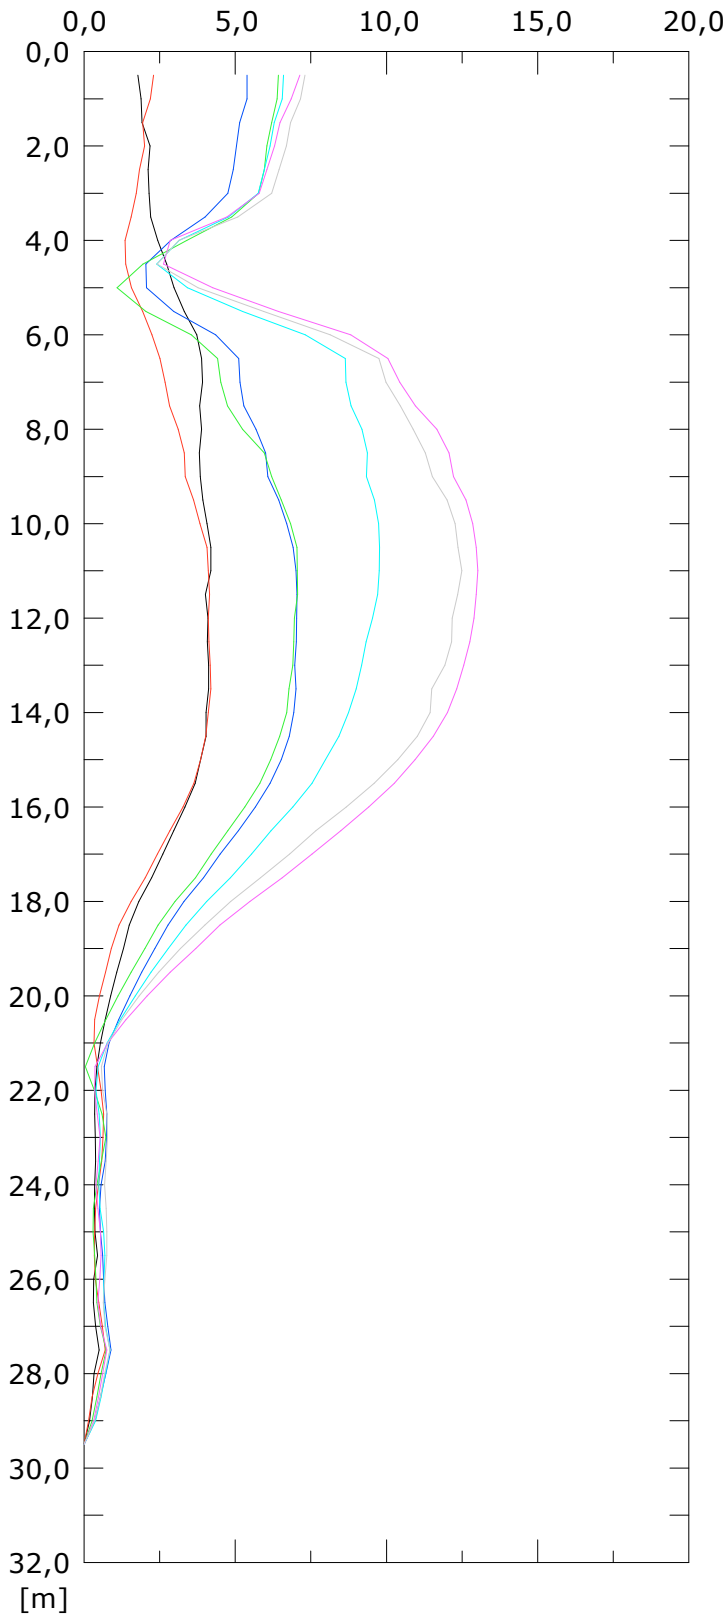
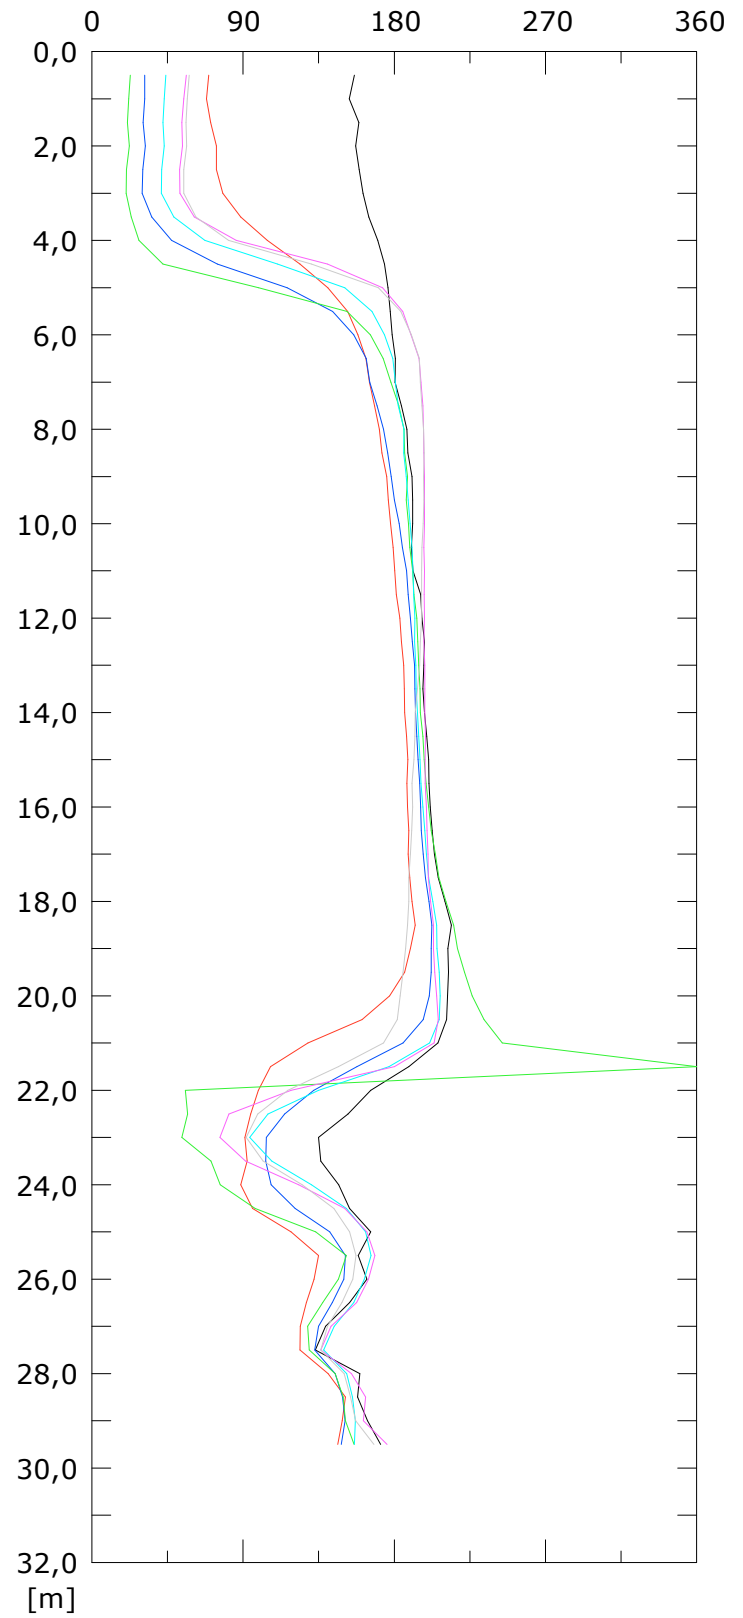
Elaborazione differenziale integrale dal basso

Risultante spost. [mm]

Angolo [gradi]

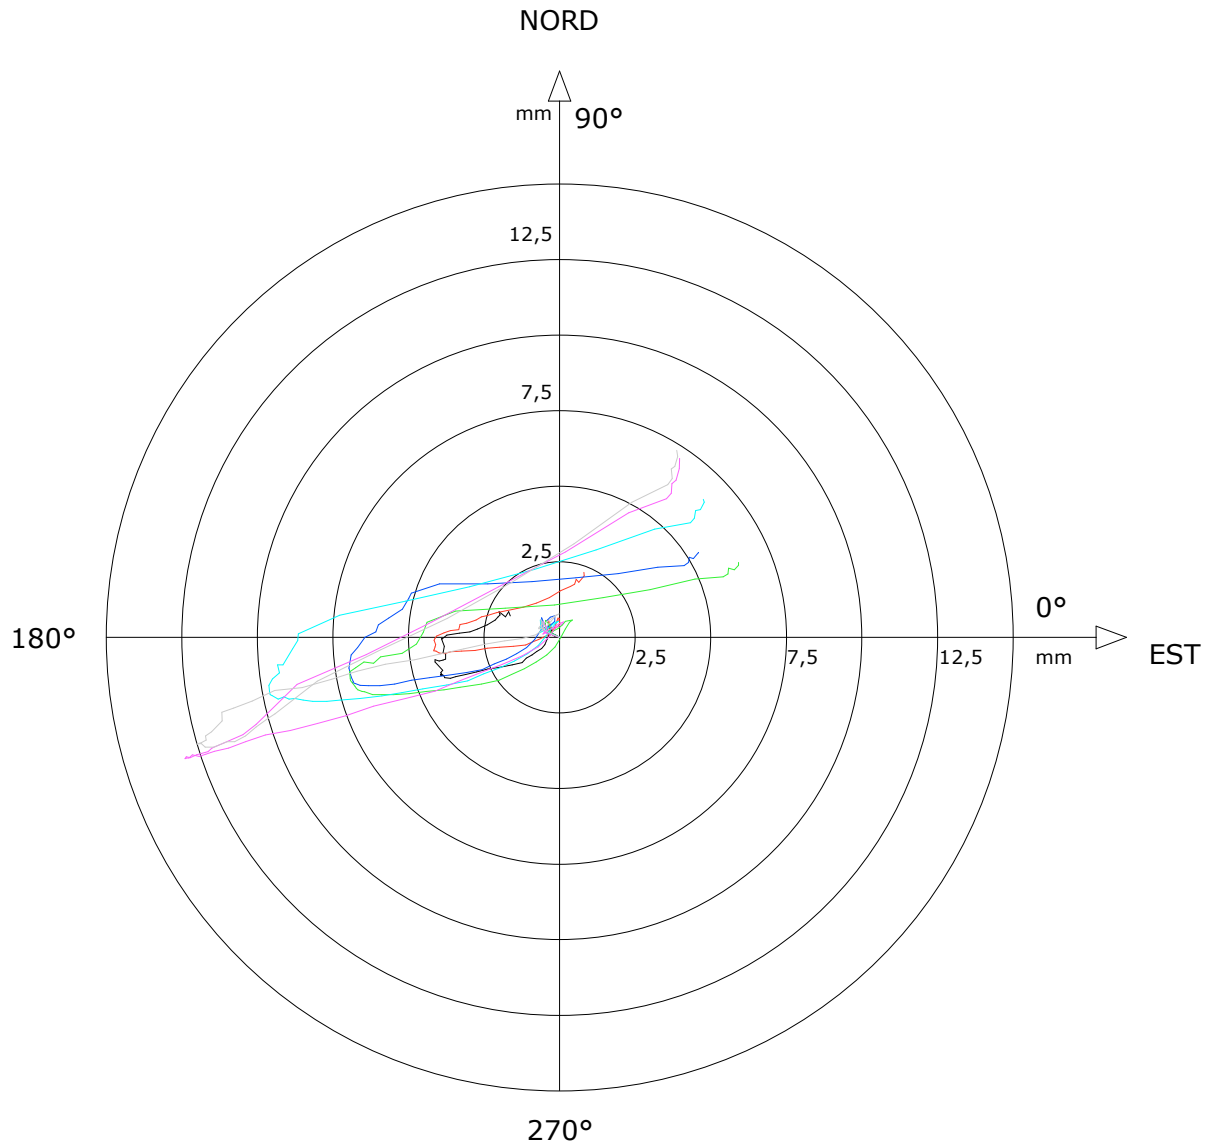
Elaborazione differenziale integrale dal basso

Diagramma polare della deviazione

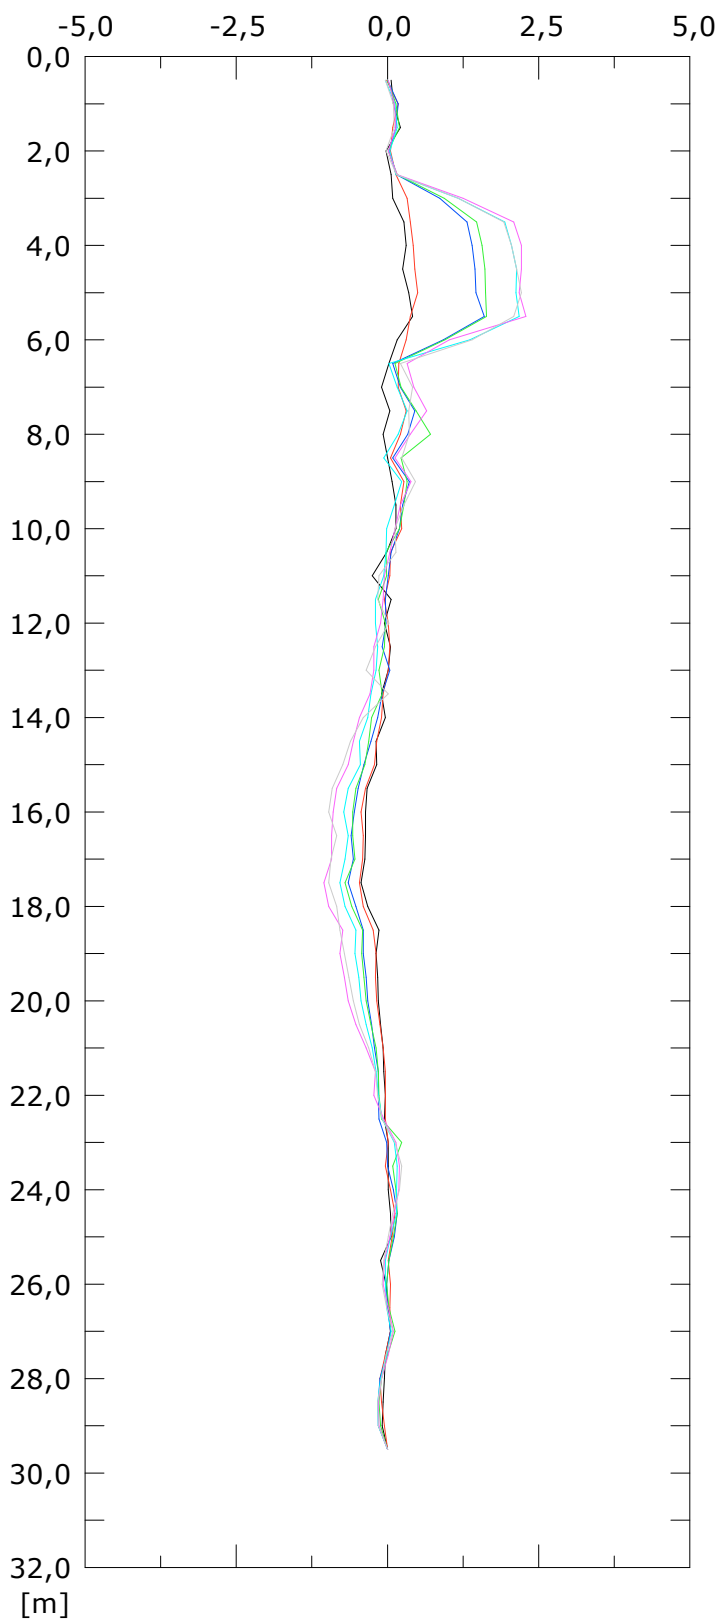
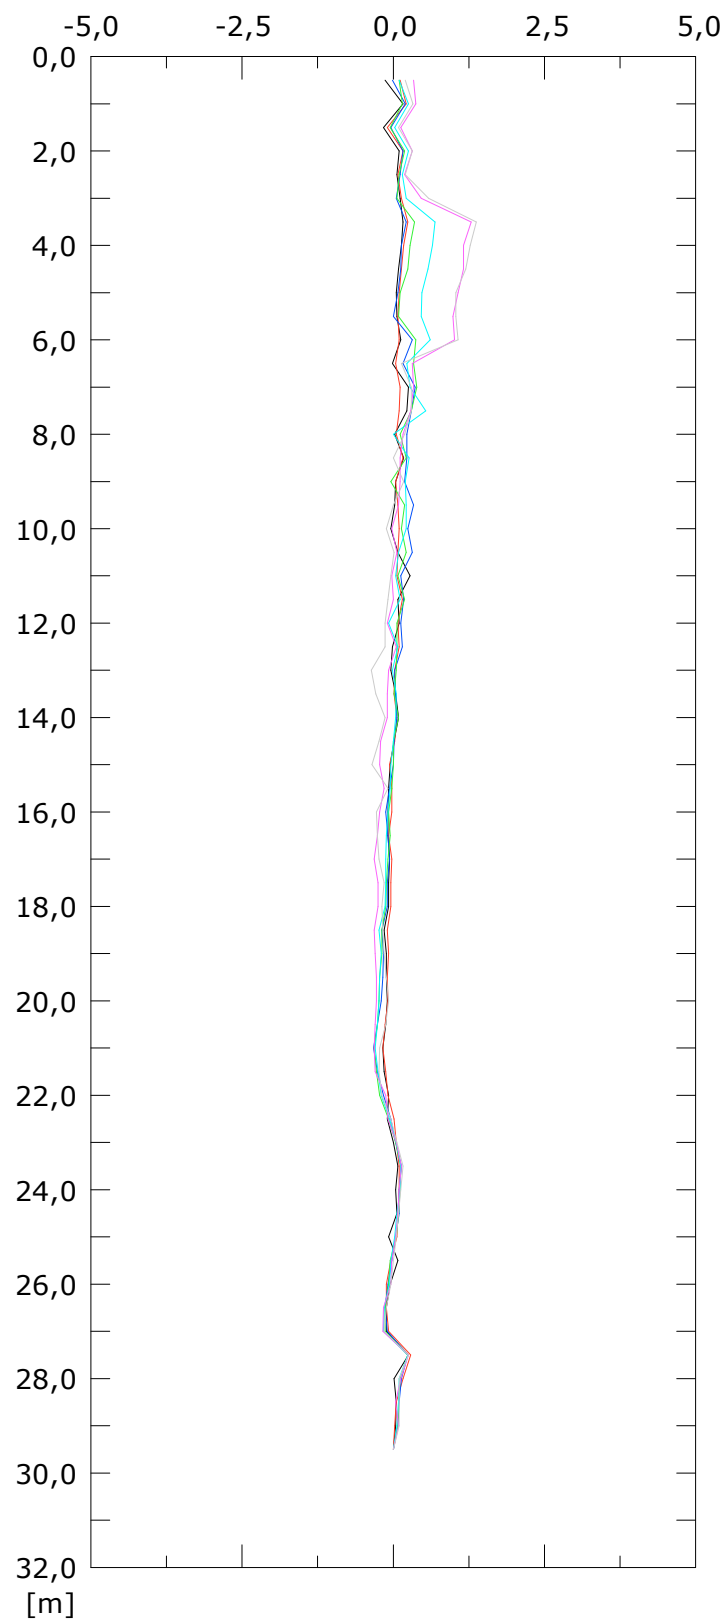
Elaborazione differenziale locale dal basso

Spost. EST [mm]

Spost. NORD [mm]

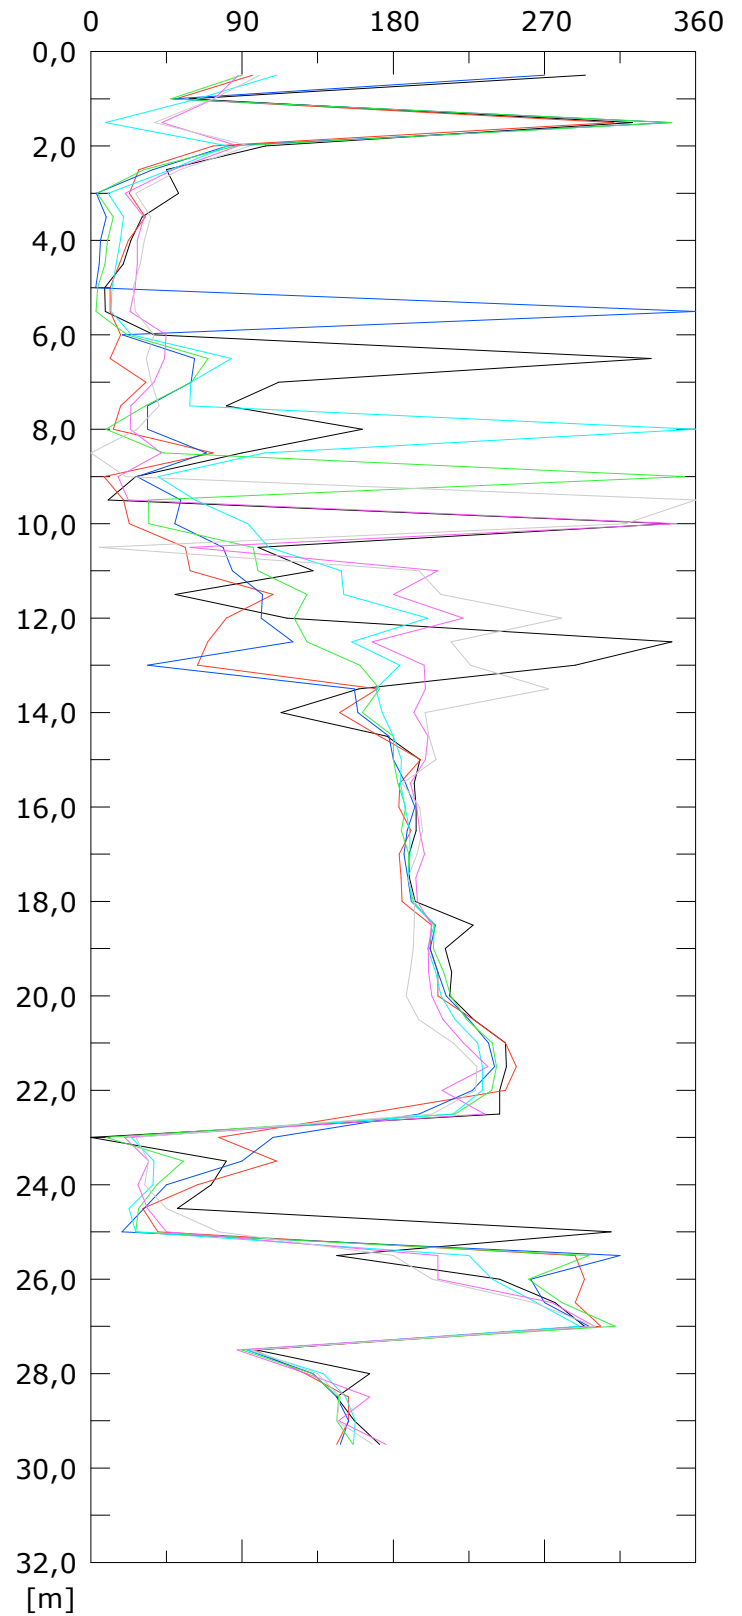
Elaborazione differenziale locale dal basso

Risultante spost. [mm]

Angolo [gradi]

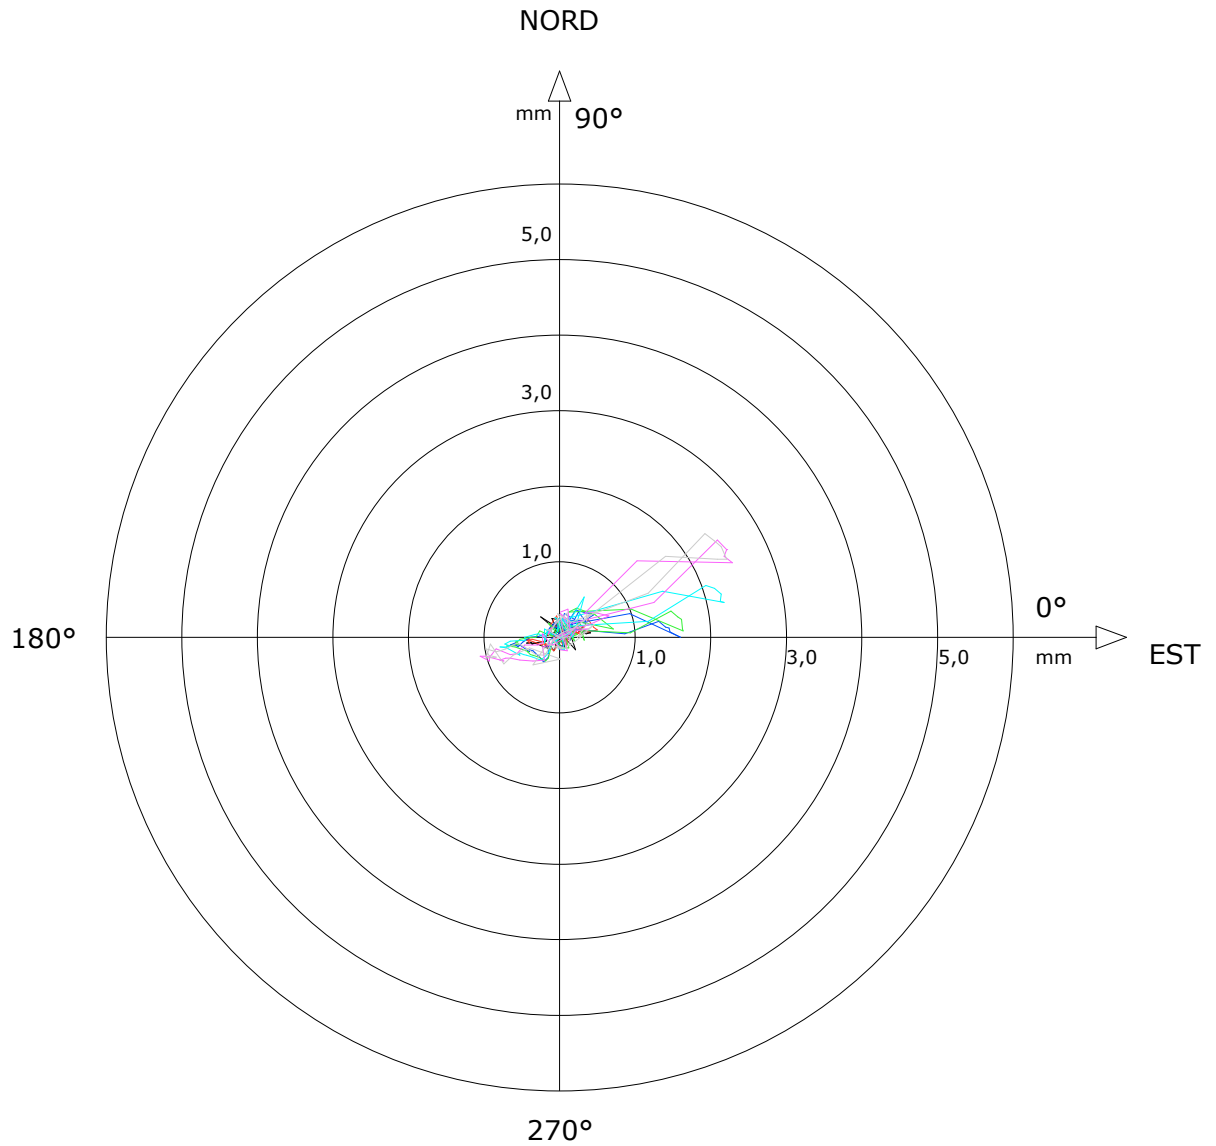
Sito: PMA-FS Tubo: SSI-SP01

Elaborazione differenziale locale dal basso

Diagramma polare della deviazione

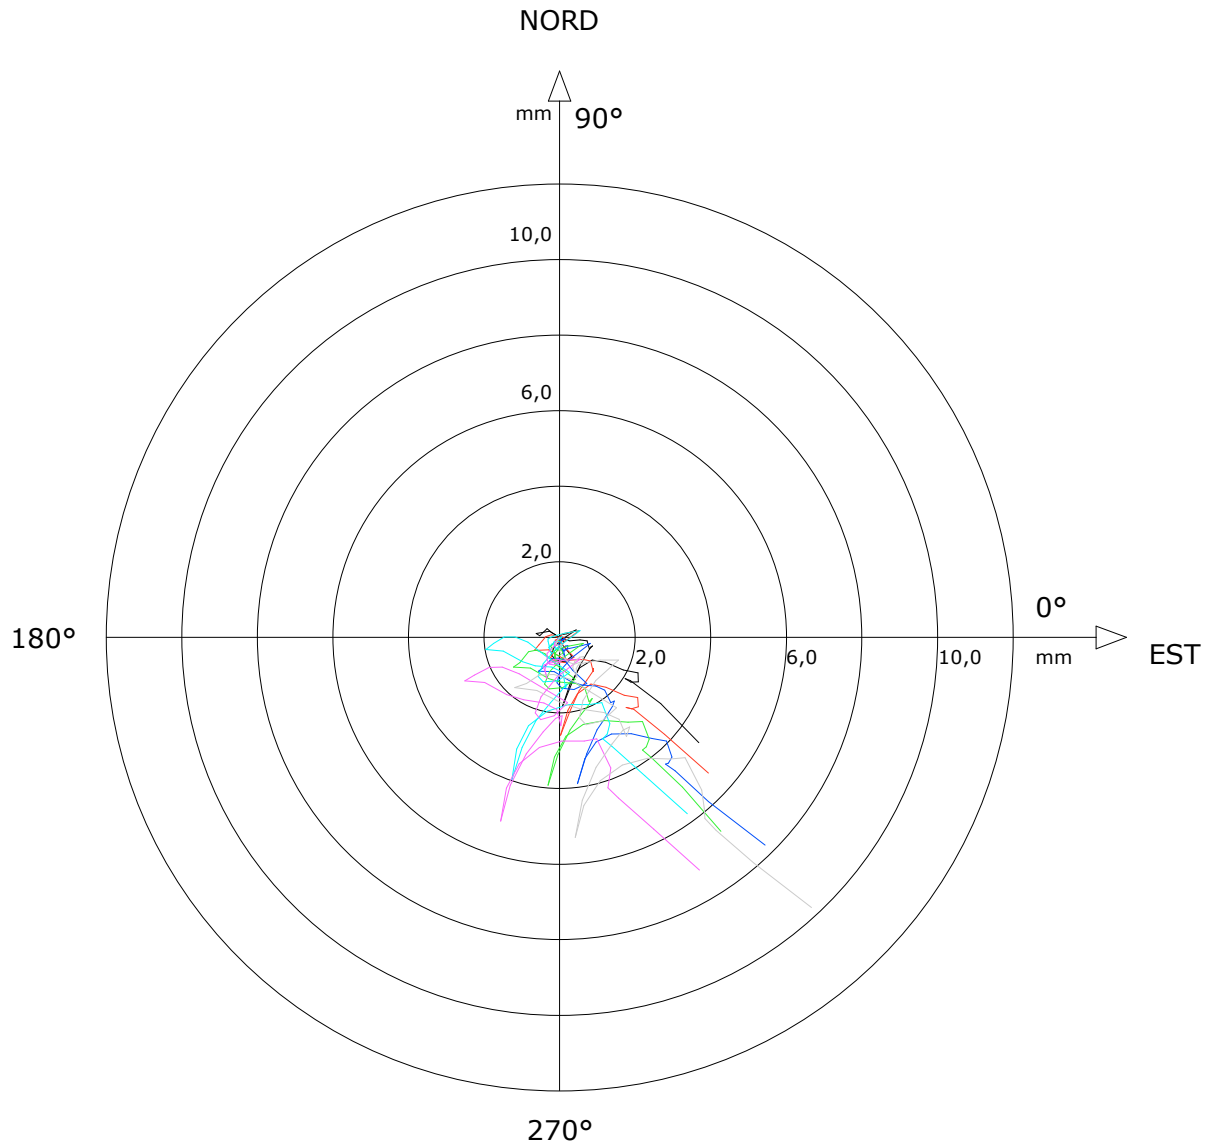
Sito: PMA-FS Tubo: SSI-SP03

Elaborazione differenziale integrale dal basso

Diagramma polare della deviazione

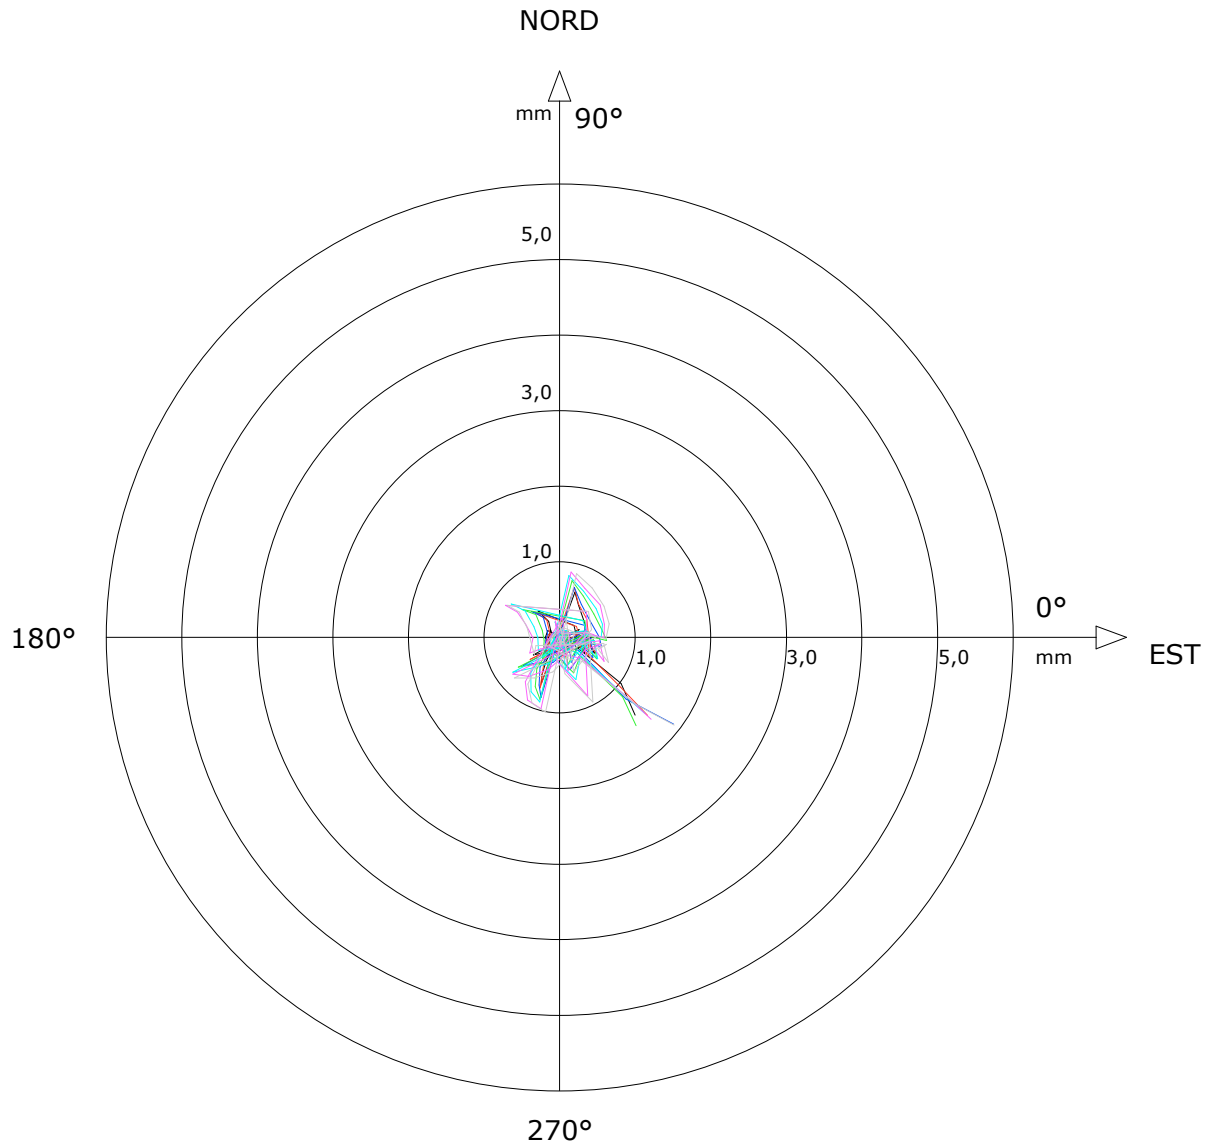
Sito: PMA-FS Tubo: SSI-SP03

Elaborazione differenziale locale dal basso

Diagramma polare della deviazione

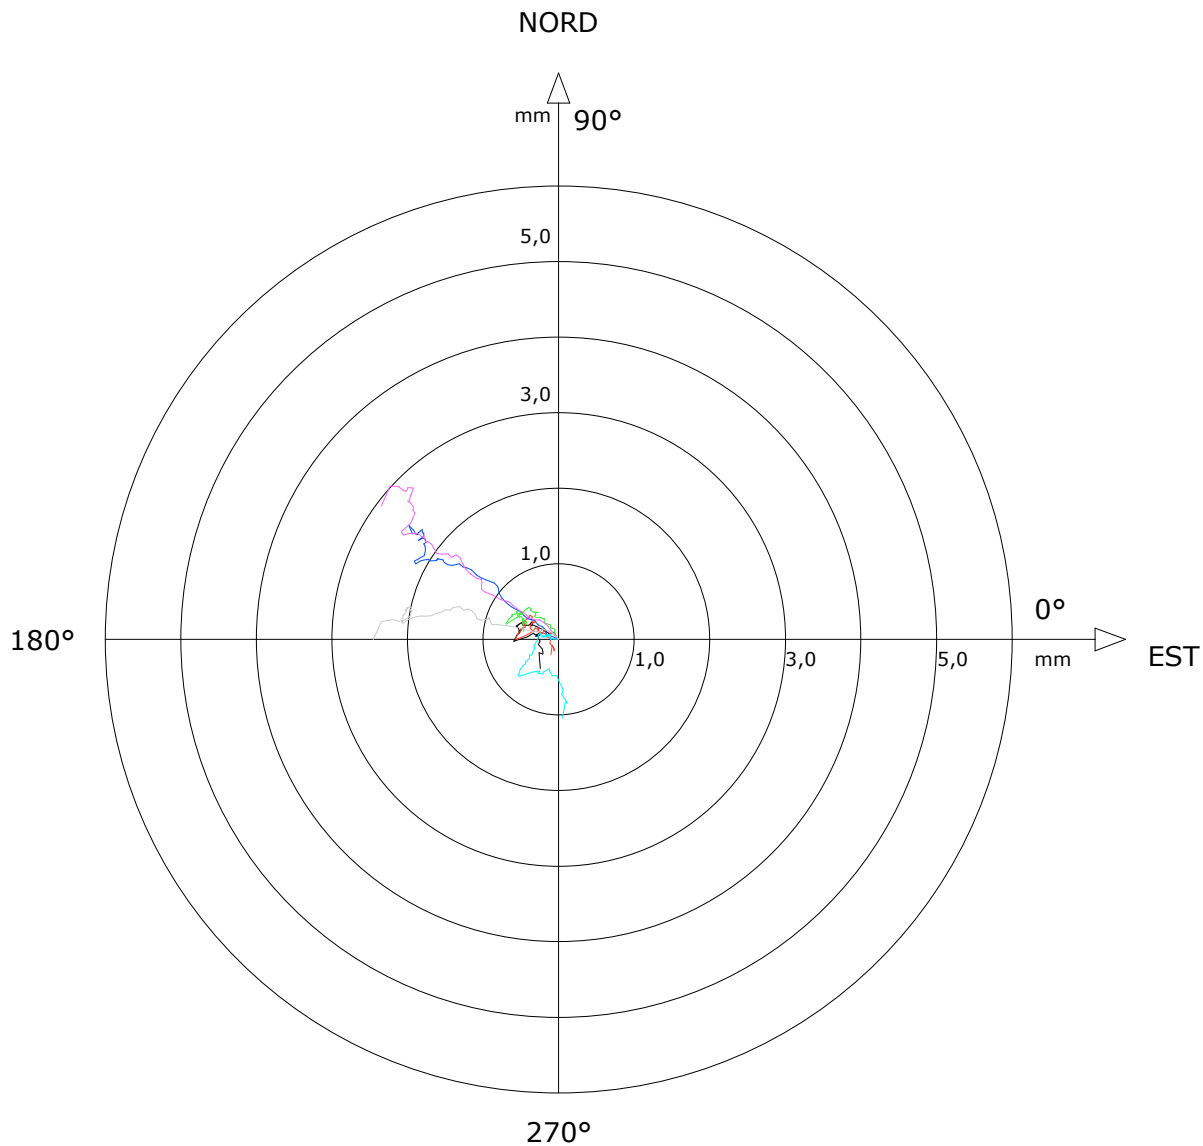
Sito: PMA-FS Tubo: SSI-SP04

Elaborazione differenziale integrale dal basso

Diagramma polare della deviazione

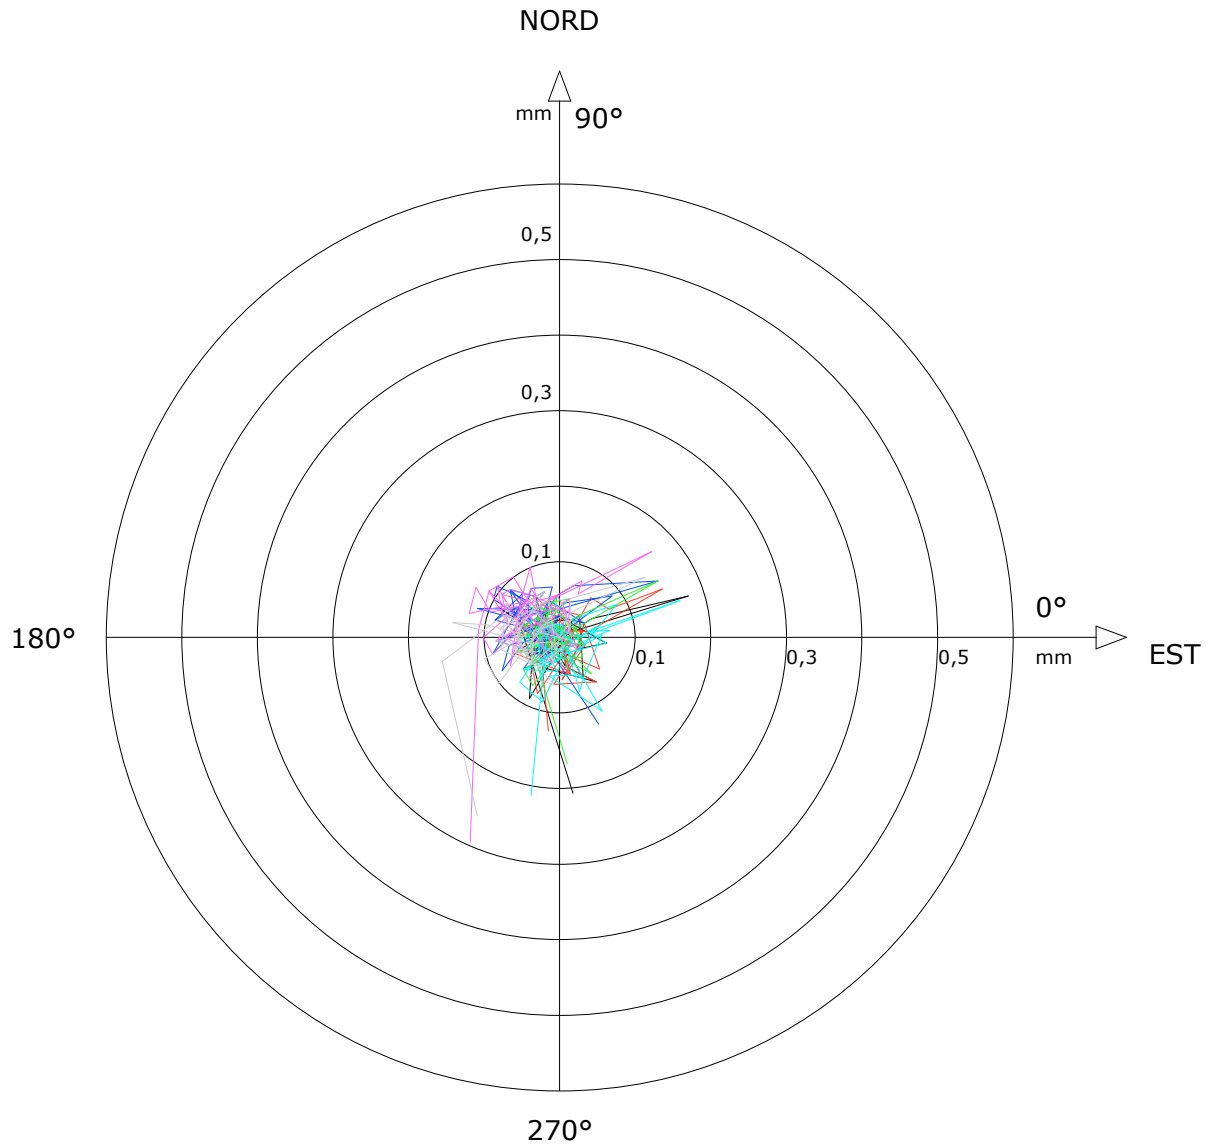
Sito: PMA-FS Tubo: SSI-SP04

Elaborazione differenziale locale dal basso

Diagramma polare della deviazione

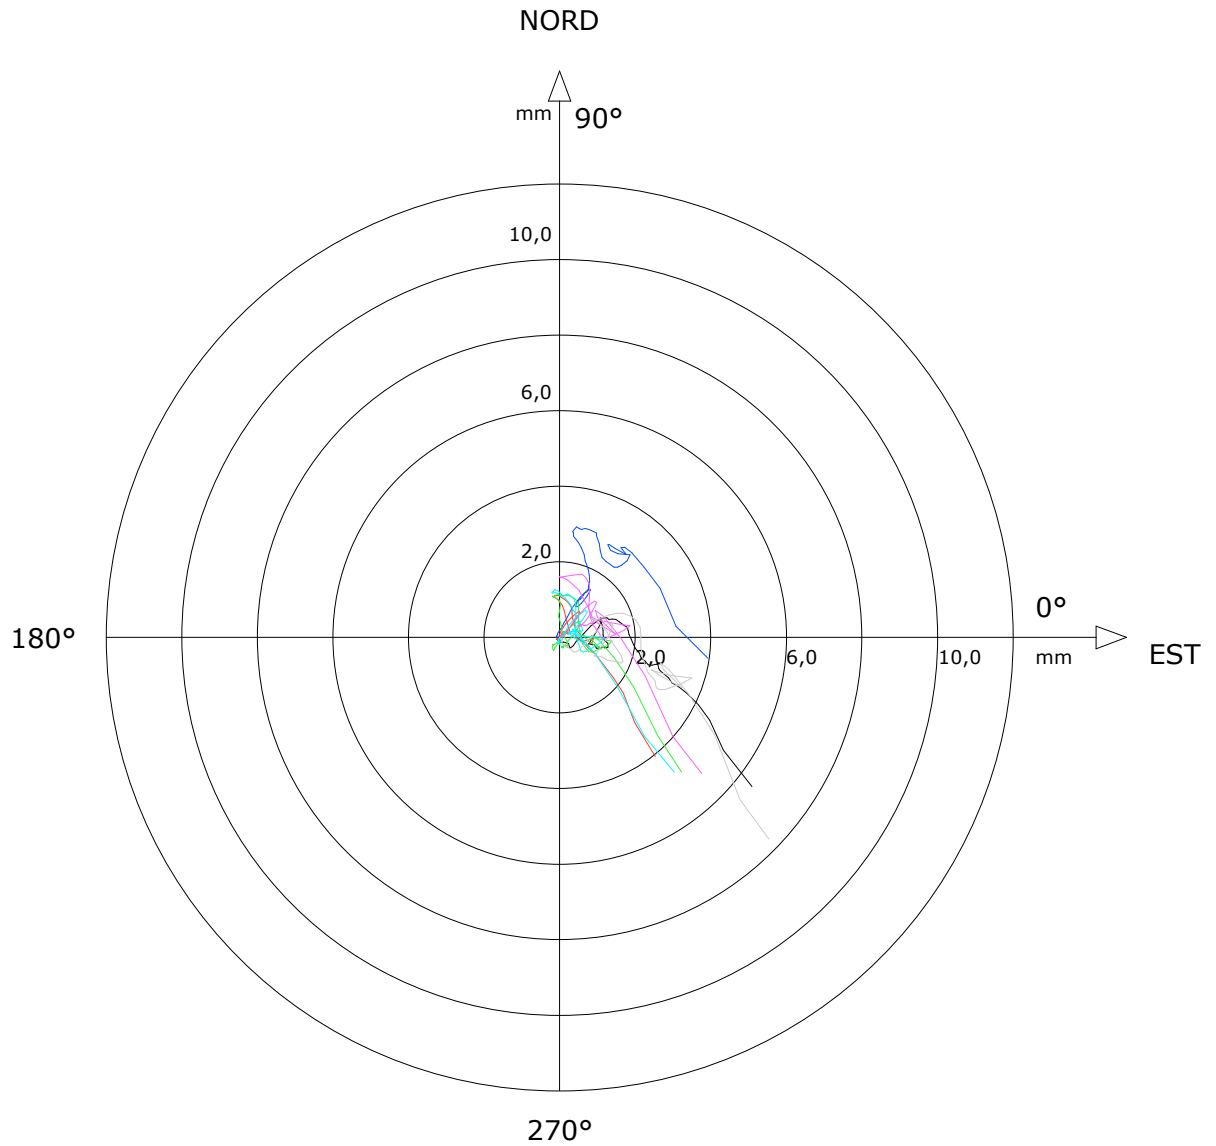
Sito: PMA-FS Tubo: SSI-SP08

Elaborazione differenziale integrale dal basso

Diagramma polare della deviazione

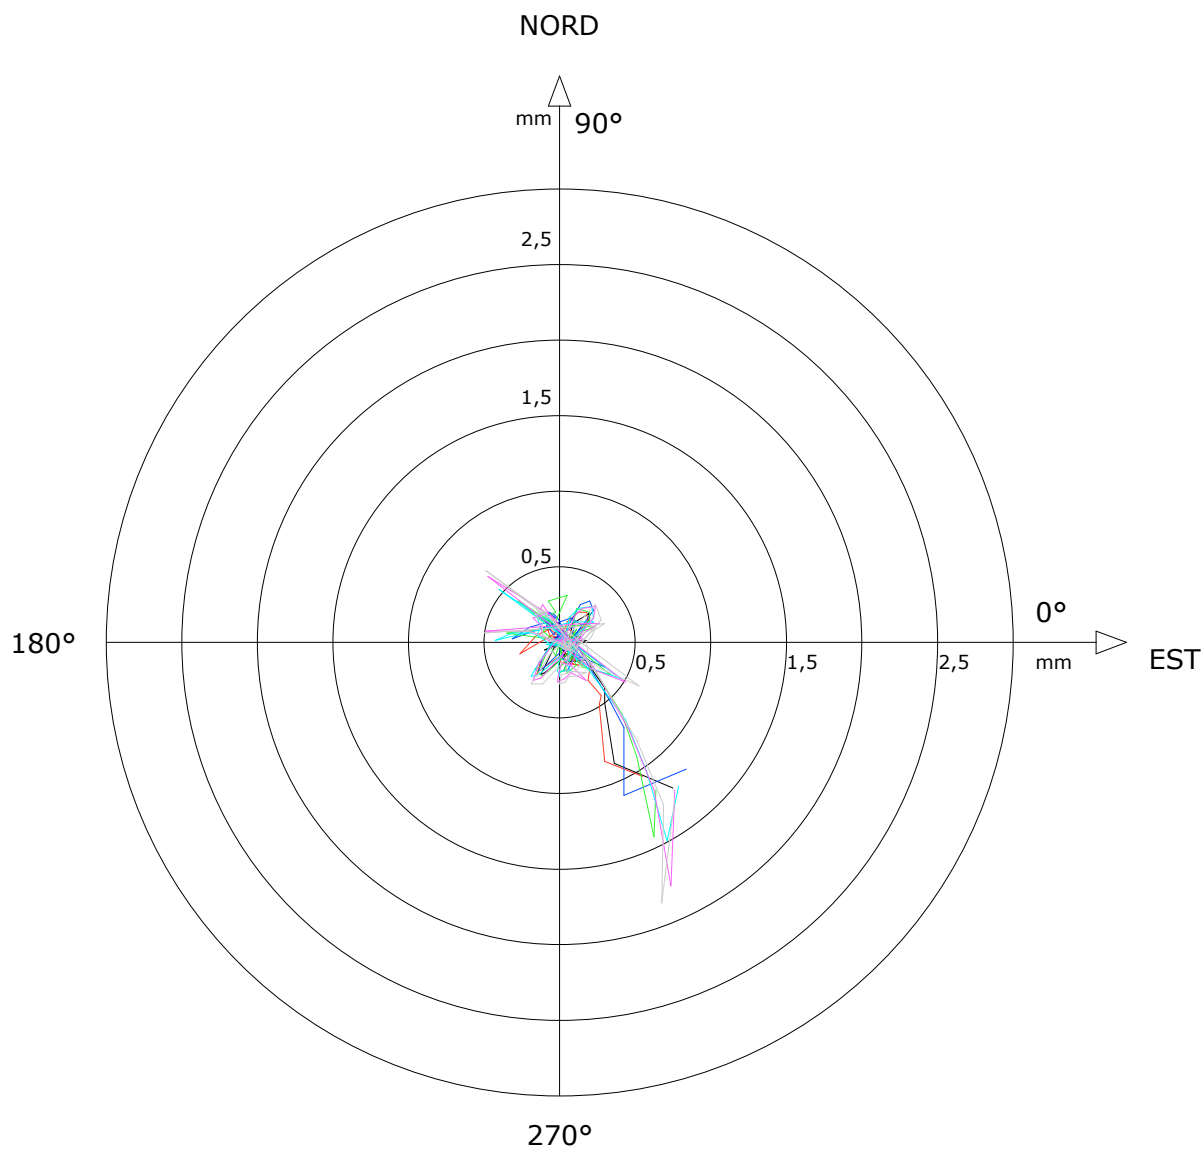
Sito: PMA-FS Tubo: SSI-SP08

Elaborazione differenziale locale dal basso

Diagramma polare della deviazione

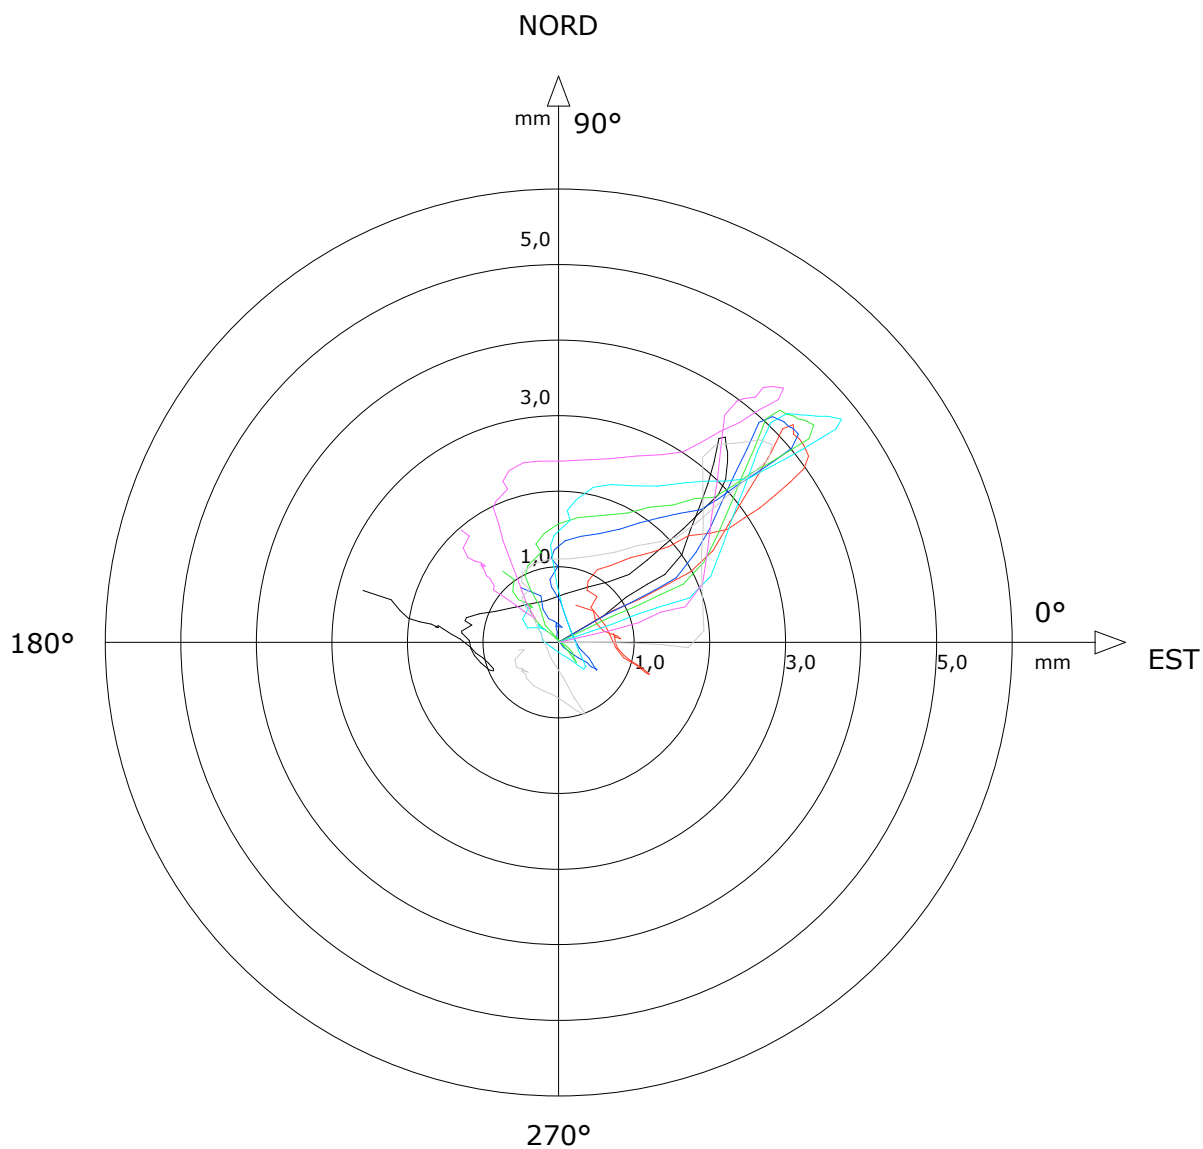
Sito: PMA-FS Tubo: SSI-SP09

Elaborazione differenziale integrale dal basso

Diagramma polare della deviazione

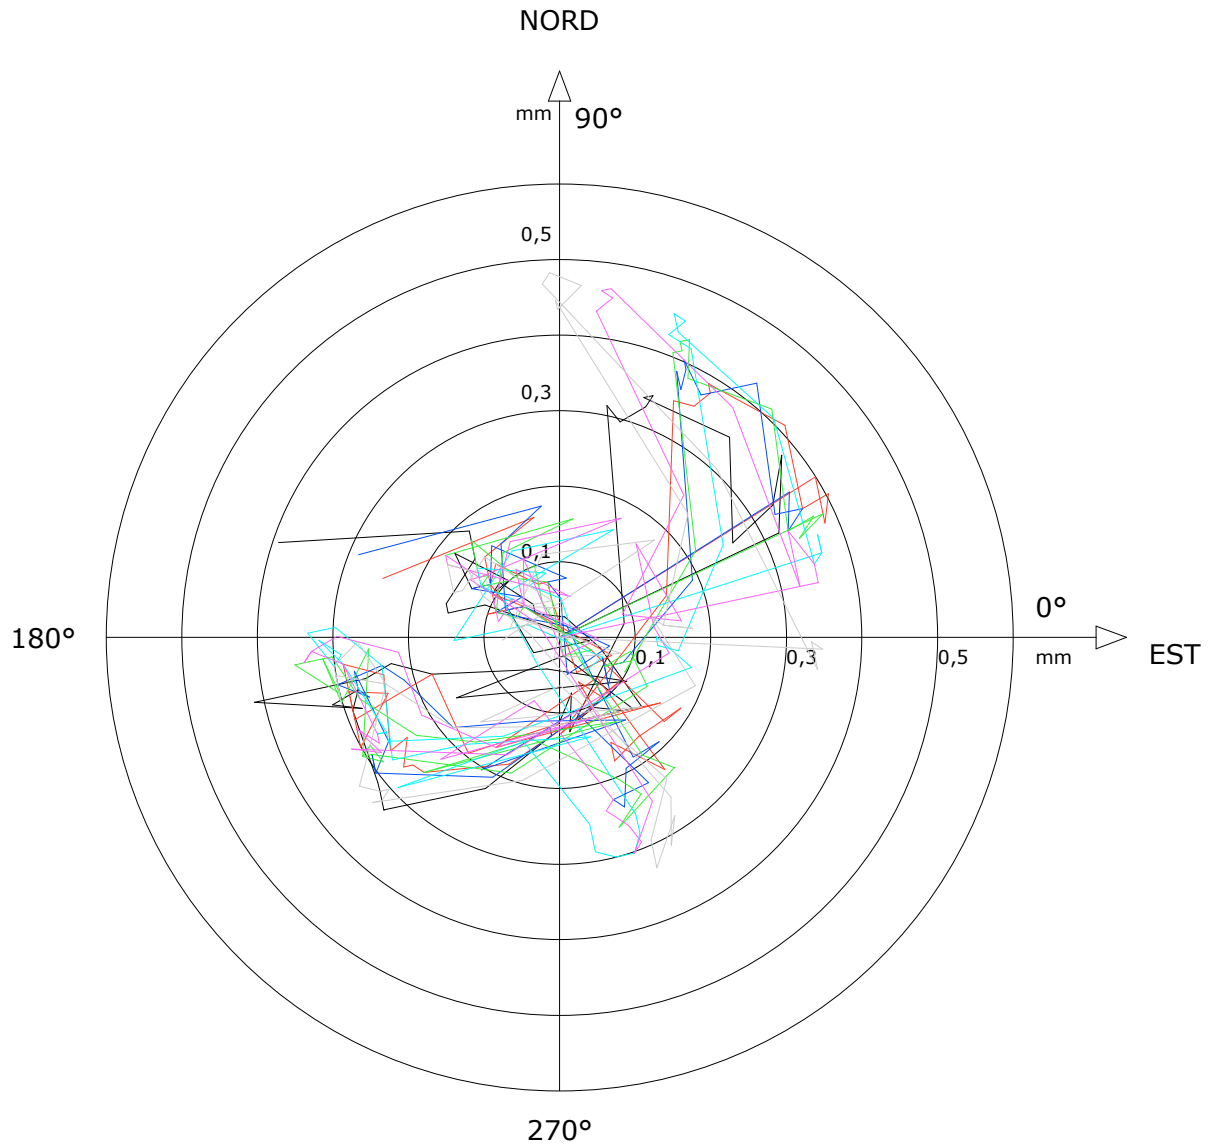
Sito: PMA-FS Tubo: SSI-SP09

Elaborazione differenziale locale dal basso

Diagramma polare della deviazione
