Elaborazione differenziale integrale dal basso

Riferimento 000:22/12/2016

Sito: PMA-FS Tubo: SSI-SP01

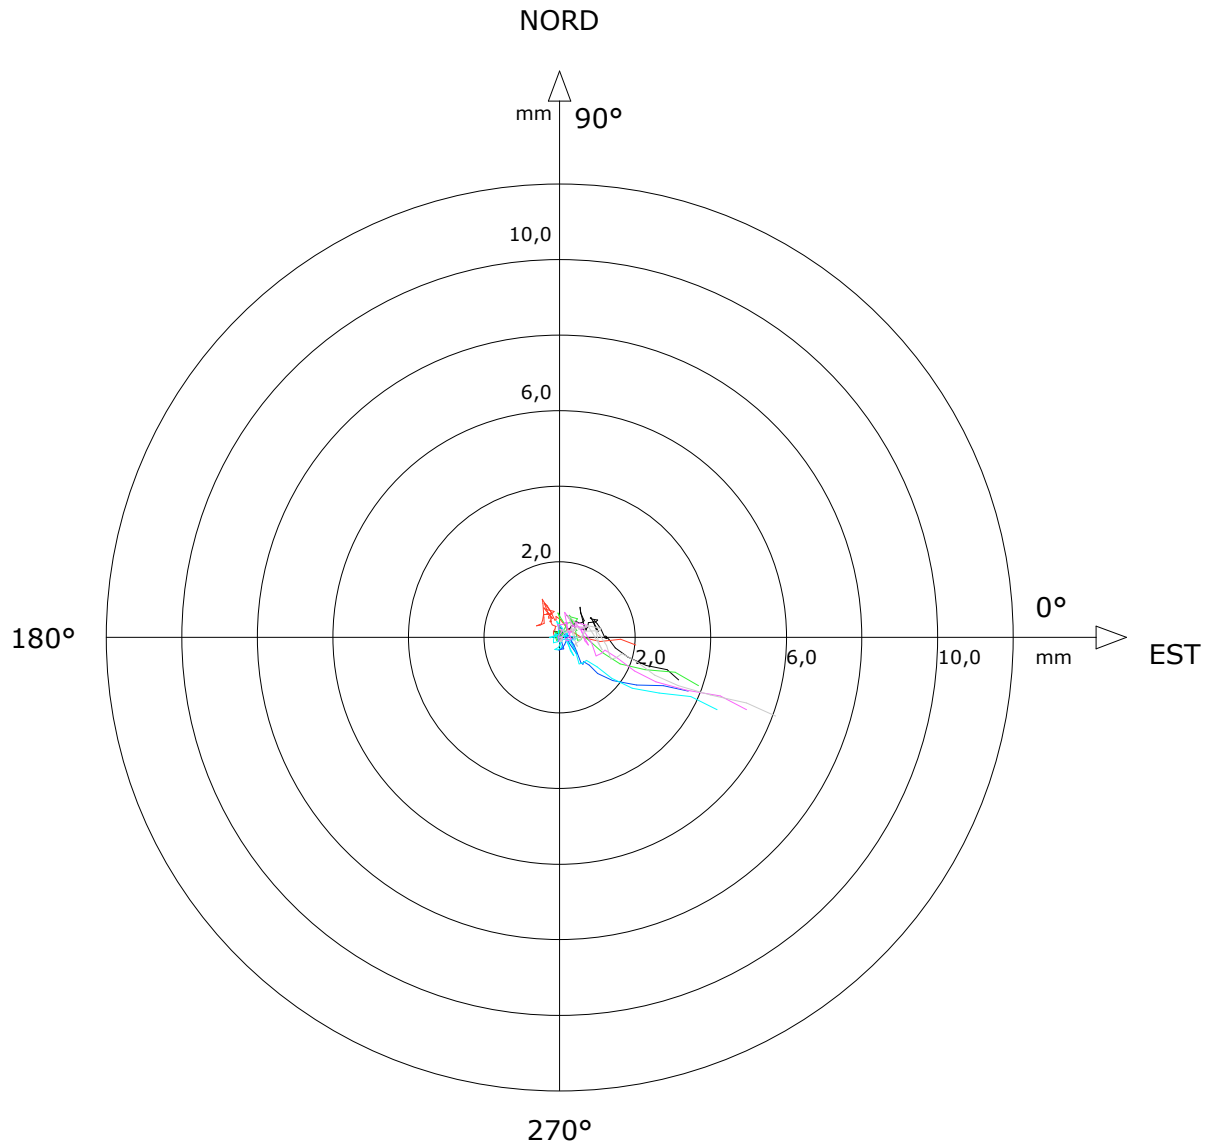
Sito: PMA-FS Tubo: SSI-SP10

Elaborazione differenziale integrale dal basso

Diagramma polare della deviazione

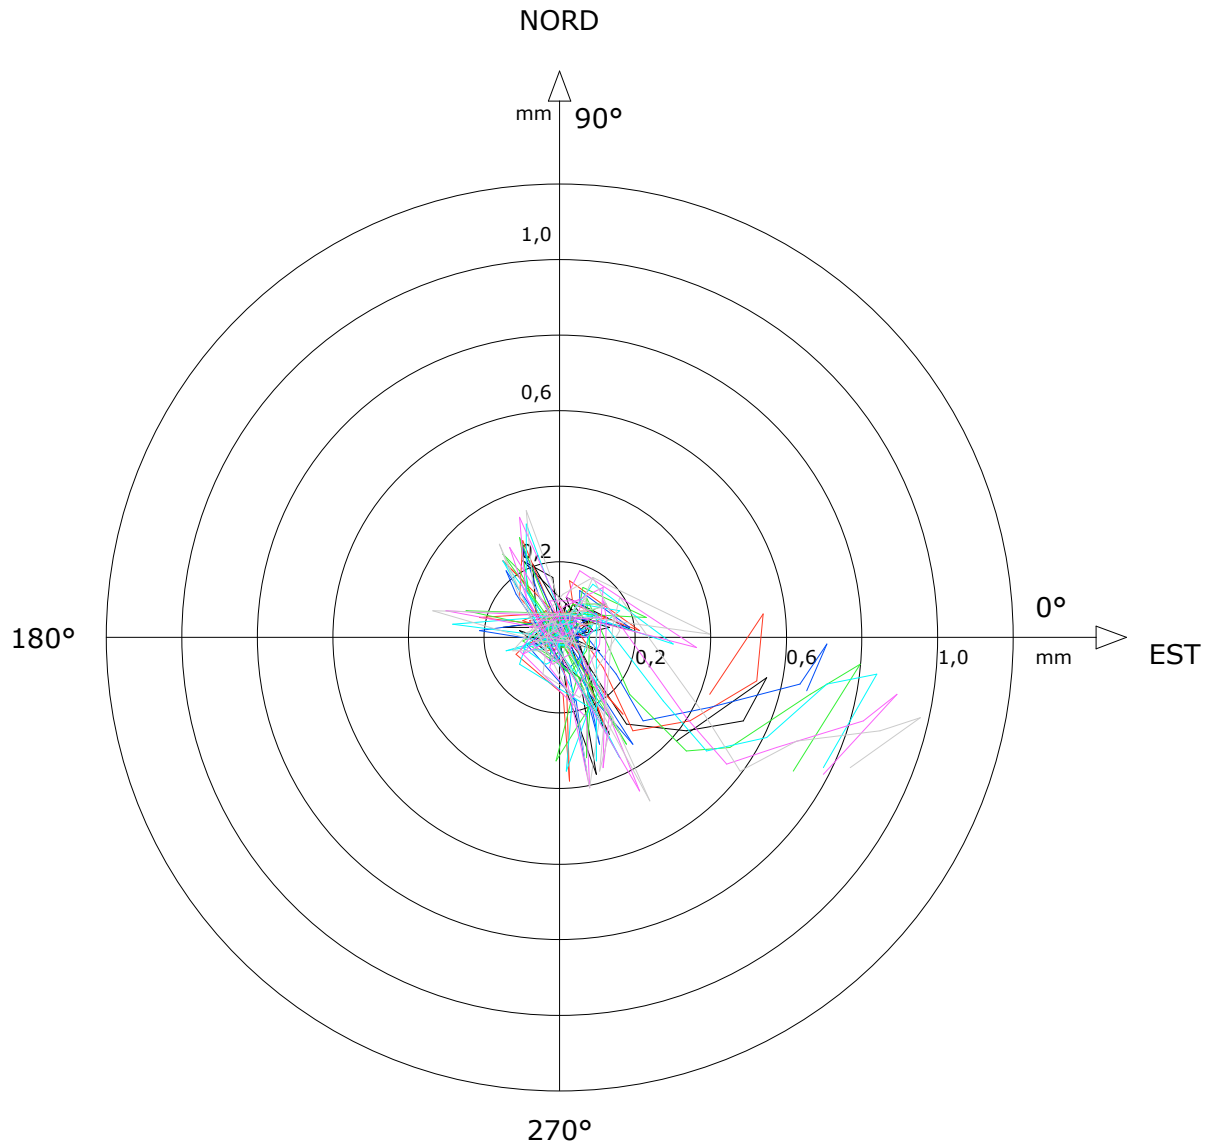
Sito: PMA-FS Tubo: SSI-SP10

Elaborazione differenziale locale dal basso

Diagramma polare della deviazione

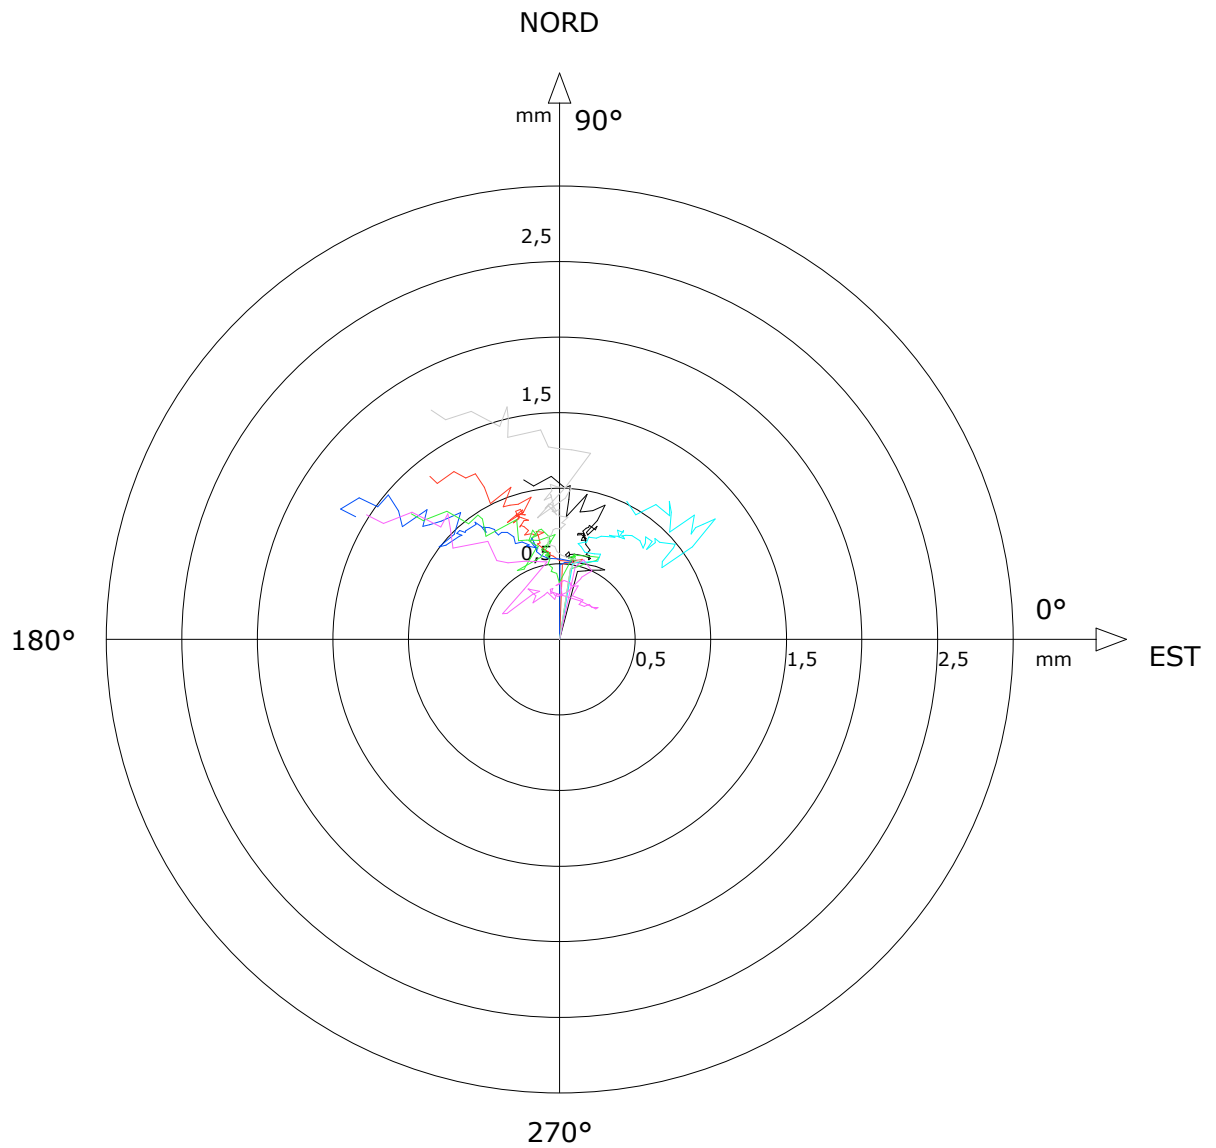
Sito: PMA-FS Tubo: SSI-SP11

Elaborazione differenziale integrale dal basso

Diagramma polare della deviazione

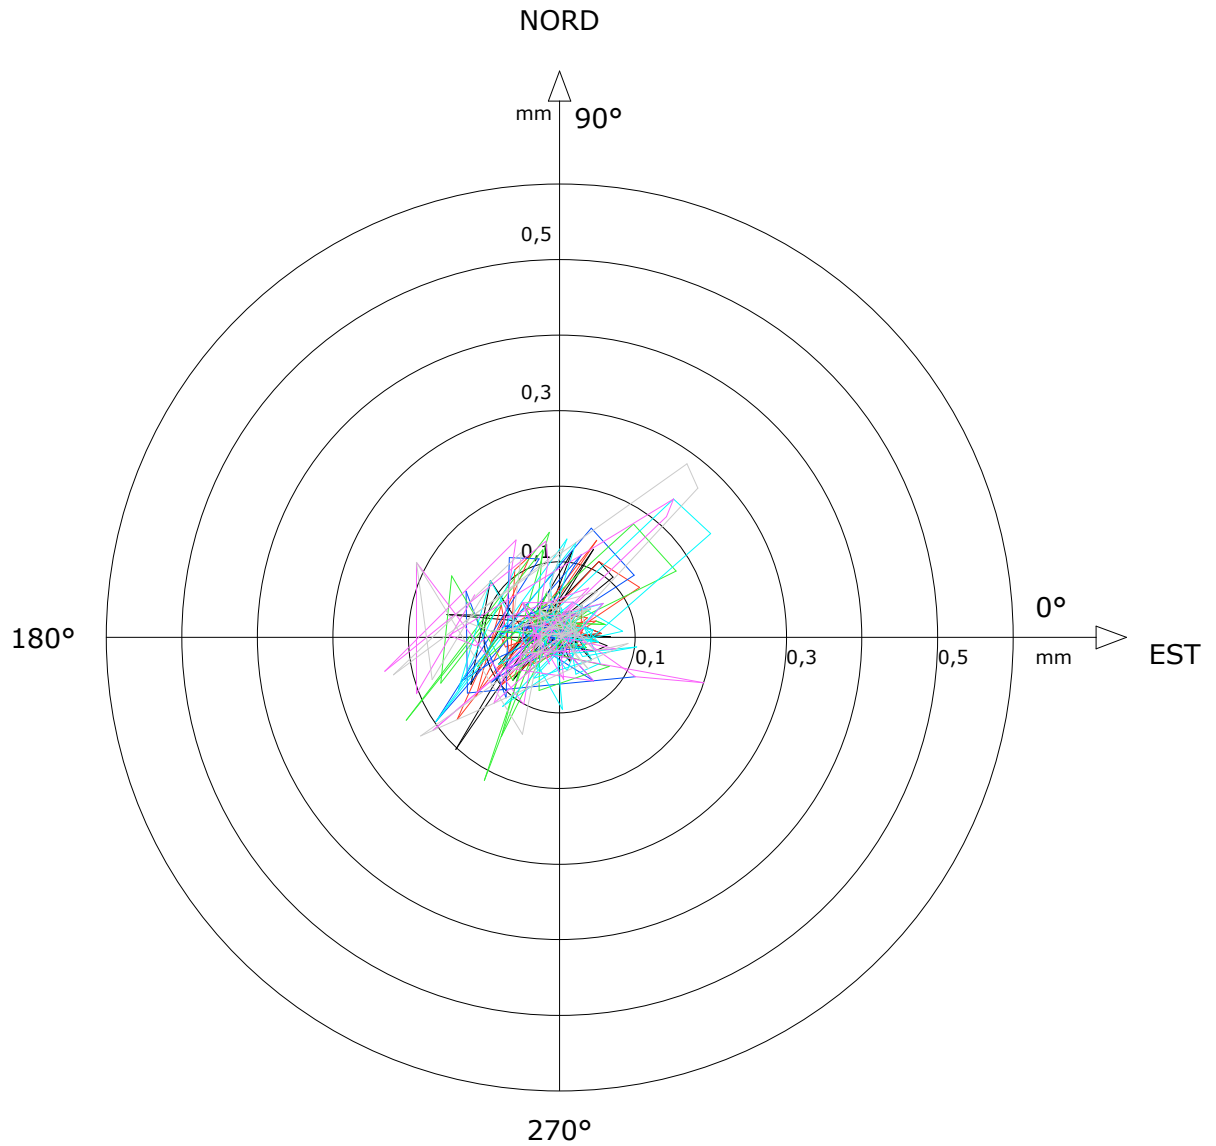
Sito: PMA-FS Tubo: SSI-SP11

Elaborazione differenziale locale dal basso

Diagramma polare della deviazione

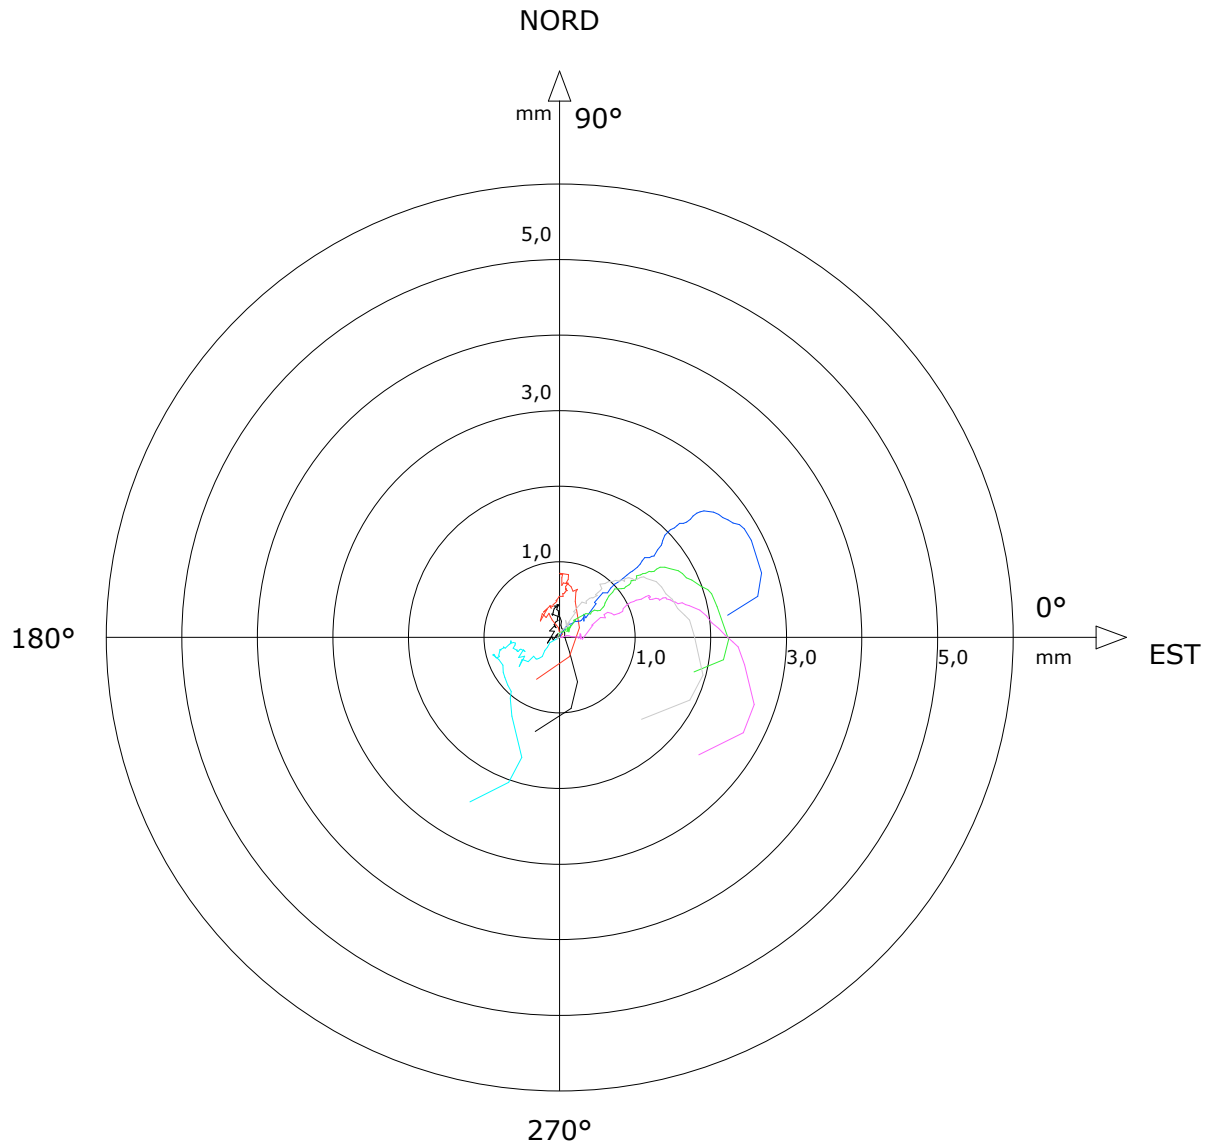
Sito: PMA-FS Tubo: SSI-SP12

Elaborazione differenziale integrale dal basso

Diagramma polare della deviazione

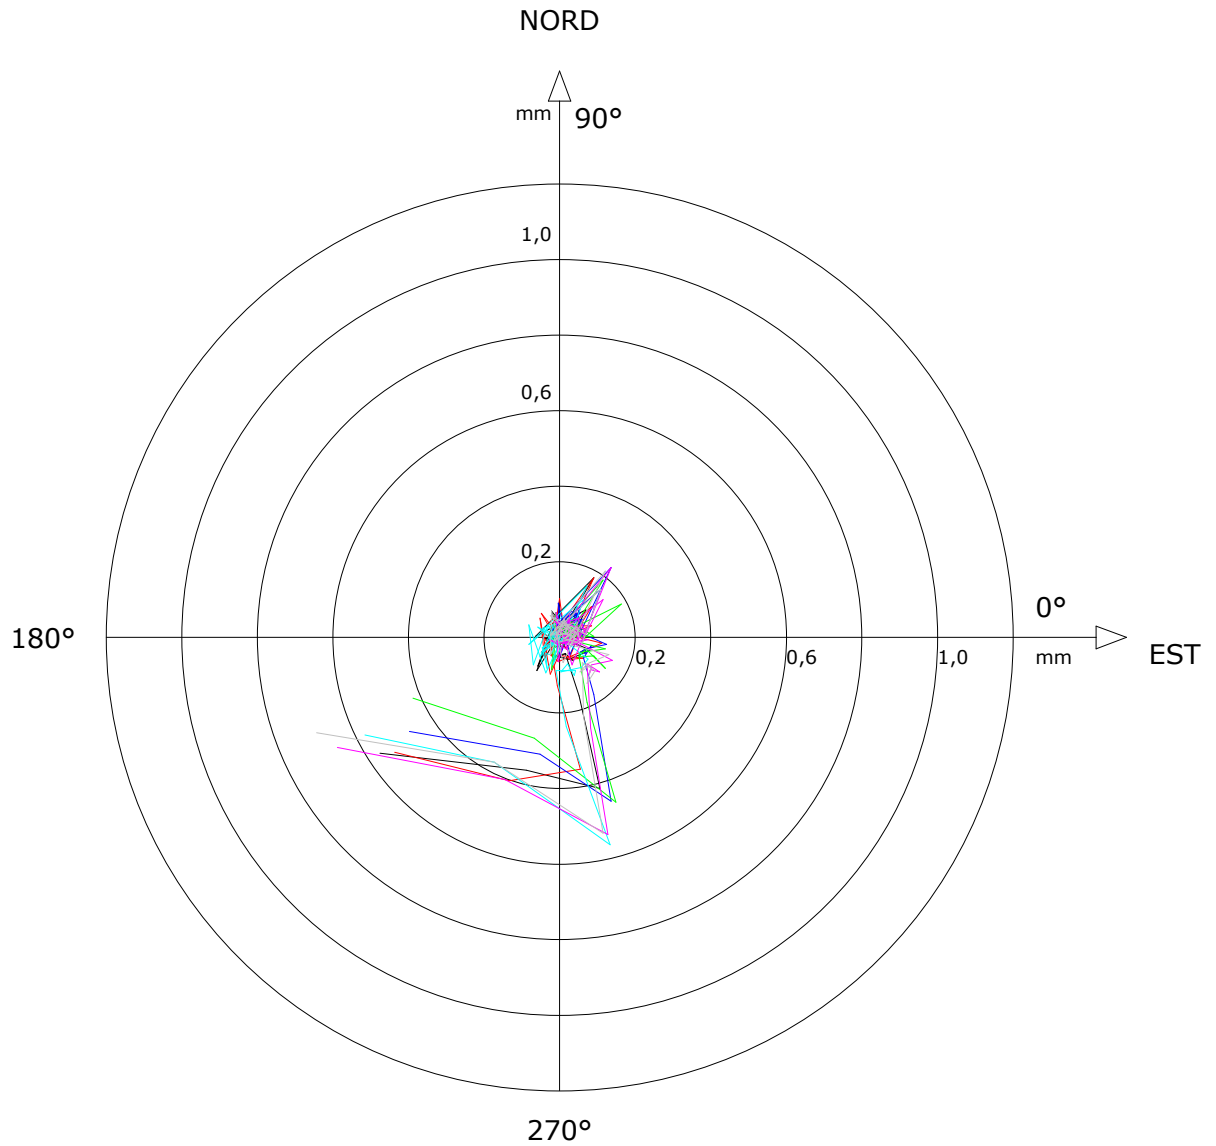
Sito: PMA-FS Tubo: SSI-SP12

Elaborazione differenziale locale dal basso

Diagramma polare della deviazione
